## FEATURE DESCRIPTIONS: PART 6. CANALS, AZ BB:13:481 (ASM)

*Thomas Klimas, Caramia Williams, and J. Homer Thiel  
Desert Archaeology, Inc.*

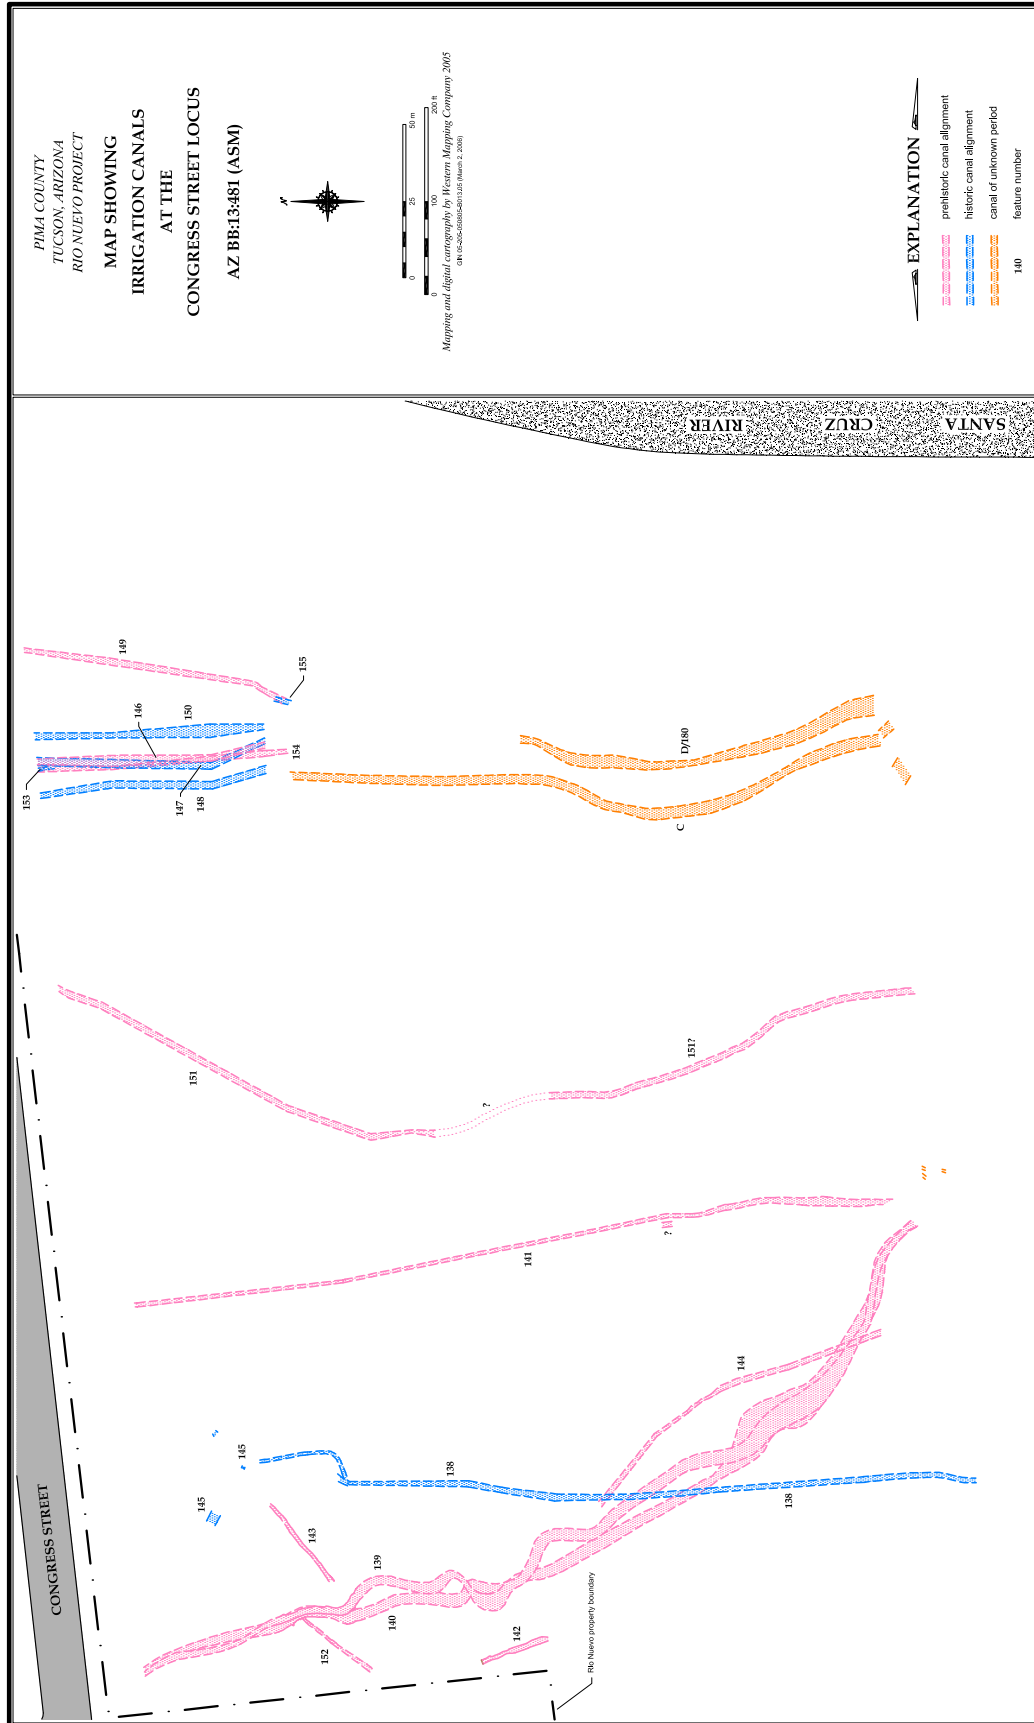
Figure 4.97. Irrigation canals, AZ BB:13:481 (ASM), located at the Congress Street locus, the Clearwater site, AZ BB:13:6 (ASM).

During test trenching and excavations at the Clearwater site, AZ BB:13:6 (ASM), numerous irrigation canals were discovered (Figures 4.96 and 4.97). Canals are considered linear features because they typically cross long distances and can transverse other sites. Following Arizona State Museum (ASM) guidelines, canals are assigned a separate site number. AZ BB:13:481 (ASM) had previously been used for the prehistoric- and historic-era canals located on the western side of the Santa Cruz River between 29th Street on the south and Alameda Street to the north. Testing of the Rio Nuevo South property and trenching along Alameda Street in 1995 located numerous irrigation canals (Diehl 1996; Freeman et al. 1999; Thiel 1995). The work conducted for the Rio Nuevo Archaeological project in 2000-2003 resulted in the discovery of additional portions of these previously discovered canals, as well as previously unknown canal alignments. These were also assigned to BB:13:481.

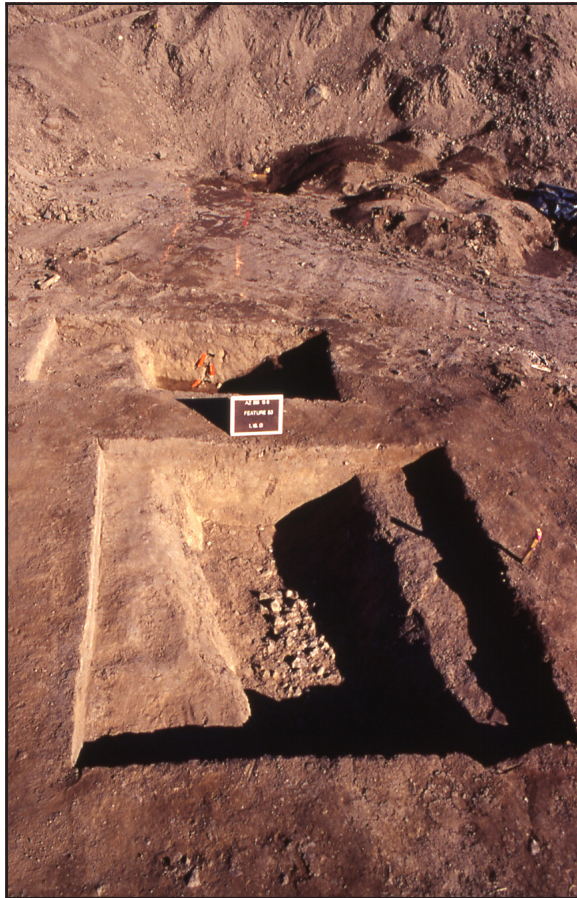
**Figure 4.98.** Photograph of canal Feature 53, AZ BB:13:481 (ASM), at the San Agustín Mission locus, the Clearwater site, AZ BB:13:6 (ASM).

Feature 53 (Figure 4.98) was a small canal that curved from the south to the east before being lost in the 1950s landfill. The canal was traced for 34.2 m. On average, it was 1.3 m wide at the top and narrowed to

70 cm wide at the base. The canal was basin shaped in profile and was 43 cm deep. Portions of the canal were apparently lined with fire-cracked rock. Three excavation units were placed in the feature, which was filled with a homogenous light brown to tan silt. The canal appears to have been filled in during a flood event—probably the same flood that dumped light-colored silt into numerous nearby Cienega phase pit structures and pits.

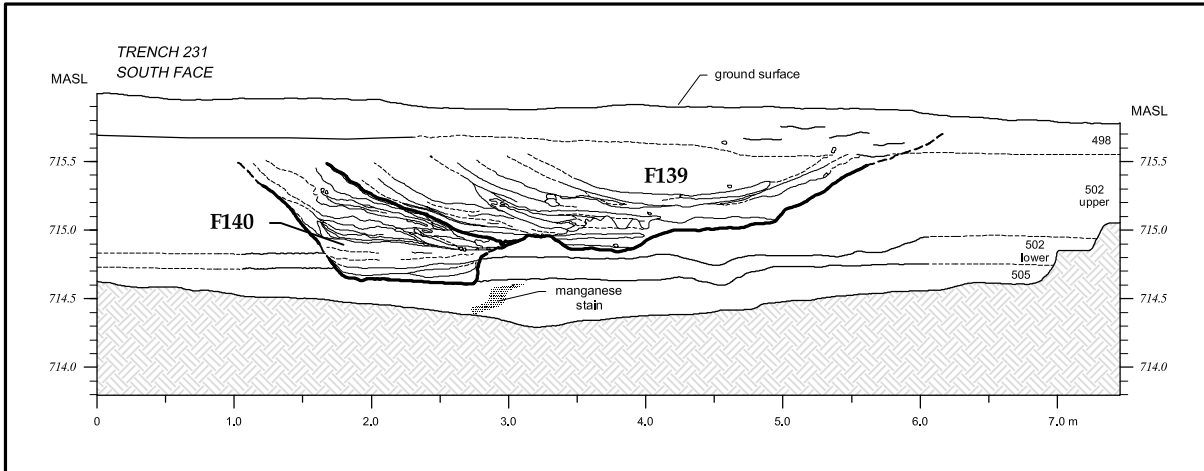
**Figure 4.99.** Cross section of canal Feature 140, AZ BB:13:481 (ASM), at the Congress Street and Brickyard loci, the Clearwater site, AZ BB:13:6 (ASM).

Feature 140 (Figure 4.99) was found in Trenches 201, 203, 205, 207, 216, 267, 275, 276, 277, 278, 279, 284, and 285. It was drawn in Trenches 201, 203, 205, 207, 215, 216, 231, 232, 275, 276, 277, 278, 279, 284, and 285. The canal ran southeast to northwest, and was traced for about 120 m. The canal was between 2.40 m and 3.75 m wide, and was 1.03 m deep, originating at 62 cm below the modern ground surface.

At least two different uses are visible. The first use cuts through cienega clays to the underlying silty clay and sand layers. Manganese staining is present at the base of the canal, with a light gray reddish-brown blocky clay filling the lower portion of the canal. The canal was re-dug into a broad basin shape. The base of this later canal was filled with dark brown blocky clay overlain by a light silty clay. The upper portion of the canal was filled with a reddish-brown silty clay. It is unclear, however, if this was deposited during use of the feature or after it was abandoned. Ostracode samples were collected from the northern wall of Trench 201, the southern wall of

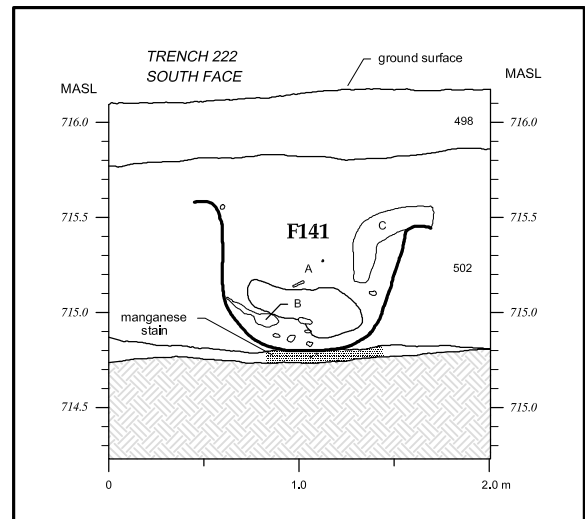
**Figure 4.100.** Cross section of canal Feature 141, AZ BB:13:481 (ASM), at the Congress Street and Brickyard loci, the Clearwater site, AZ BB:13:6 (ASM).

Feature 141 (Figure 4.100) was found in Trenches 114, 219, 220, 222, 229, 236, and 237. It was drawn in Trenches 114, 219, 220, 222, 229, 236, and 237. The broadly U-shaped canal ran south to north and could be followed for 180 m. It was between 94 cm and 1.76 m wide, and was 60 cm to 90 cm deep, originating at 25 cm to 40 cm below the modern ground surface. The canal originated within Stratum 502 and cut through Stratum 503. It was filled

with a compact blocky brown clay with some lenses of sandy clay loam to sandy loam to silty clay loam, some of which probably lie at the base of a clean-out. In Trench 222, an area where material had slumped in from the side of the canal was clearly visible. A cluster of fire-cracked rock and charcoal was found at the base of the canal in Trench 114. The top of the canal was truncated by the plowzone. It cut through Feature 545 from BB:13:6, a roasting pit. Ostracode samples were collected from the northern faces of Trenches 219 and 220. A radiocarbon date from a charred maize cupule indicated the canal dates to 2470±40 b.p. (uncalibrated <sup>14</sup>C years), or about 770-430 B.C. (at the 1-sigma range of probability).

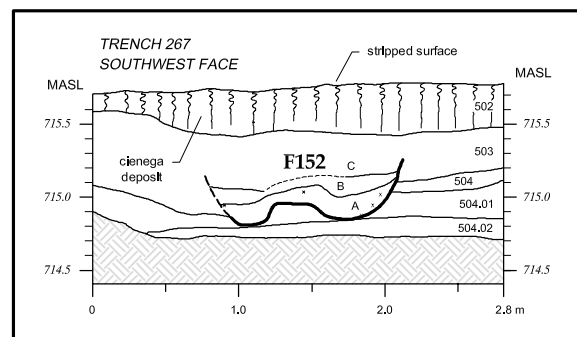
**Figure 4.101.** Cross section of canal Feature 152, AZ BB:13:481 (ASM), at the Congress Street and Brickyard loci, the Clearwater site, AZ BB:13:6 (ASM).

Feature 152 (Figure 4.101) was located in Trenches 201, 203, and 267, as well as in a stripped area. It was drawn in Trench 267. The canal ran southwest to northeast and was traced for about 27 m. The canal was 1.5 m wide and 39 cm deep. The base of the canal was filled with a medium brown sandy clay loam. Above this were a layer of dark brown blocky clay and a medium brown sandy clay. The canal originated in Stratum 503, and was cut down into Stratum 504.01. Ostracode samples were collected from the Trench 267 cross section. Based on its stratigraphic context, this canal dates to about 1500 B.C.

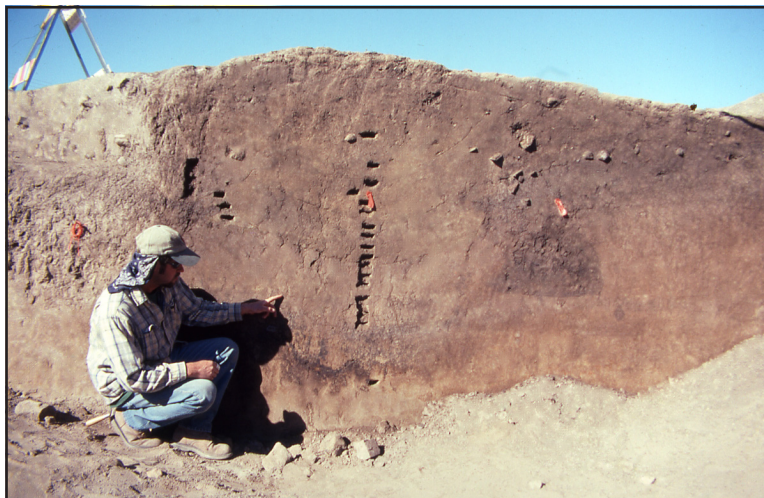
**Figure 4.102.** Photograph of canal Feature 137, AZ BB:13:481 (ASM), at the San Agustín Mission locus, the Clearwater site, AZ BB:13:6 (ASM).

Feature 137 (Figure 4.102) was a large canal found during backhoe scraping and feature excavation at the San Agustín Mission locus. The canal ran southeast to northwest, passing through the southwestern corner of the later mission compound. It was exposed for a distance of over 88.20 m. On average, it was 1.88 m wide and 1.30 m deep. The top of the canal had been truncated by modern ground disturbance.

The canal was drawn in an area south of Mission Lane, where it cut through a Cienega phase pit structure, Feature 132. The broadly U-shaped canal was cut through cienega clays into the underlying silts. The sediments below the base of the

canal had manganese staining. The bottom of the interior of the canal was covered by a sandy loam, above which were layers of silty clay. At least one clean-out was visible. The upper portion of the canal had been filled in by a flood.

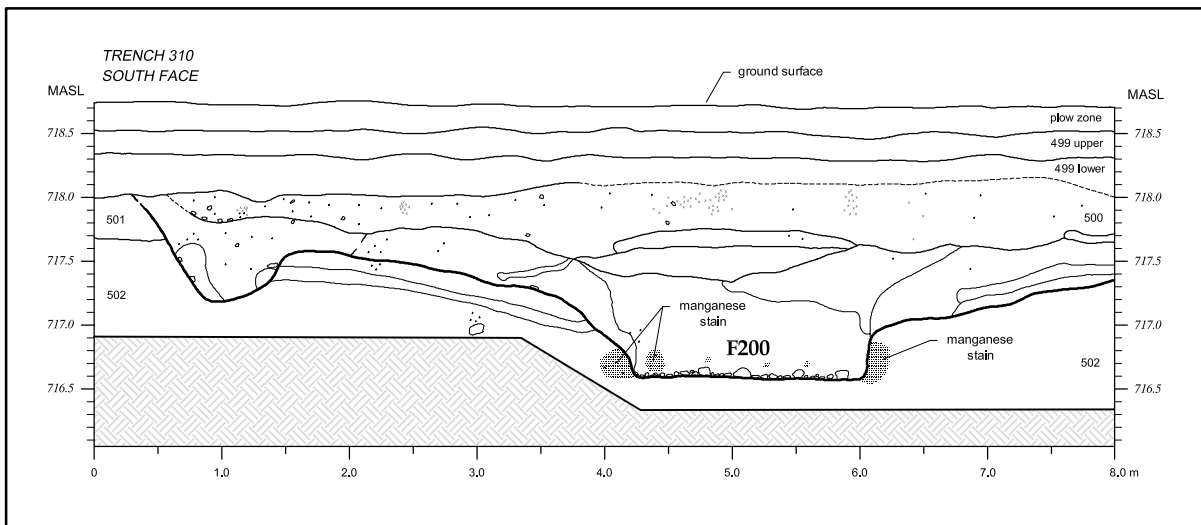
**Figure 4.103.** Cross section of canal Feature 200, AZ BB:13:481 (ASM), at the Mission Gardens locus, the Clearwater site, AZ BB:13:6 (ASM).

Feature 200 (Figure 4.103) was a massive canal located in Trenches 302, 308, 310, 311, 324, 325, and 356. It was drawn in Trenches 302, 310, and 311. The canal ran southwest to northeast through the western portion of the garden area before turning in a broad arc toward the northwest. It was traced over a distance of 121.8 m. In terms of overall size, this may be the largest Hohokam canal found to date in the Tucson Basin.

In Trench 302, the canal was 7.58 m wide and 2.20 m deep, originating at 42 cm below the modern ground surface. The canal cut through the dark brown cienega clays that are present within the gardens into an underlying compact light brown sandy-silty clay. The canal was filled with a layer of fine, loosely consolidated sand at its base. Above this was a layer of compact dark brown blocky clay that probably represents fine sediments that were deposited as the canal was in use. Above this was a pale tan sandy clayey silt or sand that filled the canal during a flood. This flood completely filled the canal, and there is no evidence that the Hohokam ever attempted to clean out and re-use the canal. Hohokam sherds were common within the fill. The canal was

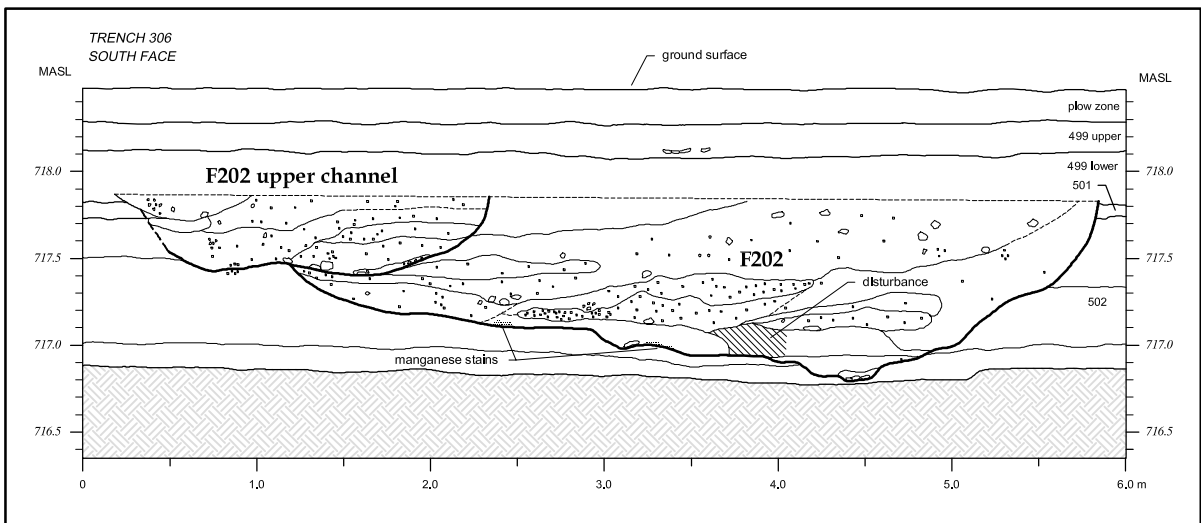
**Figure 4.104.** Cross section of canal Feature 202, AZ BB:13:481 (ASM), at the Mission Gardens locus, the Clearwater site, AZ BB:13:6 (ASM).

Feature 202 (Figure 4.104) was a large canal located and profiled in Trench 306 south of the corner of Mission Lane and Brickyard Lane. The canal was oriented north-south, perhaps trending toward the northeast, but the limited exposure makes it difficult to determine its exact alignment. The overall canal

cross section was 5.65 m wide; however, the canal shifted west through time, with the actual canal ranging from 80 cm to 194 cm wide at various times. It was 91 cm deep at its deepest point, with the top of the canal found 69 cm below the modern ground surface. Historic plowing may have truncated the upper portions of the canal. The canal was filled with a variety of sediments ranging from dark gray-brown sandy clay at the base to light brown silty clay near the top. The cutting of sediments within the canal suggested it was cleaned out on several occasions.

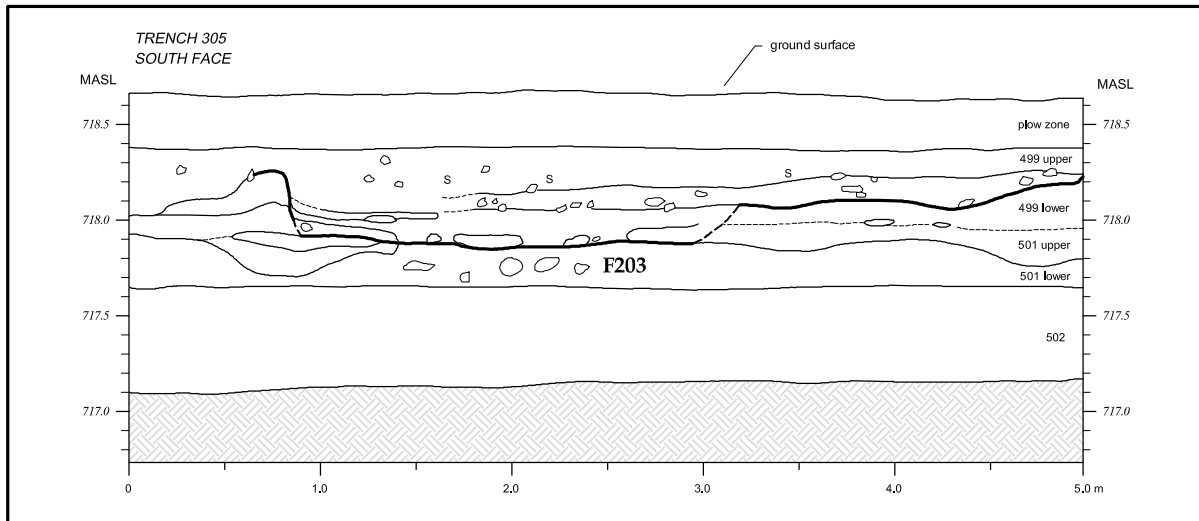
**Figure 4.105.** Cross section of canal Feature 203, AZ BB:13:481 (ASM), at the Mission Gardens locus, the Clearwater site, AZ BB:13:6 (ASM).

Feature 203 (Figure 4.105) was a probable prehistoric-era canal located and profiled only in Trench 305, a few meters west of canal Feature 210. It appeared to run south-north. The top of the canal was truncated by the plowzone. Below this, the canal was 3.8 m wide and 52 cm deep, with its top found 30 cm below the modern ground surface. The base of the canal was lined with intermittent lenses of clay and laminated bands of sand, silty sands, and clay. A berm may have been present along the eastern side of the canal, with some clean-out deposits east of the berm. Several sherds and pieces of fire-cracked rocks were present within the fill.

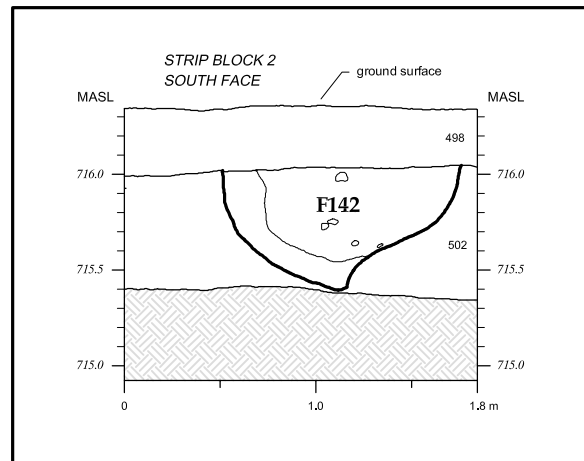
**Figure 4.106.** Cross section of canal Feature 142, AZ BB:13:481 (ASM), at the Congress Street and Brickyard loci, the Clearwater site, AZ BB:13:6 (ASM).

Feature 142 (Figure 4.106) was a canal found in Trench 206 and during backhoe scraping. It ran southeast to northwest, and was traced for approximately 20 m, extending west beyond the project area and south into a disturbed area. An excavation unit, 1.30 m long by 1.29 m wide, was placed over the feature. It was filled with blocky clay, with a thin sand lens above the canal base. In profile, the canal was basin shaped with shallow, sloping sides. On average, it was 1.2 m wide and 40 cm deep. Screening of dirt from the unit resulted in the recovery of one small sherd, some flaked stone, a piece of ground stone, and 56 pieces of fire-cracked rock. The canal originated

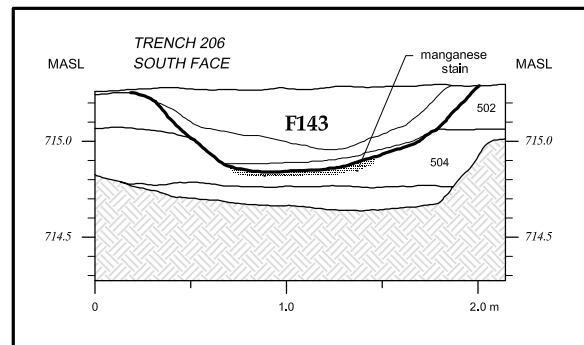
**Figure 4.107.** Cross section of canal Feature 143, AZ BB:13:481 (ASM), at the Congress Street and Brickyard loci, the Clearwater site, AZ BB:13:6 (ASM).

Feature 143 (Figure 4.107) was a canal located in Trench 201, in an unnumbered trench south of Trench 201, and during backhoe scraping. It was drawn in the unnumbered trench segment. Only a 10-m-long segment was documented, running southwest to northeast. The feature was originally thought to be a pit structure. The basin-shaped canal averaged 1.64 m wide and at least 46 cm deep. The base of the canal was reddish-brown lightly compacted sand. Above this was a layer of compact grayish-brown sandy clay loam which was, in turn, covered by compact brown sandy clay. Manganese staining was present below the base of the canal.

An excavation unit measuring 2 m long by 2 m wide was placed over the feature. It was identified as a canal based on the presence of distinctive sedi-ments that consisted of blocky clay similar to Stra-tum 502. The canal cut into the underlying orange brown sand, Stratum 504. Charcoal flecks and cal-cium carbonate stringers and nodules were present. Excavation of the unit resulted in the recovery of only a few artifacts – one piece of flaked stone, one sherd, and six pieces of fire-cracked rock. Ostracode samples were collected from the southern cross section in the unnumbered trench.

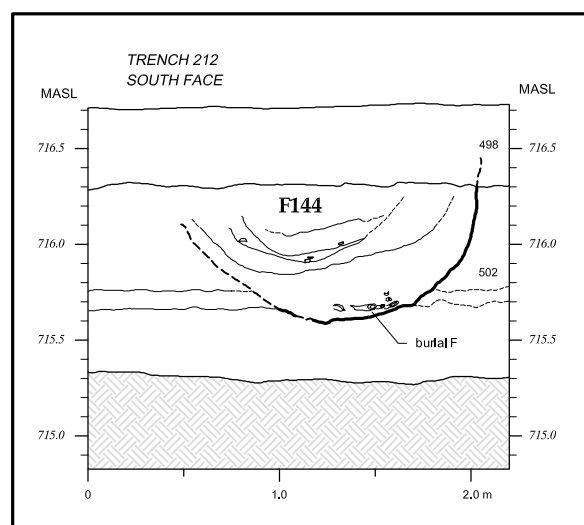
**Figure 4.108.** Cross section of canal Feature 144, AZ BB:13:481 (ASM), at the Congress Street and Brickyard loci, the Clearwater site, AZ BB:13:6 (ASM).

Feature 144 (Figure 4.108) was found in Trenches 208, 210, 212, 234, 246, 269, and 270. It was drawn in Trenches 212 and 270. The canal ran southeast to northwest, and was traced for about 110 m. On av-erage, the canal was 1.24 m wide in Trench 270, and was 80 cm deep. The base of the canal was filled with light brown clay and compact grayish-yellow silt. Above this were blocky gray clayey silt and very hard, compacted, grayish-yellow-brown silt. In some areas, the sediments had a green hue, perhaps indi-cating a high organic content or gley (low oxygen) conditions.

Feature 144 was also studied through an excava-tion unit measuring 1.14 m by 90 cm that was placed in the feature after human bone was discovered. Ex-cavation of a 5-cm level resulted in the recovery of flaked stone, 70 pieces of fire-cracked rock, a pos-sible figurine fragment, 20 sherds, a hammerstone, and additional human bone. A human burial may have eroded into the canal. The fill of the feature was a blocky tan compact clay. Ostracode samples were collected from the northern cross section of Trench 212.

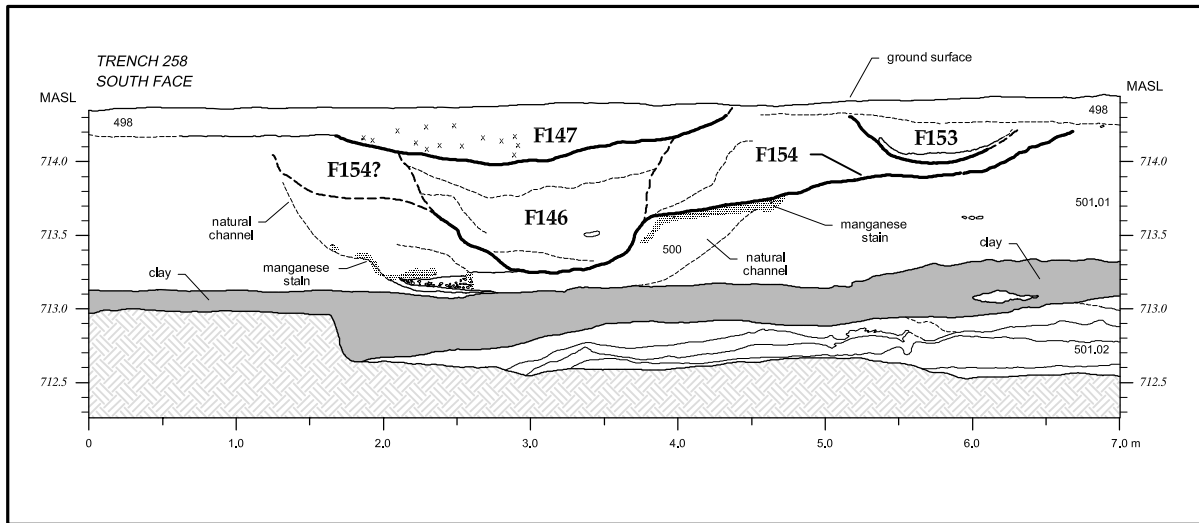
**Figure 4.109.** Cross section of canal Feature 146, AZ BB:13:481 (ASM), at the Congress Street and Brickyard loci, the Clearwater site, AZ BB:13:6 (ASM).

Canal Feature 146 (Figure 4.109) was located in Trenches 248, 253, 255, 258, 260, and 274. The canal was drawn in Trenches 253, 255, and 258. It ran southwest to northeast and was traced for roughly 90 m. On average, the canal was between 1.16 m and 3.16 m wide, and was 66 cm deep. It was filled with dark brown compact silty sand at its base, with tan compact clayey silt above. Manganese staining was visible at the base of the feature. Feature 146 was cut into by another canal, Feature 147. It intruded into the eastern side of canal Feature 154 in Trenches 258 and 271. Ostracode samples were collected from the southern cross section of Trench 253 and from Trench 258. This canal contained pottery sherds of the Late Rincon and Tanque Verde phases (circa A.D. 1100-1300).

Feature 147 (see Figure 4.109) was found in Trenches 248, 253, 255, 258, 271, 272, and 273, and was drawn in Trenches 253, 255, 258, 271, and 272. The canal ran southeast to northwest before turning due north. It was traced for 75 m. On average, the canal was 2.4 m wide and was about 30 cm deep, originating at 43 cm below modern ground surface.

Feature 153 (see Figure 4.109) was found in Trenches 258 and 271, and it was drawn in Trench 258. This canal was traced for only a short distance and ran north-south. On average, it was 1.1 m wide and about 25 cm deep. The top of the canal had been cut by the plowzone and was found at about 20 cm below the modern ground surface. The canal had dark brown, blocky clay at the base, above which

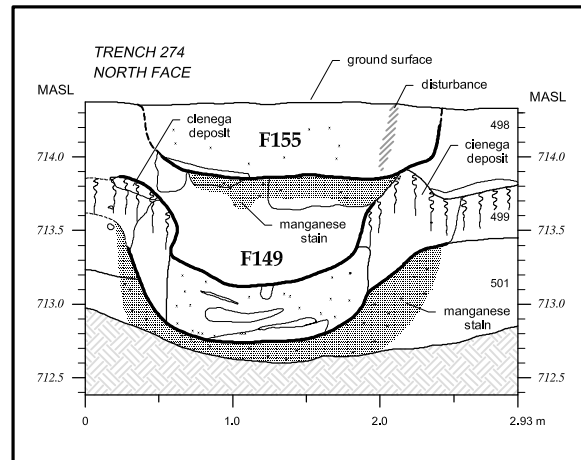
**Figure 4.110.** Cross section of canal Feature 149, AZ BB:13:481 (ASM), at the Congress Street and Brickyard loci, the Clearwater site, AZ BB:13:6 (ASM).

Feature 149 (Figure 4.110) was found in Trenches 253, 258, 260, and 274. The canal was drawn in Trenches 253, 258, 260, and 274. It was traced for approximately 90 m. The broad, basin-shaped canal averaged 2.5 m wide at the top, narrowing to 1.1 m at the base. It was about 1.0 m deep. The canal had been dug through the dark brown, blocky cienega clay into the underlying light tan-brown sandy silt. The base of the canal was filled with water-deposited sands, above which were blocky, dark brown clay with coarse sands mixed in. A re-excavation of the canal was visible, with the clays dug out to make a U-shaped canal that was 1.6 m wide and 64 cm deep. Some overbank deposits were visible in the profile of Trench 274. This latter canal was filled with

a thick band of tan-yellowish sands deposited during a flood. Above this was a layer of brown cienega clays that developed after the canal was filled in by the sandy flood deposit. This canal contained sherds of the Tanque Verde phase (circa A.D. 1150-1300).

Feature 155 (see Figure 4.110) was a canal located in Trench 274, where it was drawn. The broad basin-shaped feature was 2.04 m wide and 50 cm deep. It was filled with a very compact, brown, sandy clay. Charcoal flecks were present in the fill. The base of the canal had manganese staining. The top of the feature was located at the modern ground surface, suggesting it may be one of the more recent historic-era canals. Feature 155 intruded a prehistoric canal, Feature 149.

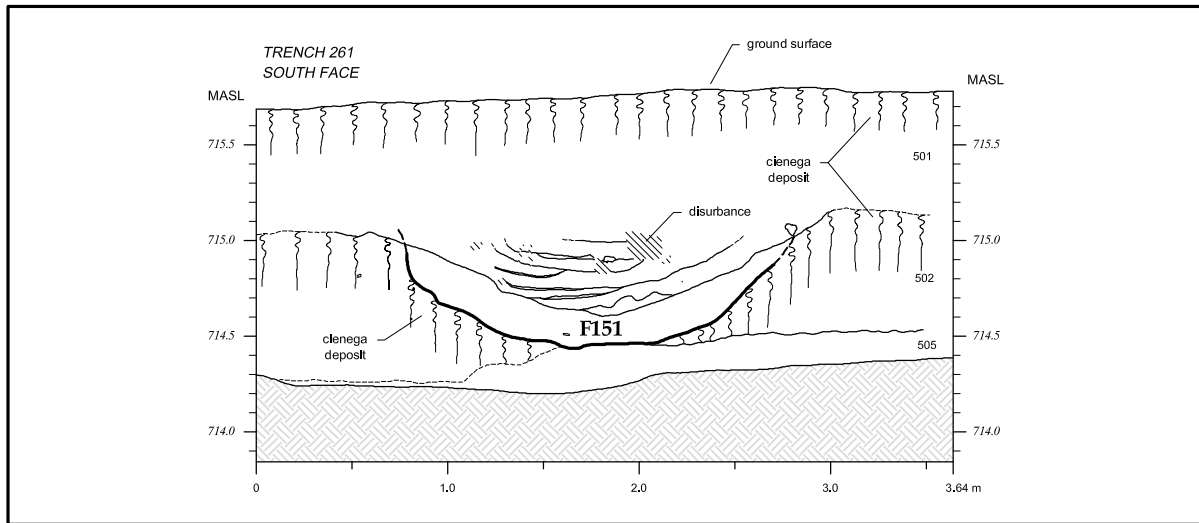
**Figure 4.111.** Cross section of canal Feature 151, AZ BB:13:481 (ASM), at the Congress Street and Brickyard loci, the Clearwater site, AZ BB:13:6 (ASM).

Canal Feature 151 (Figure 4.111) was located in Trenches 246, 249, 256, 257, 261, 262, 263, 264, and 265. It was drawn in Trenches 257, 261, 265, and 354. It ran in a broad arc from southeast to northwest and then northeast over a distance of 300 m, having been located in previous trenching in 1995. On average, the canal was 2.2 m wide at the top,

narrowing to 86 cm at the base. The canal averaged 84 cm deep, originating at roughly 78 cm below the modern ground surface. The feature was filled with layers of brown clay, sand, tan silty clay, and bands of sand and clay. Some evidence for cleaning out and re-use of the canal is suggested by the basin-shaped fill layers. Manganese staining was present below the base of the canal. Ostracode samples were collected from the southern faces of Trenches 265 and 354.

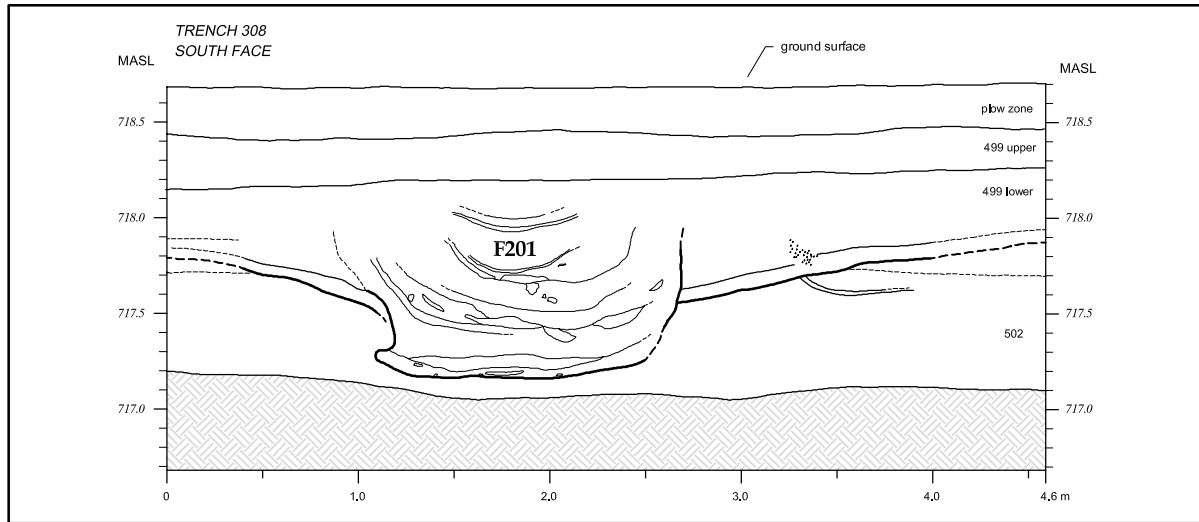
**Figure 4.112.** Cross section of canal Feature 201, AZ BB:13:481 (ASM), at the Mission Gardens locus, the Clearwater site, AZ BB:13:6 (ASM).

Feature 201 (Figure 4.112) was a canal found in Trenches 302, 308, 310, 311, and 324. Cross sections of the canal were drawn in Trenches 302, 308, 310, and 311. The canal ran in a south-to-north direction. It was traced for 116 m. The canal ranged from 1.35-4.80 m wide at the top, narrowing to between 60 cm and 1.3 m at the base. It was between 84 cm and 1.22 m deep, with the top of the canal 39 cm below the modern ground surface. Examination of the cross section of the canal suggested it was re-dug several times. Most of the fill was a light brown-brown clayey silt. Bands of fine sands and silts were present within the feature. The base of the canal contained a light gray-brown sandy clayey silt with some coarse sands and numerous small shells. Just above the base was a lens of bedded medium sands. Through time, as the canal was filled and re-dug, it became progressively more narrow and shallow.

Many sherds, flaked stone, and pieces of fire-cracked rocks were present in the fill. Excavation was conducted within the base of the canal in backhoe Trench 302. Sherds, flaked stone, and shell were collected, as was a flotation sample. The canal was sampled for ostracodes in the southern walls of Trenches 308 and 310.

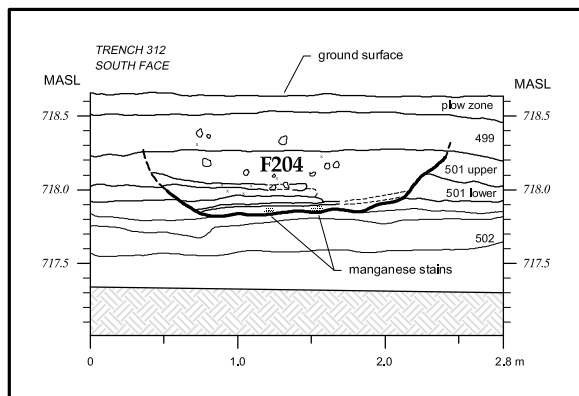
**Figure 4.113.** Cross section of canal Feature 204, AZ BB:13:481 (ASM), at the Mission Gardens locus, the Clearwater site, AZ BB:13:6 (ASM).

Feature 204 (Figure 4.113) was located within Trenches 300, 302, 305, 312, 317, 332, 333, and 352. It

was drawn in Trenches 302, 305, and 312. The canal ran south to north, gradually turning northwest through the portion documented within the Mission Gardens. It was traced for 103.6 m. The canal averaged 2 m wide and 50 cm deep, with the top of the feature found at 30 cm below the modern ground surface, probably truncated by historic plowing. The fill of the U-shaped canal consisted of laminated lenses of brown silty sands and clays. A small amount of manganese staining was present along the base, just above a clay band. Several pieces of fire-cracked rock were noted in the cross sections.

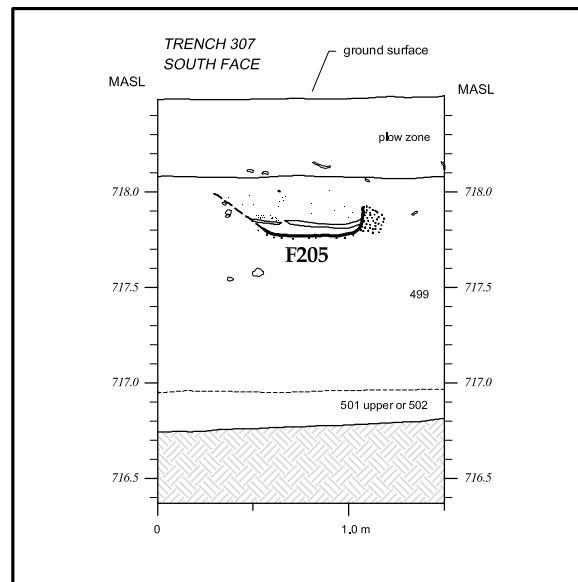
**Figure 4.114.** Cross section of canal Feature 205, AZ BB:13:481 (ASM), at the Mission Gardens locus, the Clearwater site, AZ BB:13:6 (ASM).

Feature 205 (Figure 4.114) was a canal found in Trenches 307, 316, and 334; it was drawn in Trench 307. This canal ran southwest to northeast, and it was

traced for 20.3 m. On average, it was about 90 cm wide and 31 cm deep, with the top of the canal found at 41 cm below the modern ground surface. The fill of the canal was a blocky clay with a layer of fine sands above. In one area, a concentration of small freshwater mollusks was visible in the cross section.

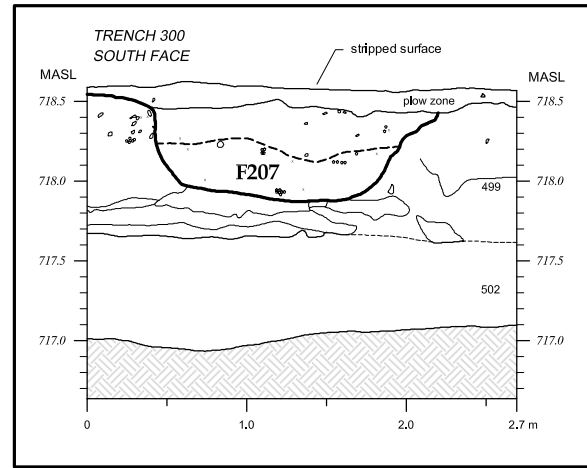
**Figure 4.115.** Cross section of canal Feature 207, AZ BB:13:481 (ASM), at the Mission Gardens locus, the Clearwater site, AZ BB:13:6 (ASM).

Feature 207 (Figure 4.115) was a canal found in Trenches 300, 301, 302, 304, 305, and 350. It was drawn in Trenches 300, 301, 325, and 304. The canal

ran south to north and was located immediately west of the eastern Mission Gardens wall. This suggested the canal existed when the wall was built, perhaps in the 1790s. However, the structure located on the interior of the eastern wall, Feature 3083, was positioned above the canal, indicating the canal was no longer in use when the dwelling was built. The exact date of construction for this building is unknown, although it appears on the 1862 Fergusson Field map, and excavation within the floor area of the building located English transfer-print ceramics that may date to the 1840s. The canal had cut into Feature 3106, a large unexcavated bell-shaped pit.

The canal was traced for 110.2 m, and ranged between 1.34 m and 2.40 m wide and 13 cm to 53 cm deep, originating at 32 cm below the modern ground surface. It had been truncated by historic-era plowing. The base of the canal was filled with a gray-brown, silty sand that, in turn, was overlain by a light grayish-brown, sandy silt with some sands and a fair amount of charcoal staining and small mollusk shells. Many fire-cracked rocks, sherds, and small shells were visible in the fill. The canal cut through the cienega clays present within the site. Ostracode samples were removed from the southern cross section in Trench 300.

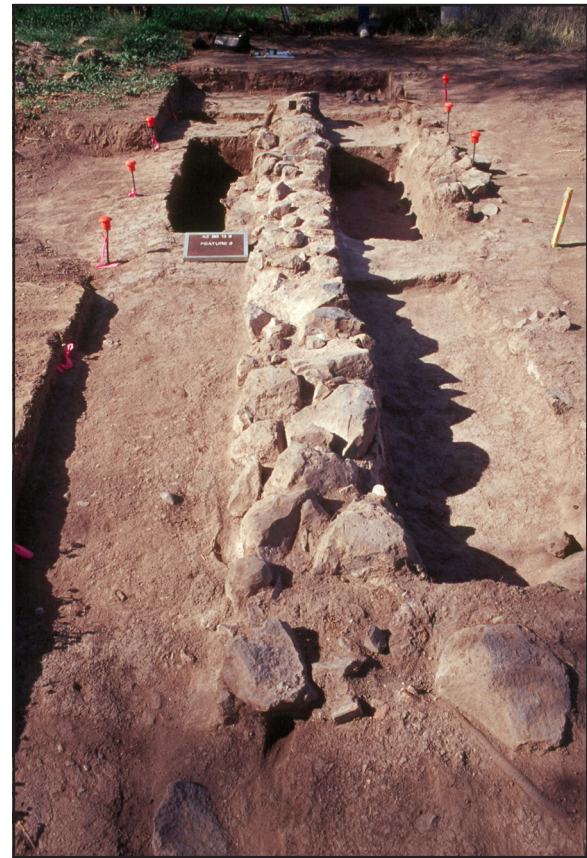
**Figure 4.116.** Feature 3, Solomon Warner's millrace; the northern wall of the millrace has been severely damaged by modern roadwork, San Agustín Mission locus, the Clearwater site, AZ BB:13:6 (ASM).

Feature 3 (Figure 4.116) was the millrace, or spillway, for Solomon Warner's grist mill, which began operating in 1875. It ran down the southern side of Mission Lane, and the excavated portion was lined with stones. Most of the interior of the millrace had been previously excavated by Jack Williams in 1986; unfortunately, Williams has not published a description of what he found. The surviving portion is at least 6.35 m long and 60 cm wide, with rock and mortar walls at least 22 cm high. The interior was filled with layers of brown to gray-brown, silty sandy clay. An ostracode sample was taken from one cross section of the feature.

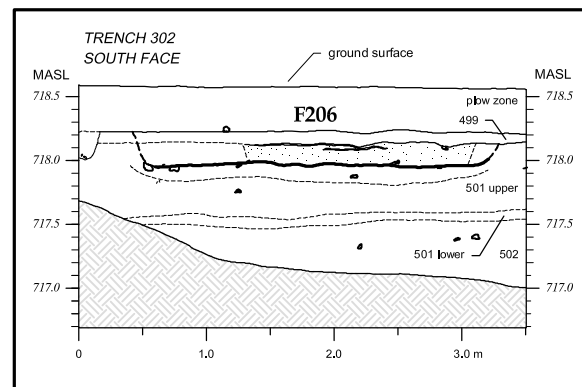
**Figure 4.117.** Cross section of canal Feature 206, AZ BB:13:481 (ASM), at the Mission Gardens locus, the Clear-water site, AZ BB:13:6 (ASM).

Feature 206 (Figure 4.117) was found in Trenches 302, 309, 311, and 328. It was drawn in Trench 302, where it was cut at an oblique angle, and in Trenches 309 and 328. The canal arcs from west to north through the northwest corner of the Mission Gardens. It was traced for 55.1 m. The canal was 1.36 m wide in Trench 309 and averaged 33 cm deep, with the top of the canal found at 44 cm below the ground surface. The top of the canal had been cut by the historic plowzone. The canal had a fairly flat base with gradually sloping sides. It was filled with a compact light brown fine sandy silt with charcoal flecks, fire-cracked rocks, sherds, and snail shells. Ostracode samples were collected from the western wall of Trench 309.

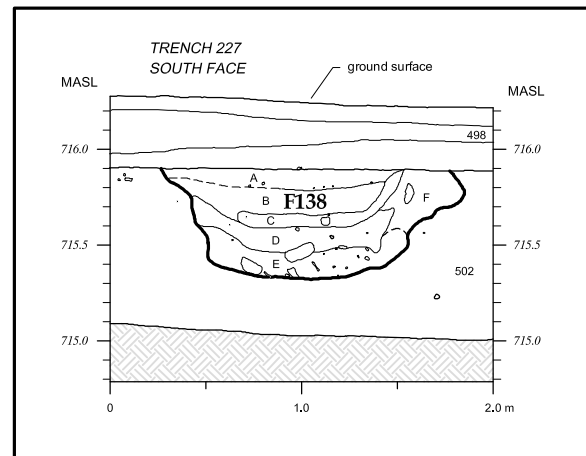
**Figure 4.119.** Cross section of canal Feature 138, AZ BB:13:481 (ASM), at the Congress Street and Brickyard loci, the Clearwater site, AZ BB:13:6 (ASM).

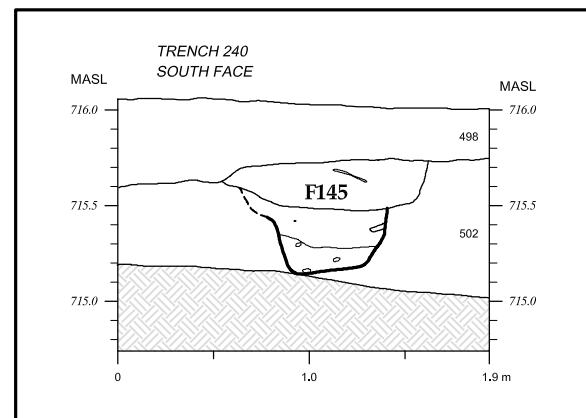
**Figure 4.120.** Cross section of canal Feature 145, AZ BB:13:481 (ASM), at the Congress Street and Brickyard loci, the Clearwater site, AZ BB:13:6 (ASM).

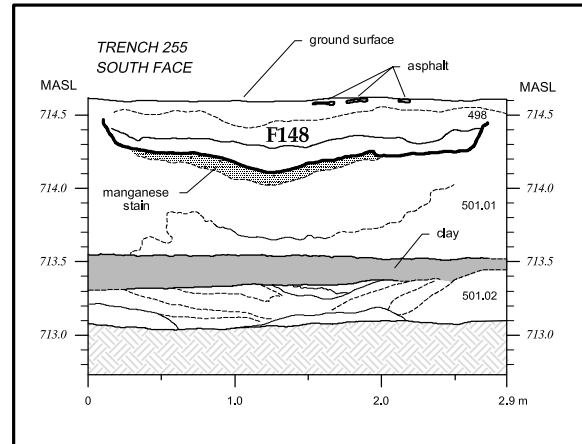
**Figure 4.121.** Cross section of canal Feature 148, AZ BB:13:481 (ASM), at the Congress Street and Brickyard loci, the Clearwater site, AZ BB:13:6 (ASM).

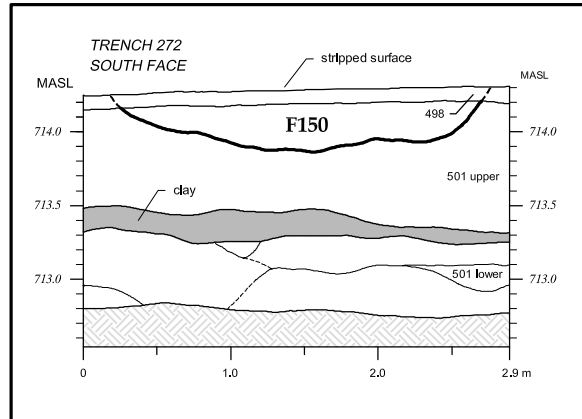
**Figure 4.122.** Cross section of canal Feature 150, AZ BB:13:481 (ASM), at the Congress Street and Brickyard loci, the Clearwater site, AZ BB:13:6 (ASM).

Feature 150 (Figure 4.122) was found in Trenches 248, 253, 255, 258, 271, and 272; it was drawn in Trenches 253, 255, 258, 271, and 272. The basin-shaped canal ran south to north and was traced for 75 m. The canal was between 2.46 m and 2.55 m wide and between 41 cm and 55 cm deep, originating at about 40 cm below the modern ground surface. The upper fill of the canal was a compact, brown, silty sandy clay with the lower fill being a brown, clayey silty sand that was moderately compact. Small charcoal flecks were dispersed throughout the fill. The upper portion of the canal was truncated by plowing. Ostracode samples were collected from the southern wall of Trench 253.
