# CAMP NACO STRATEGIC PRESERVATION PLAN 2015-2017

## Appendix 4-2

### COMMERCIAL BUILDINGS

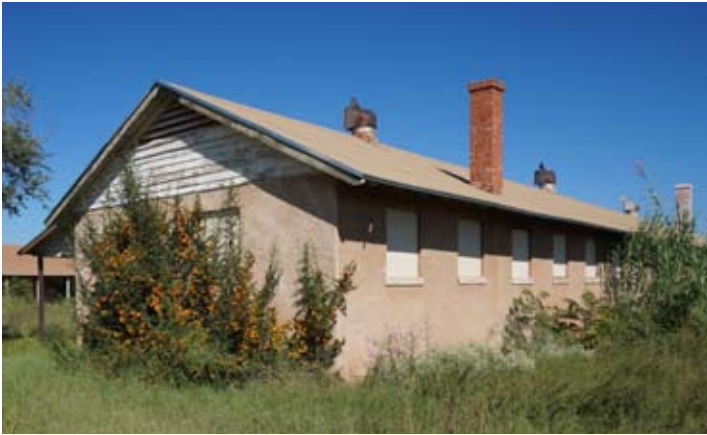
**BUILDING A2 - EAST SIDE**

**BUILDING NO. :** A2, Barracks - Western Quadrangle

Shingles (Asbestos) Removed, New Roll Roofing With Shingles, Windows Boarded, Chimneys Rebuilt, No Missing Ventilators, Porch Stabilized (New Deck and Supports). Work completed under EPA Brownfields Grant (Awarded in 2011, Completed in 2013).

No additional work needed to stabilize building.

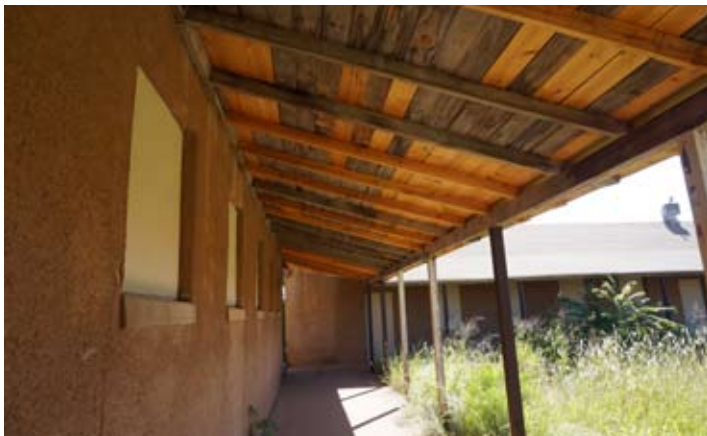
**BUILDING A3 - SOUTH PORCH - LOOKING EAST**

**BUILDING NO. :** A3, Barracks - Western Quadrangle

Shingles (Asbestos) Removed, New Roll Roofing, Windows Boarded, No Missing Ventilators, Porch Stabilized (New Deck and Supports). Work completed under EPA Brownfields Grant (Awarded in 2011, Completed in 2013).

No additional stabilization work needed.

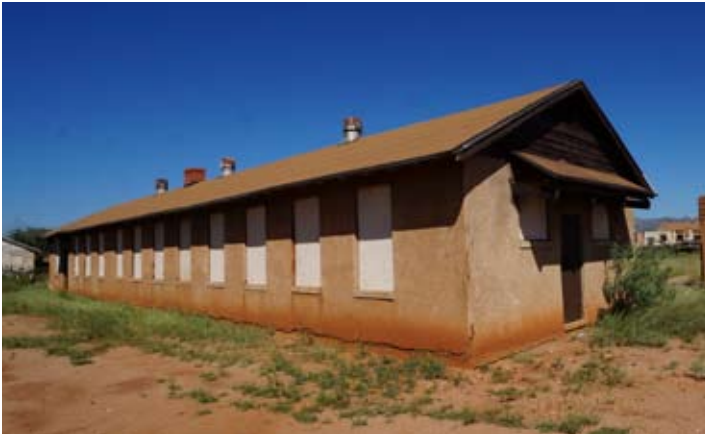
**BUILDING A5 - LOOKING SOUTH**

**BUILDING NO. :** A5, Barracks - Eastern Quadrangle

Shingles (Asbestos) Removed, New Roll Roofing, Windows Boarded, No Missing Ventilators. Work completed under ADEQ Grant (Awarded in 2010, Completed in 2010).

No additional stabilization work needed.

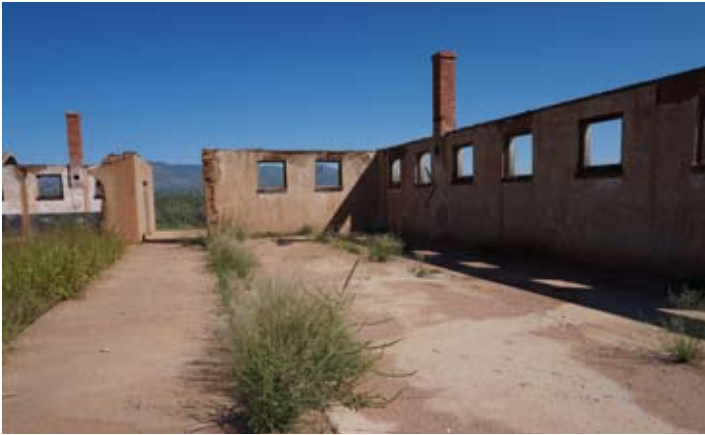
**BUILDING A6 - LOOKING NORTH**

**BUILDING NO. :** A6, Barracks - Eastern Quadrangle

No additional work needed to stabilize building.

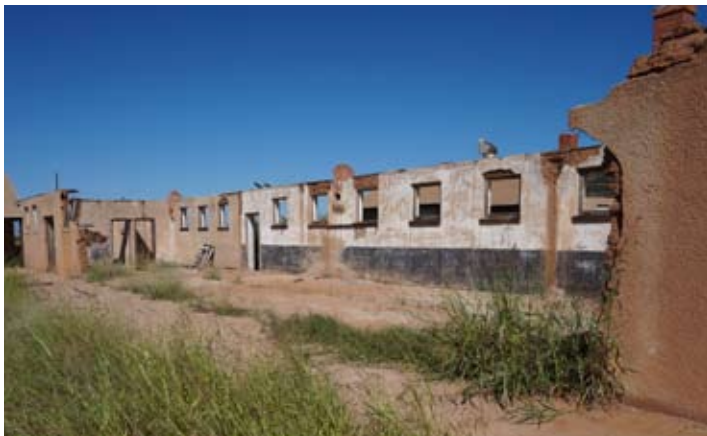
**BUILDING A7 - LOOKING NORTH**

**BUILDING NO. :** A7, Barracks - Eastern Quadrangle

Shingles (Asbestos) Removed, New Roll Roofing, Windows Boarded, Chimneys Rebuilt, No Missing Ventilators, Porch Stabilized (New Deck and Supports). Work completed under EPA Brownfields Grant (Awarded in 2011, Completed in 2013).

Selective Demolition Work, New Roof Framing and Deck, Insulation at Roof, Electrical, HVAC, Window and Door Repair, Finish Carpentry, Repair Cracks in Foundation, Cracks and Coving in Exterior Adobe Walls Repaired and New Adobe Walls Built, New Coat Exterior Plaster, Exterior Wood Fascias and Siding Replaced as Needed, New Paint at all Wood Trim, Additional Structural Repairs as Needed, Vegetation Cleared

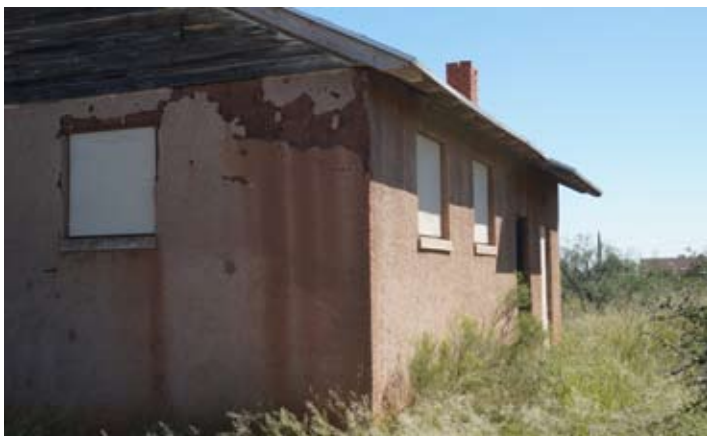
**BUILDING A9 - SOUTHWEST CORNER**

**BUILDING NO. :** A9 - Bathrooms

Shingles (Asbestos) Removed, New Roll Roofing, Windows Boarded, No Missing Ventilators. Work completed under EPA Brownfields Grant (Awarded in 2011, Completed in 2013).

Selective Demolition Work, Concrete Work, Insulation at Roof, Electrical, HVAC, Window and Door Repair, Finish Carpentry, Repair Cracks in Foundation, Cracks and Coving in Exterior Adobe Walls Repaired, New Coat Exterior Plaster, Exterior Wood Fascias and Siding Replaced as Needed, New Paint at all Wood Trim, Additional Structural Repairs as Needed, Vegetation Cleared

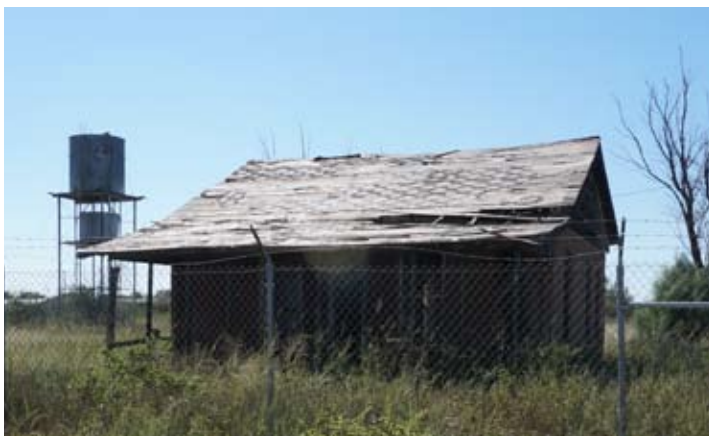
**BUILDING C3 - NORTH ELEVATION**

**BUILDING NO. :** C3, Officer's Quarter

Rebuild Collapsed South Adobe Wall, Replace Damaged Roof Members, Rebuild Chimney, Rebuild Porch, Resheet Entire Roof, Dry-in and Apply Roll Roofing.

Selective Demolition Work, New Floor Pavers, Rough Carpentry, Plumbing, Electrical, HVAC, Repair Cracks in Foundation, Cracks and Coving in Exterior Adobe Walls Repaired, New Coat Exterior Plaster, Exterior Wood Fascias and Siding Replaced as Needed, New Paint at all Wood Trim, Additional Structural Repairs as Needed, Vegetation Cleared, Repair Windows and Doors, Insulation at Roof, Finish Carpentry Work
