Laser Imaging of El Morro Inscriptions, El Morro National Monument, New Mexico

Project Number ELMO 2006 E

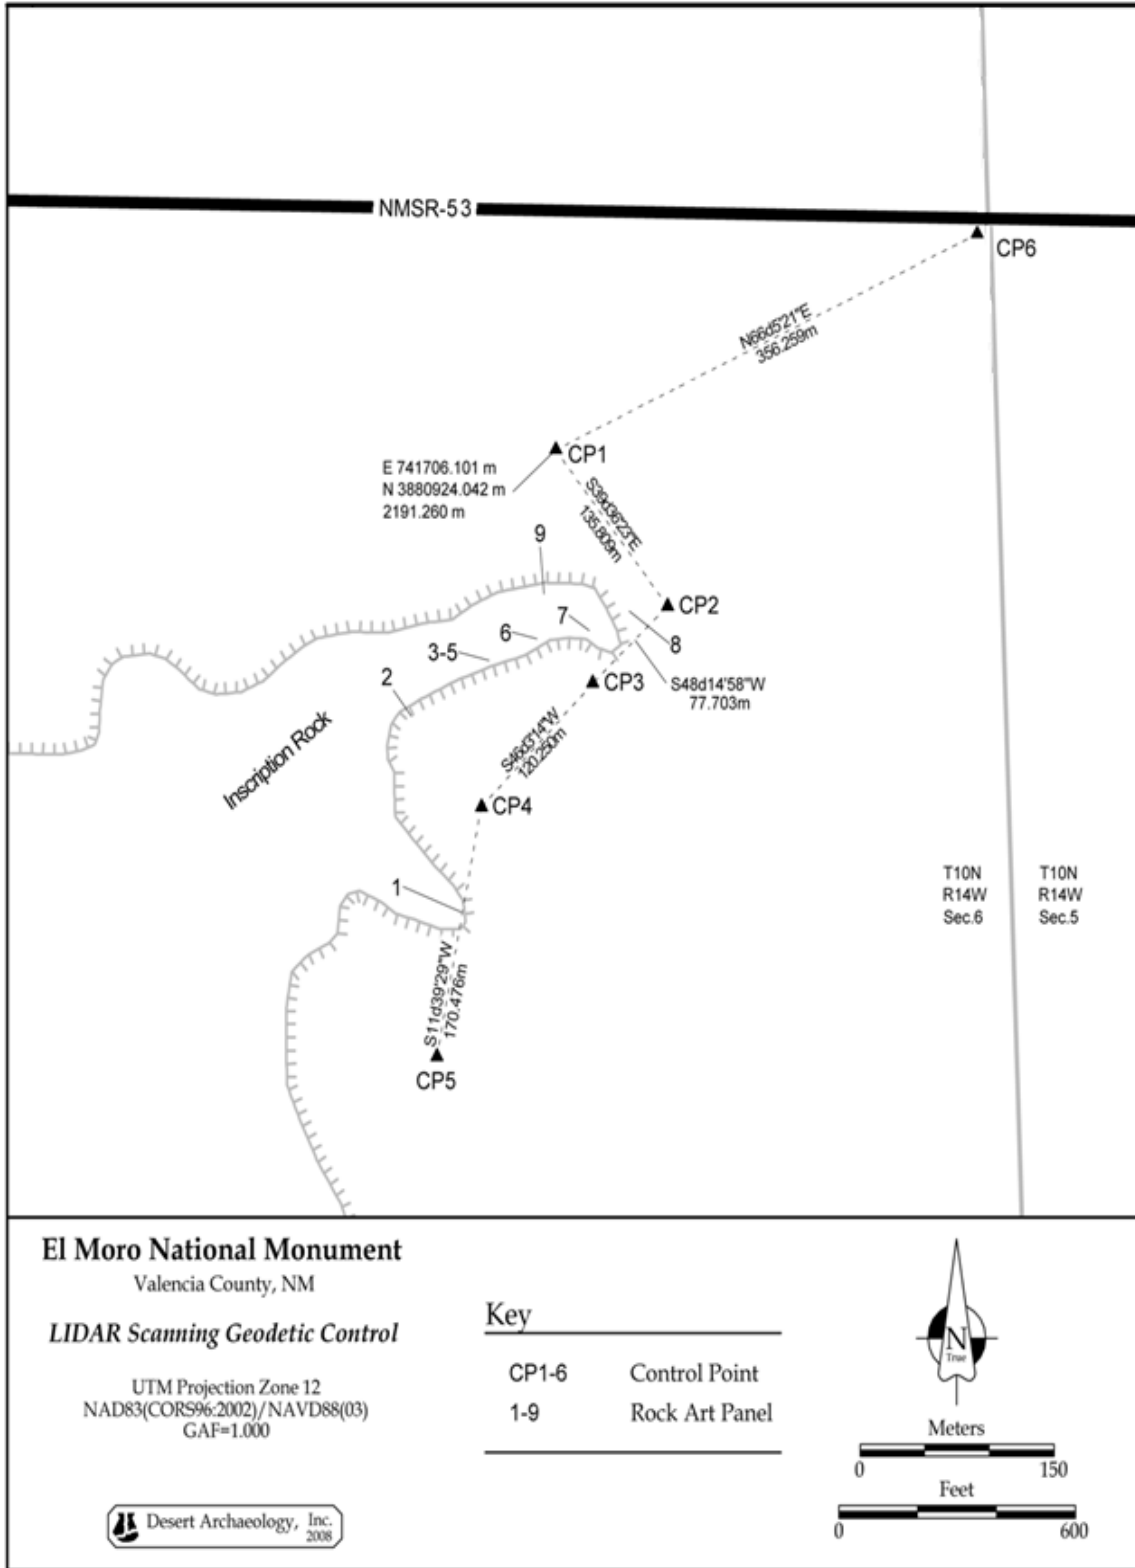
Figure 1 - Geodetic Control and Inscription Scan Panel locations

Horizontal and vertical geodetic control was established by the use of survey grade Global Positioning System (GPS) receivers, providing the most accurate location data possible. Wilson & Associates, Inc., Albuquerque, NM, was contracted by Statistical Research to establish a GPS control network at the monument. Six points consisting of rebar with aluminum caps (CP1-6) were set along the eastern aspect of Inscription Rock (Figure 1, Coordinates listed in Table 1). CP1 and CP6 coordinates are OPUS solutions computed using rapid ephemerides from approximately three hours of static GPS observations at each monument. GPS measurements were made with a Trimble 5800 L1/L2 integrated receiver/antenna on 25 October 2006 (CP1) and 30 October 2006 (CP6). CP1 and CP6 positions have an overall RMS of .016 m and .013 m. CP2-5 were measured using L1/L2 RTK GPS relative to CP1. All project area geodetics are metric coordinates UTM Zone 12, NAD83(CORS96:2002), NAVD88(Geoid03).

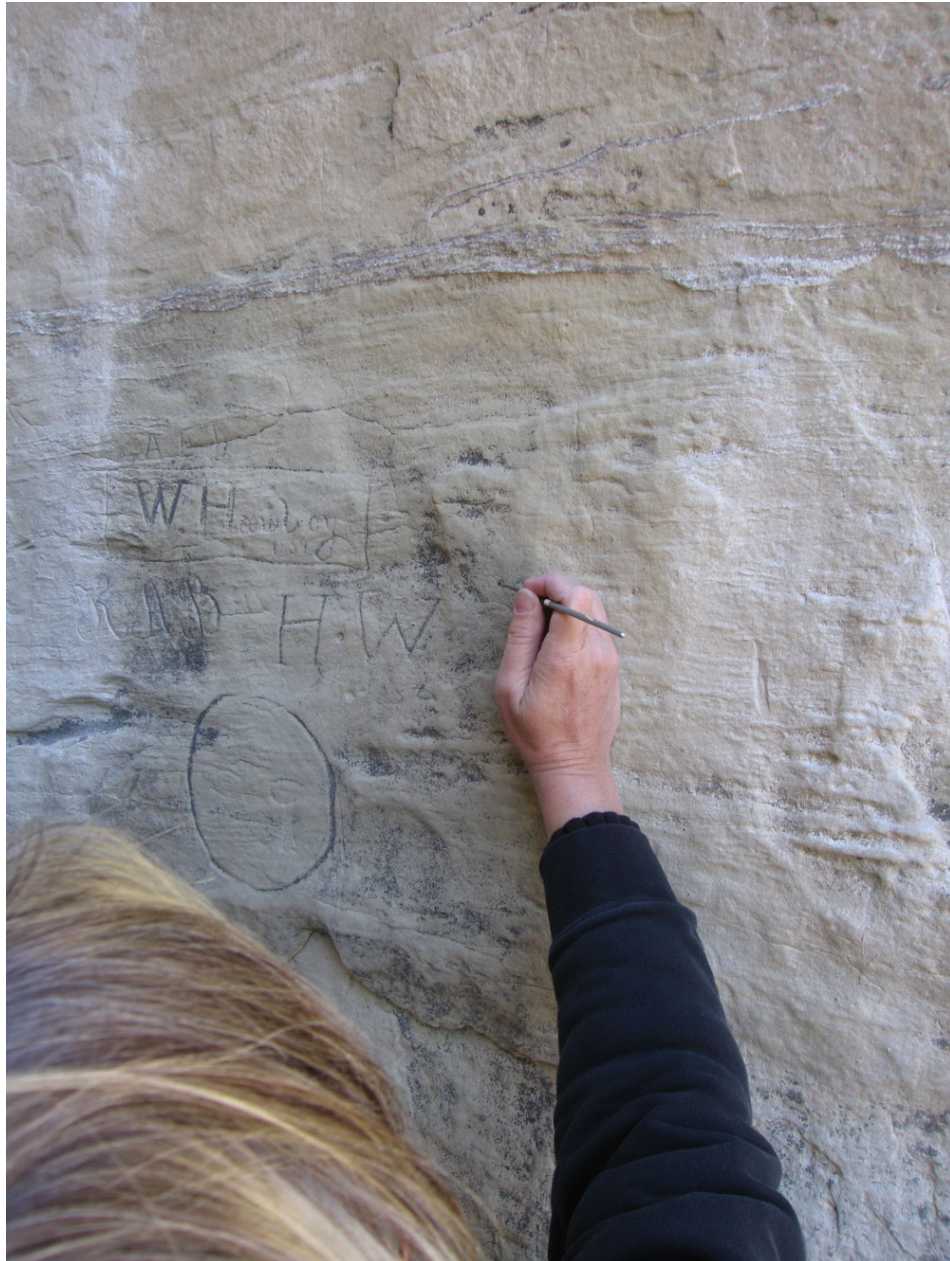
Figure 2 - Affixing a Scan Target

bound the area to be scanned, and provide spatial control on a year to year basis. The scanning targets consist of 2 mm pieces of paper, with a crosshair consisting of 2 filled triangles within a circle. The targets were affixed to the inscription panels with a b-42 parasol adhesive, by NPS conservator Gretchen Voeks. (See Figures 2, and 3).

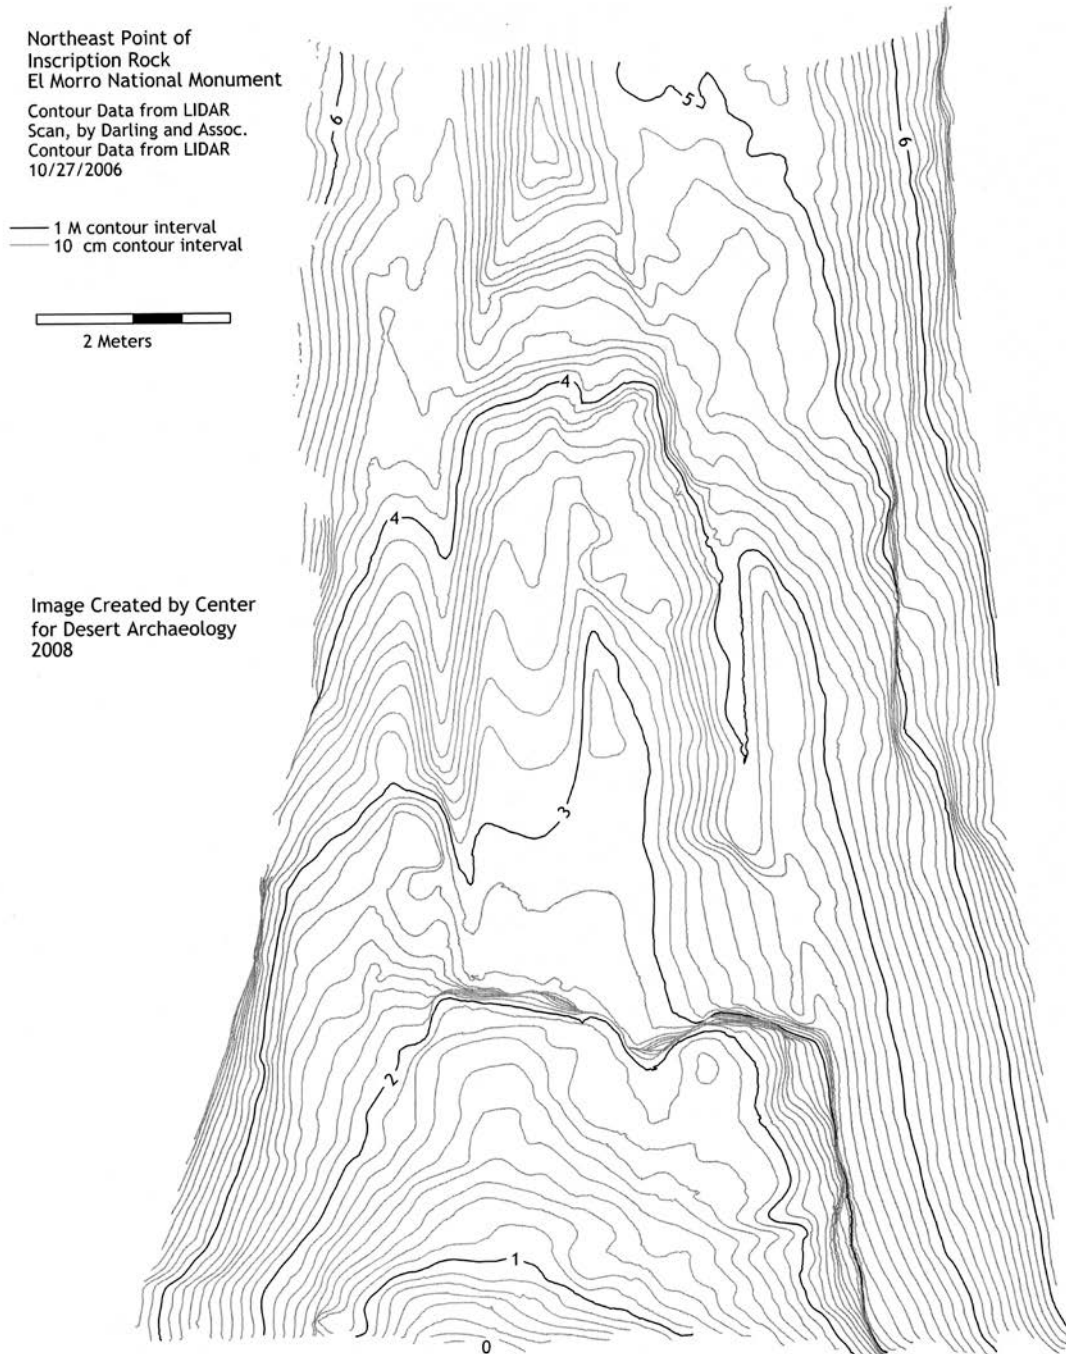
Figure 4 - Cad Plot of 10 Cm Contours of Northeastern Point of Inscription Rock

As part of the inscription scanning and modeling process, Tucson based registered surveyors Darling and Associates Ltd. conducted a wide area LIDAR scan of the Northeast point of Inscription rock. This scan data is intended to augment existing studies of clay wash and other depositional processes that may be effecting the dense collection of historic inscriptions on this portion of the sandstone surface. According to the Scope of Work agreement, his scan was supposed to be at a resolution of 3 cm of accuracy, but Darling and Associates were able to provide a scan at a resolution of 5 mm. The resulting scan data, presented as a simplified Autocad drawing can be seen in Figure 14. This data was converted into a digital mesh, and rendered with a photographic texture map in Figure 15.

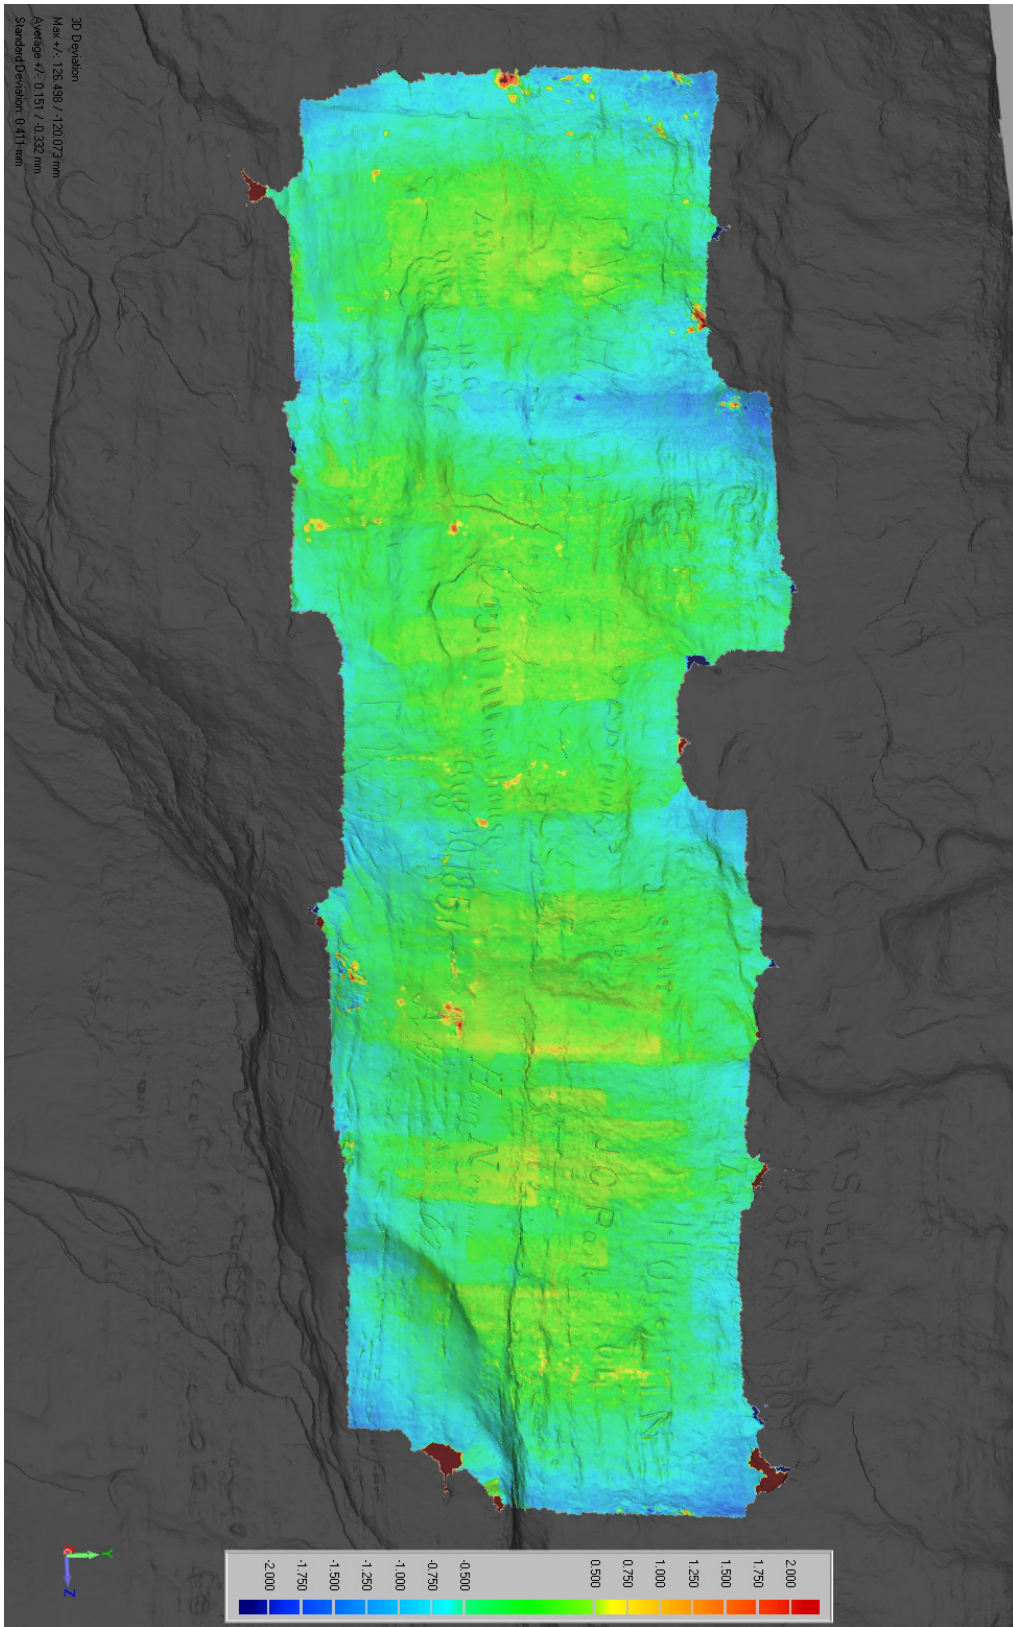
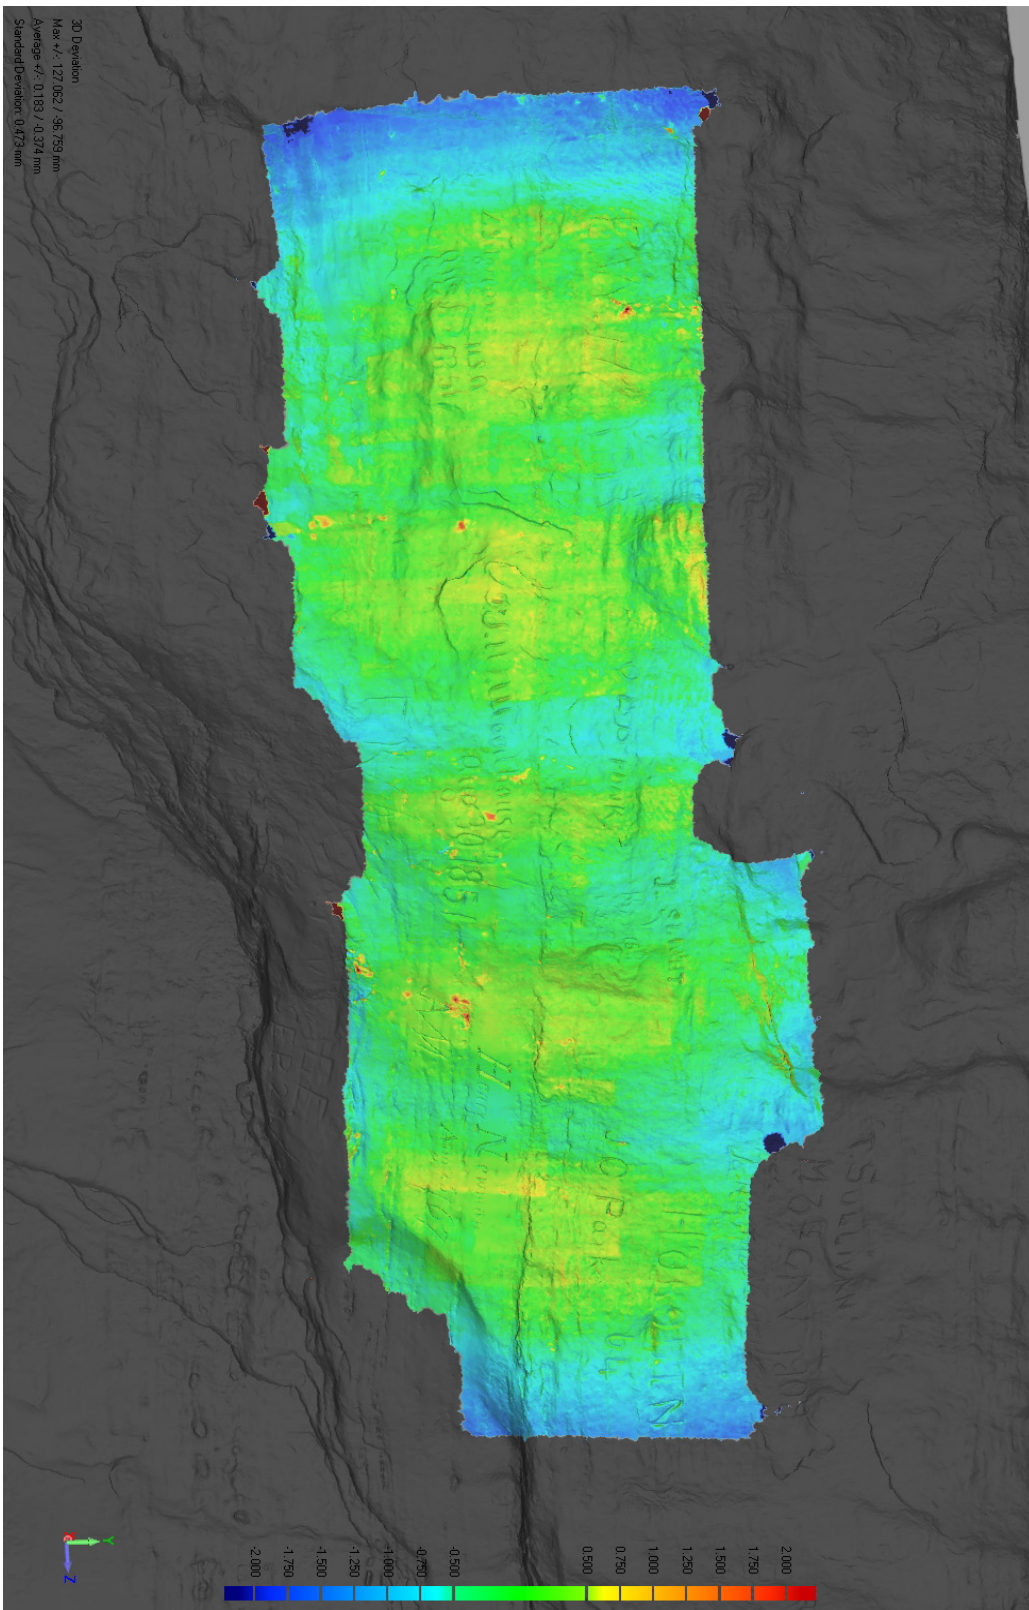
Figures 6 and 7 provide the loss / gain model analysis for Panel 1. The graphics illustrate differences in the model's surfaces on a scale of -2 to +2 millimeters with a standard deviation of .411 mm in the 2006 comparison, and .473 millimeters in 2007 comparison. Close examinations of these two figures reveals that there are problems with this analysis. The 2006 vs. 2010 scan data indicates a significant area of surface loss above and slightly to the right of the "U.S.A." text (indicated as the blue stripe) of the Sitgreaves inscription. In the 2007 vs. 2010 comparison this area shows very little inferred surface loss. If the data in these models were accurate, we would have to infer that this area lost a full millimeter of surface in 2006, which was then replaced by 2007. A more likely explanation for this finding is that the striping we see in the scan comparisons are due to areas of light and shadow interfering with the scanner function, and that this interference indicates that the scanner's precision in this setting is greater than 1 mm. Once again, this project was supposed to provide accurate scans at scale of .2 mm which our efforts have failed to achieve.

Despite these problems it does appear that the gain/loss models provide some details at a more coarse scale of analysis. In the case of Panel 1 there are a number of areas that show evidence for the accumulation of extra materials, including a slight amount of clay wash and areas of discrete accumulations of sands and clays captured by spider webs and wasp castings.

Figure 6 – Comparison Between 2006 and 2010 scan data on Panel 1

Figure 7 – Comparison Between 2007 and 2010 scan data on Panel 1

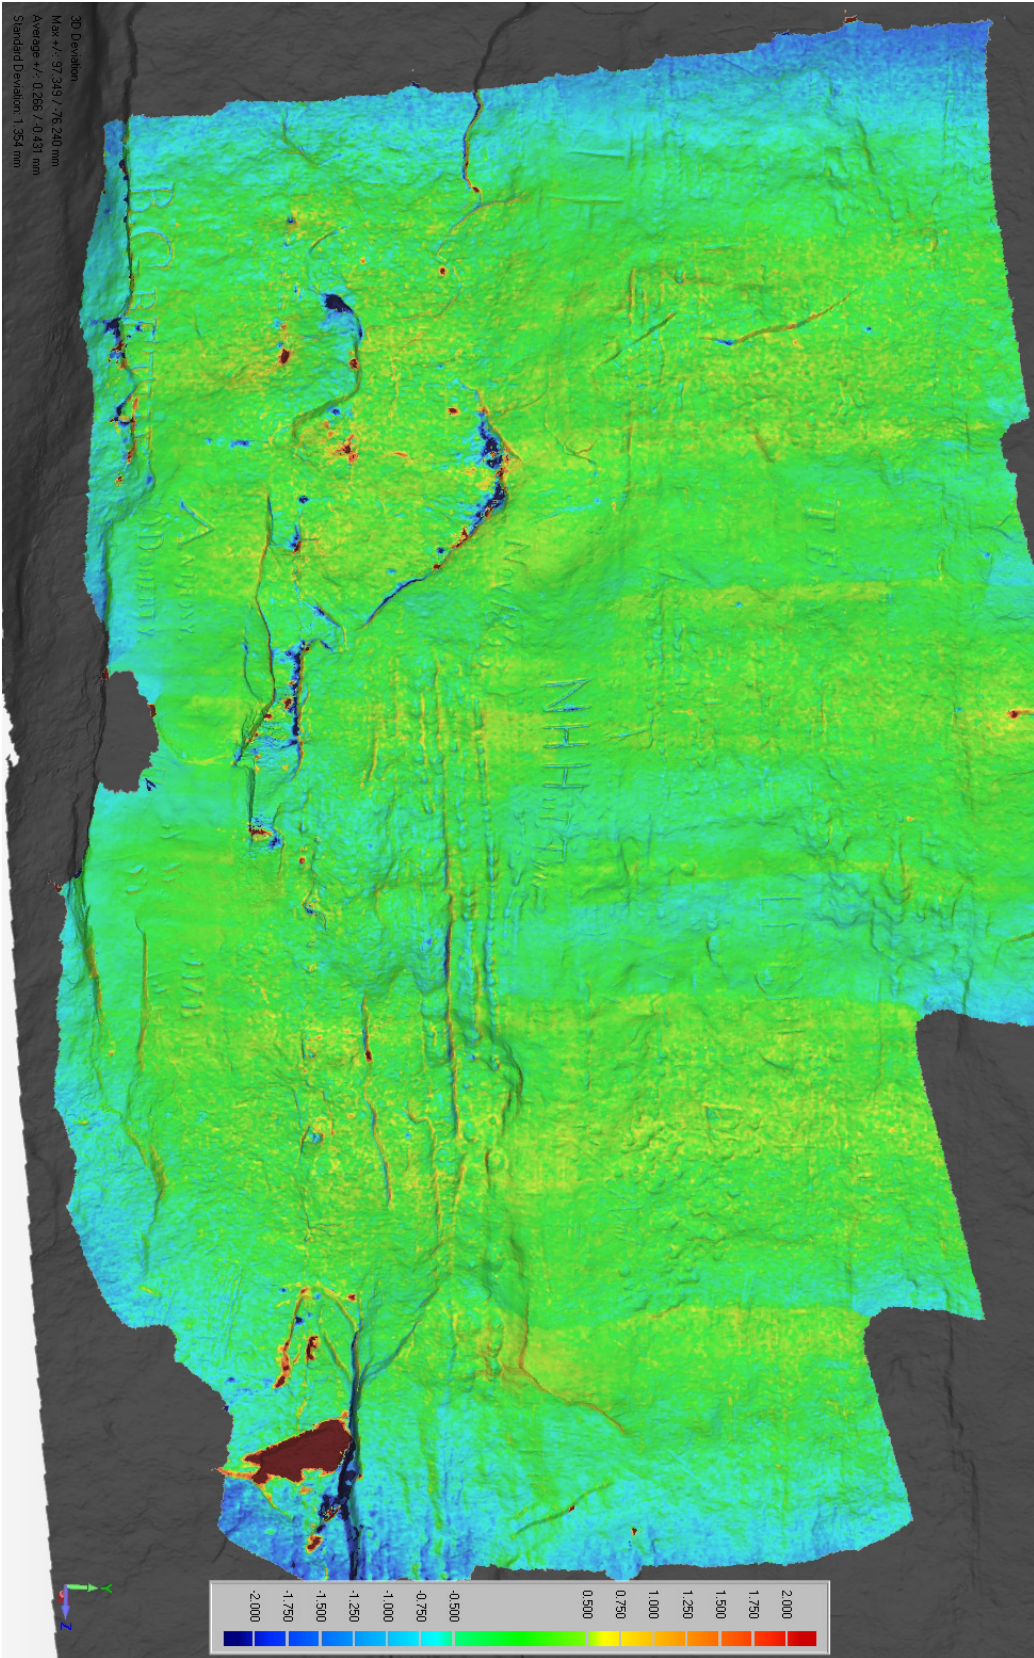
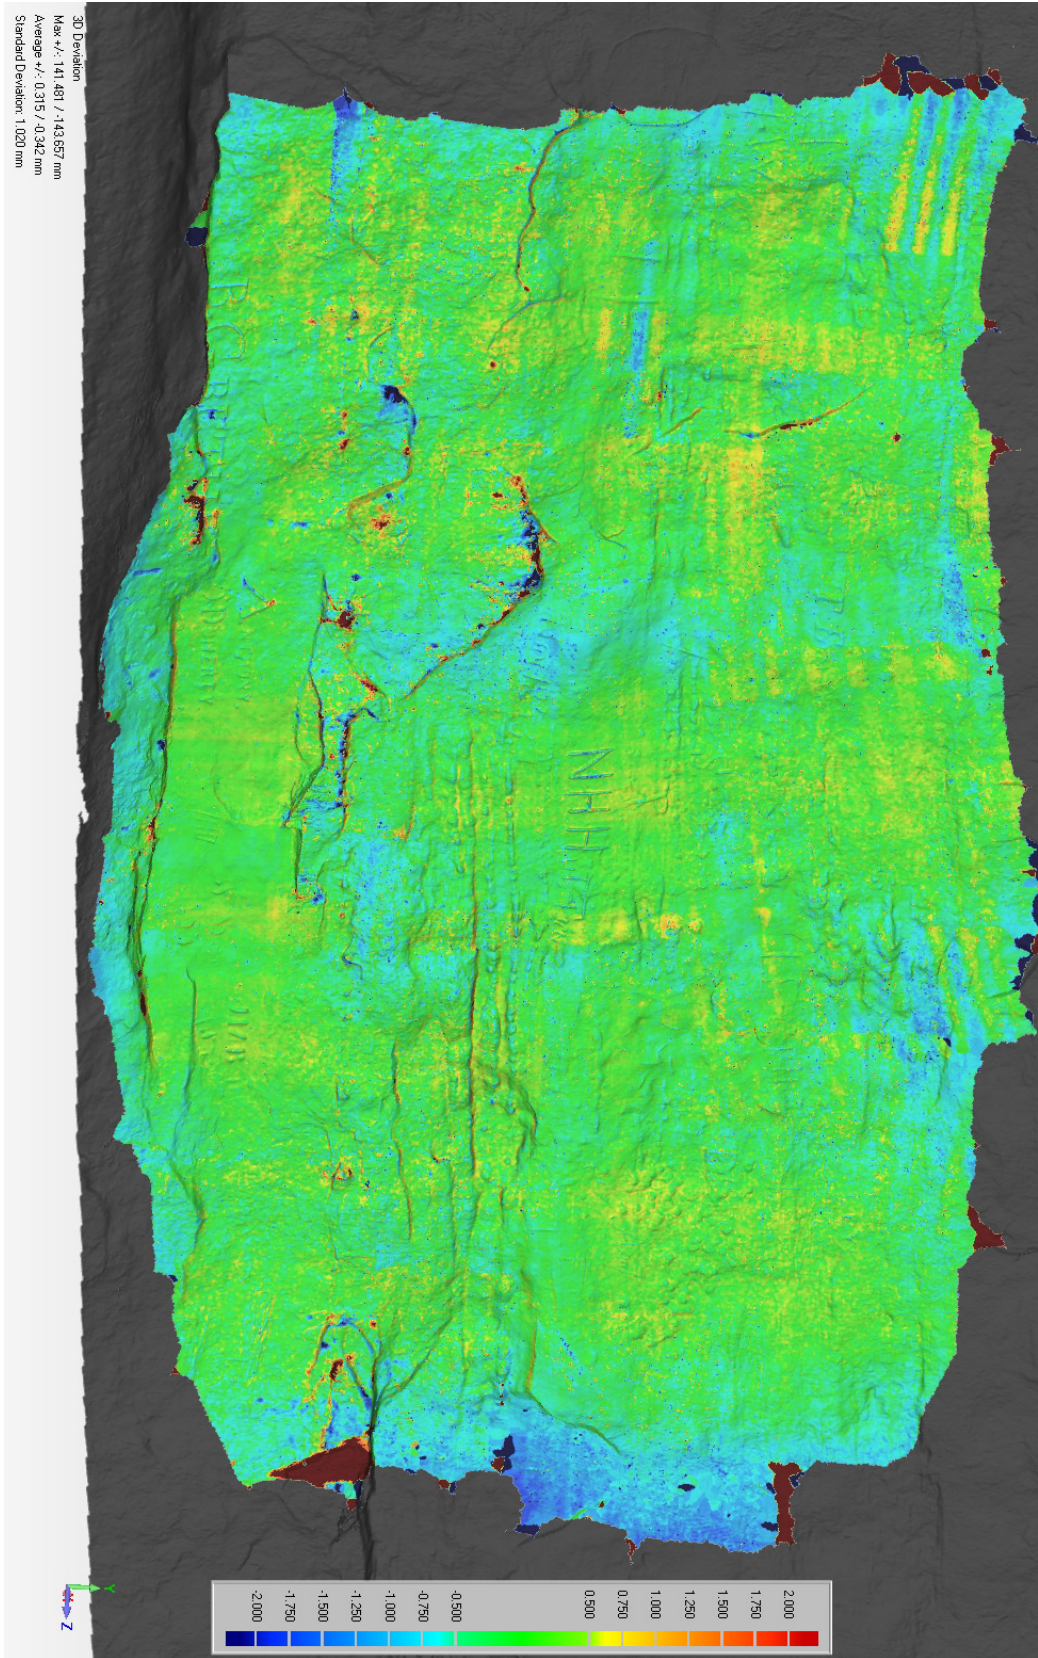
Panel 2, situated over the small pond and damn, and one of the first stops on the interpretive trail apparently did not suffer the same degree of striping and uneven lighting as Panel 1, but there are still significant problems with the precision of the measurements generated. The standard deviation for the 2006 vs. 2010 scans is 1.354 mm, and 1.020 mm for the 2007 vs. 2010 comparison, but the standard deviation value appears to be skewed by the analysis software including differences between areas on the edges of the scan world that did not match exactly between the annual scans. Given the degree of uncertainty associated with this value, the following findings should be evaluated critically, but it does appear that the

comparisons between scan worlds indicates that this panel is undergoing a high degree of activity in both loss and accretion of material, particularly immediately below the small stone ridges and at the bottom edge of the inscription panel. Much of the accretion is due to insect activity but there have also been some significant areas of spalling indicated by the scan world comparisons (see Figures 8 and 9).

Figure 8 – Panel 2 Comparison of 2006 and 2010 Scan Data

Figure 9 – Panel 2 Comparison of 2006 and 2010 Scan Data

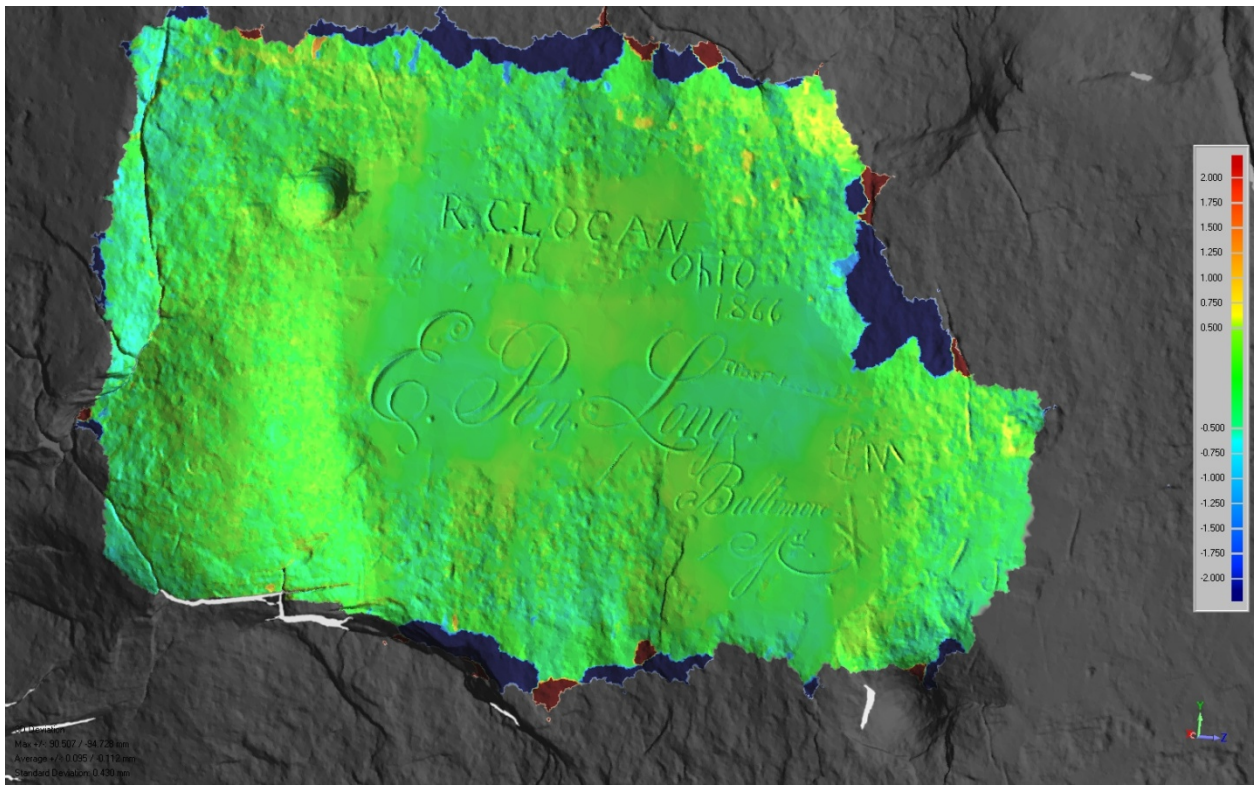
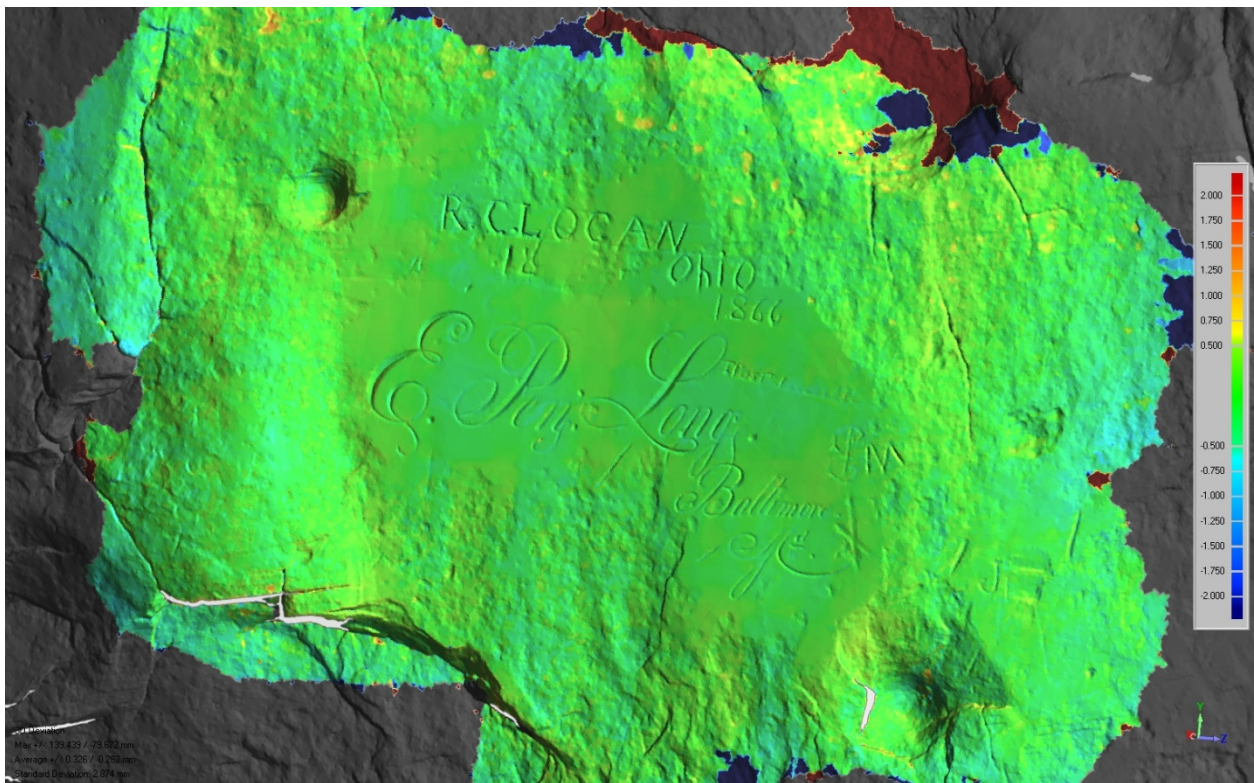
The scanning results for Panel 3 were much more encouraging. Again the standard deviation values range around .43 mm, but once again, this high value seems to have more to do with the edge matching problem than a wide range of possible gain or loss in the sandstone.

The comparison of scans from 2006 and 2007 to 2010 present a much more realistic case for the use of LIDAR in rock art documentation because the area to be scanned is much smaller, resulting less accumulation of error in the assemblage of individual scans, and because of the smaller size of the scan, the lighting conditions remained unchanged through the scanning process. Despite the unreliable value for standard deviation it seems fairly clear that the only process acting upon this inscription panel might be a slight amount of clay wash adding perhaps 1/10 of 1 mm of extra material to the stone surface, However, it seems more likely that this panel remained in a stable state for the 2006-2010 period.

Figure 10 - Panel 3 Comparisons of 2006 and 2007 scan world data

Figure 11- Panel 3 Comparisons of 2007 and 2010 scan world data

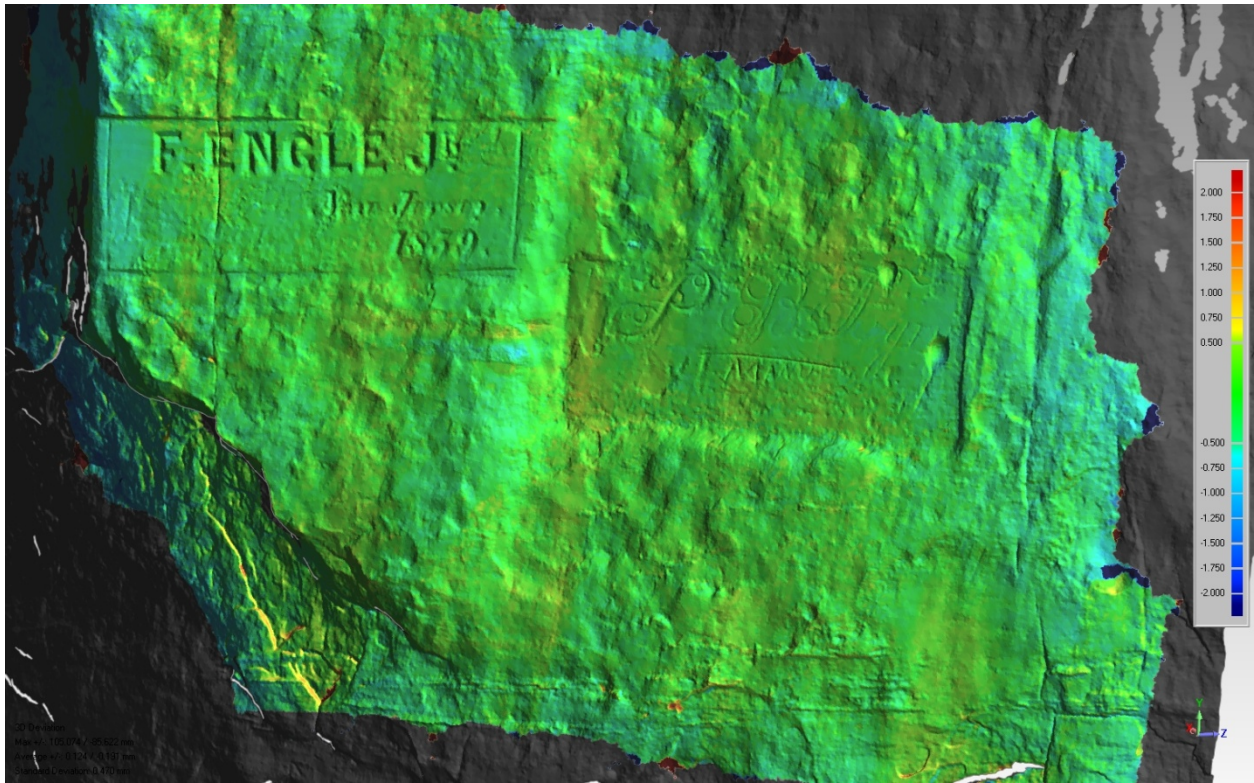
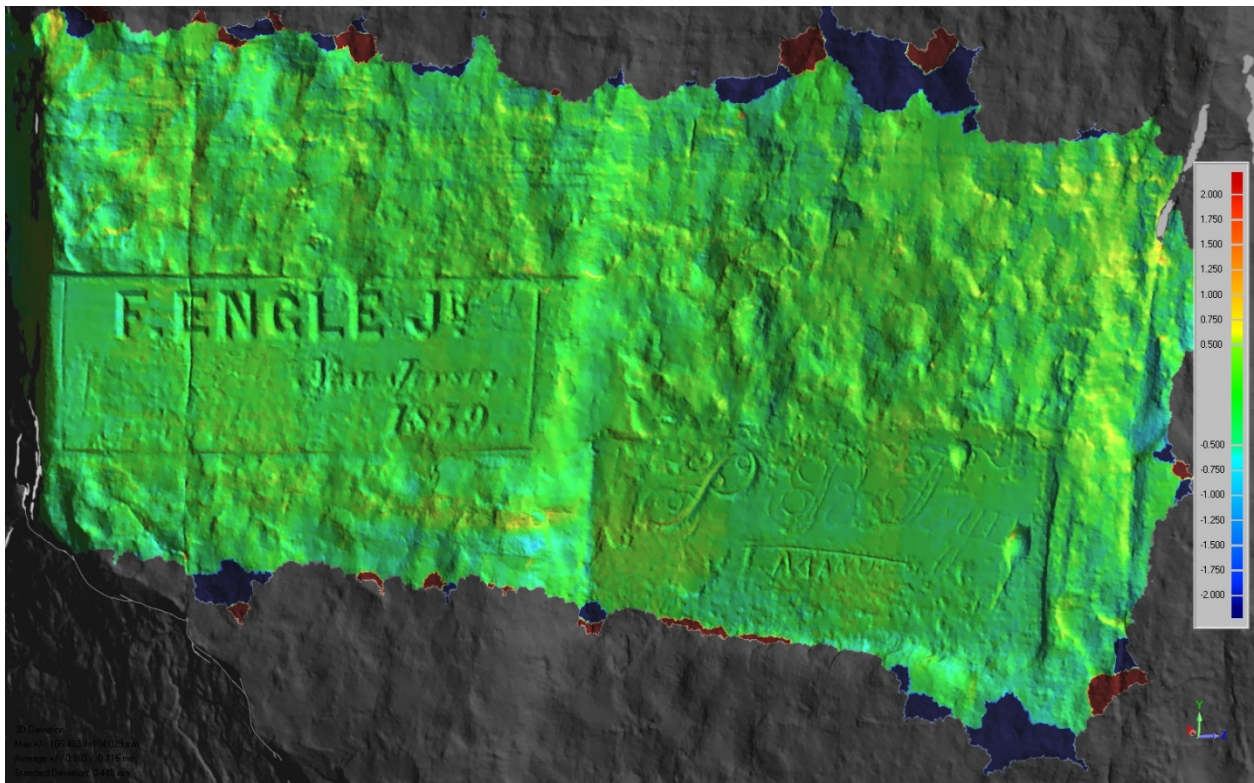
Like Panel 3, the results from the Panel 4 comparisons indicate a relatively stable inscription panel without serious episodes of erosion or deposition. The 2007 to 2010 comparison of scan world data does seem to indicate a slight amount of clay wash may be impacting this feature. Panel 4 data is presented in Figures 12 and 13, and resides on disk 2 in the panel 4 folder.

Figure 12 – Panel 4 Comparison of 2006 and 2010 scan worlds

Figure 13 – Panel 4 Comparison of 2007 and 2010 scan worlds

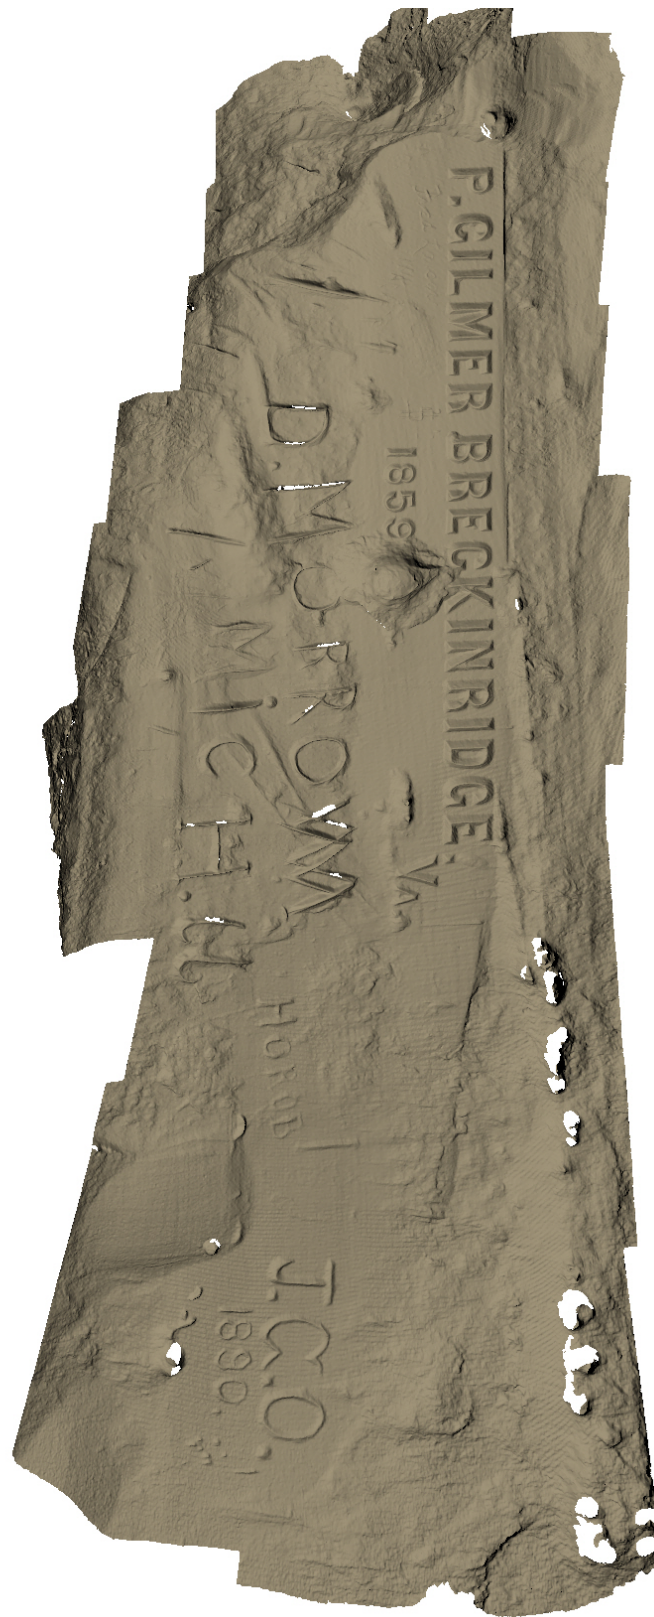
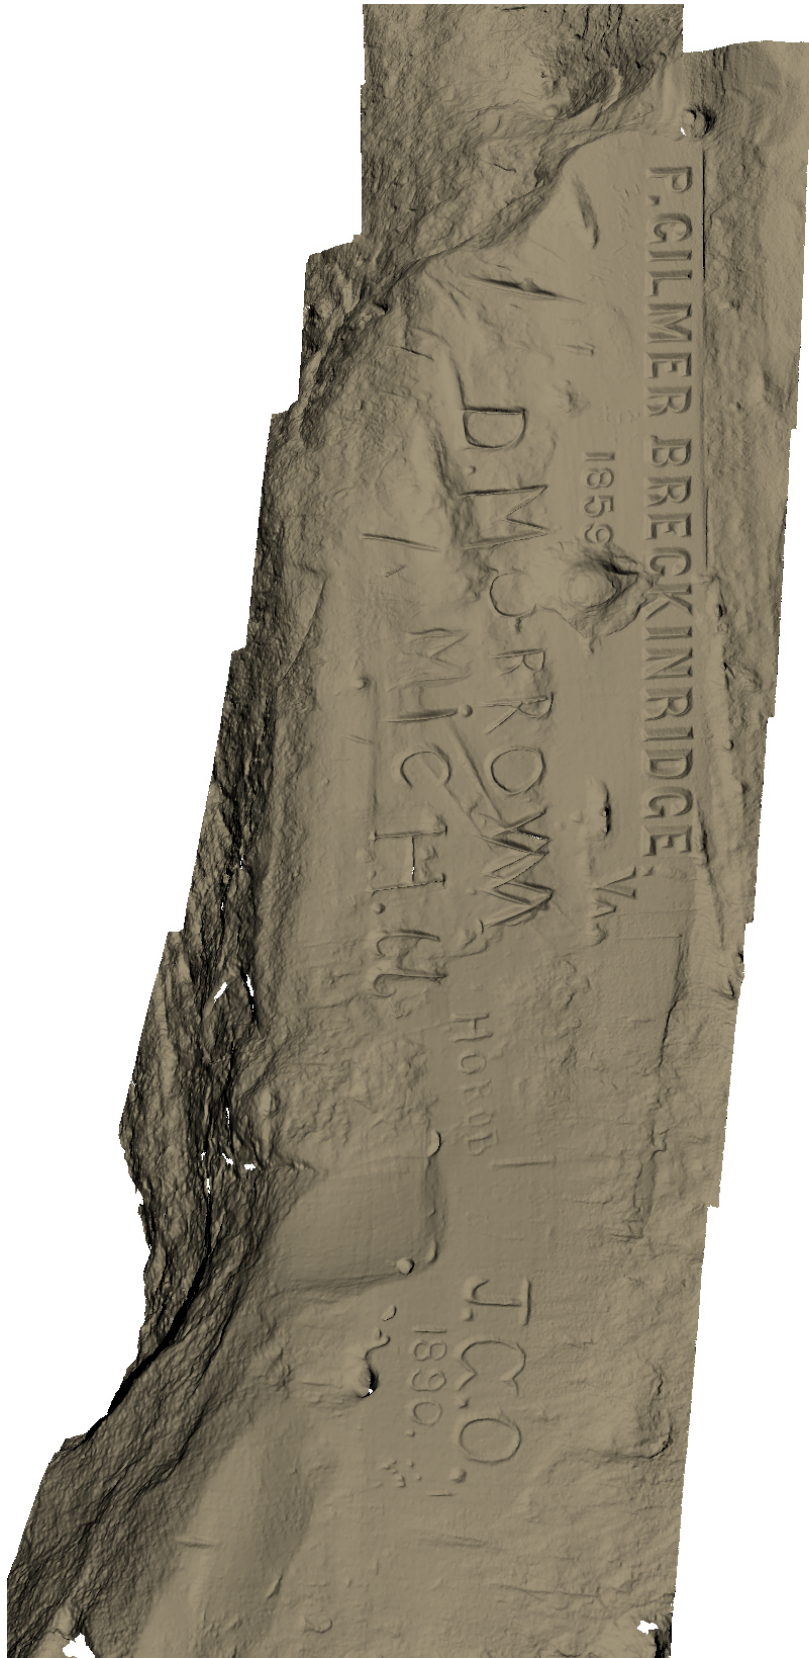
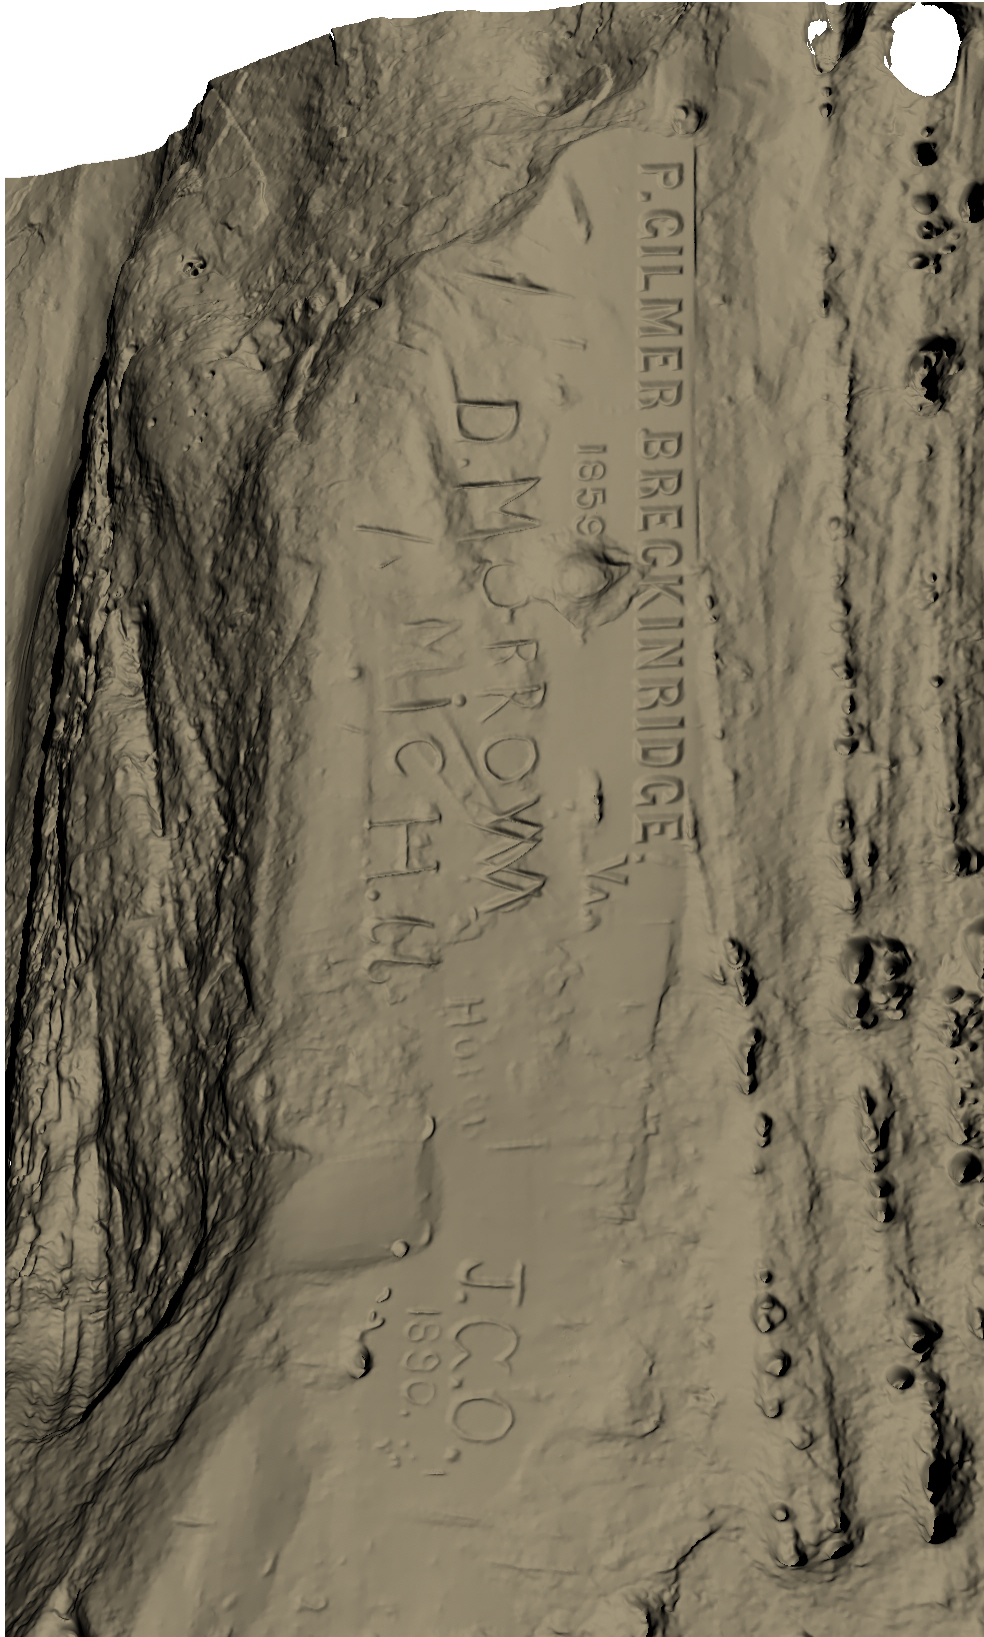
Panel 5, the inscription by Breckenridge appears to show the same basic results as panels 3 and 4, but there are some complications with this data. If one looks closely at the original scan data from 2006 and 2007 there are some obvious errors in the collection of this data. The raw scan data is presented in figures 14,15, and 16. In figure 14, above and to the right of the Breckenridge inscription there appears to be sets of many fine parallel lines. This represents statistical noise being generated by the scanner's sensor being overloaded by bright light during the scan. The problem is not as pronounced in the 2007 scan (compare figures 15 and 16) but the 2007 scan still presents more noise than is visible in the 2010 scan.

Figure 14 - Panel 5 Scan Results for 2006 – Note the noise in the area above the JCO inscription

Figure 15 – Panel 5 Scan Data with extra noise visible throughout scanned area

Figure 16 – Panel 5 Clean Scan data from 2010
