Laser Imaging of El Morro Inscriptions, El Morro National Monument, New Mexico

Project Number ELMO 2006 E

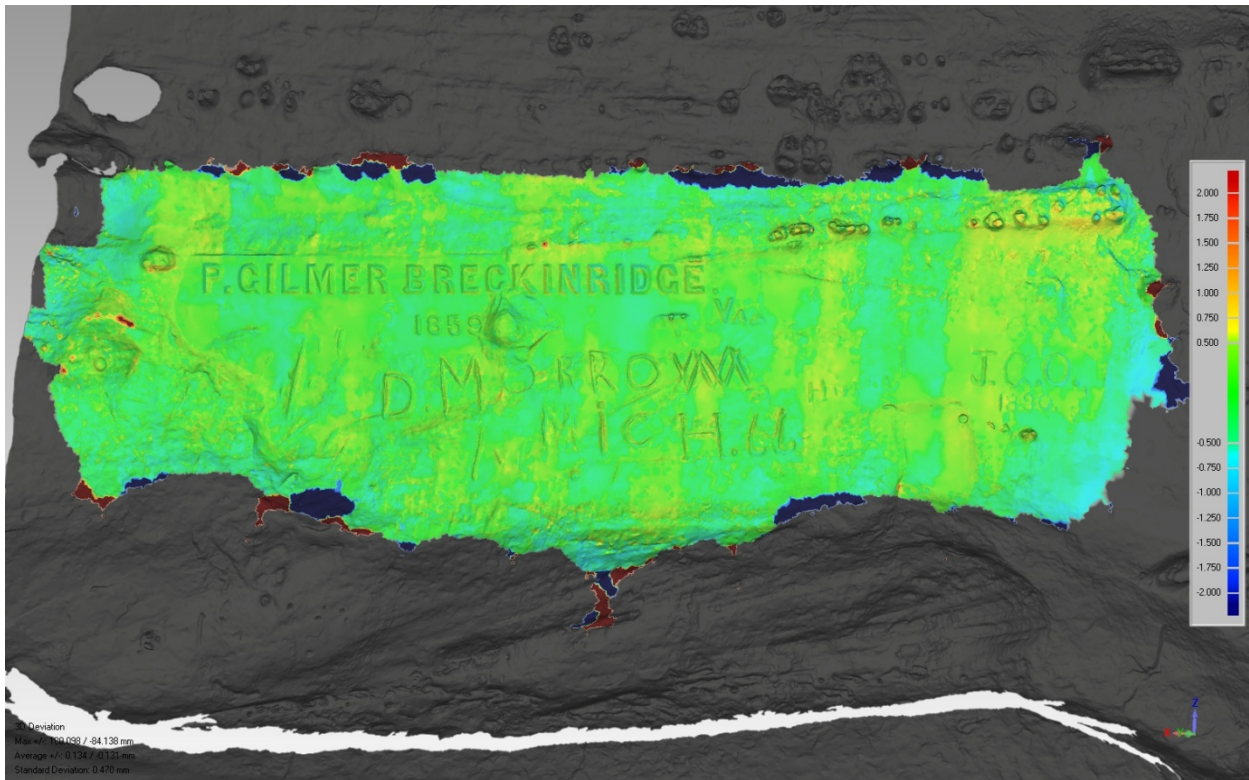
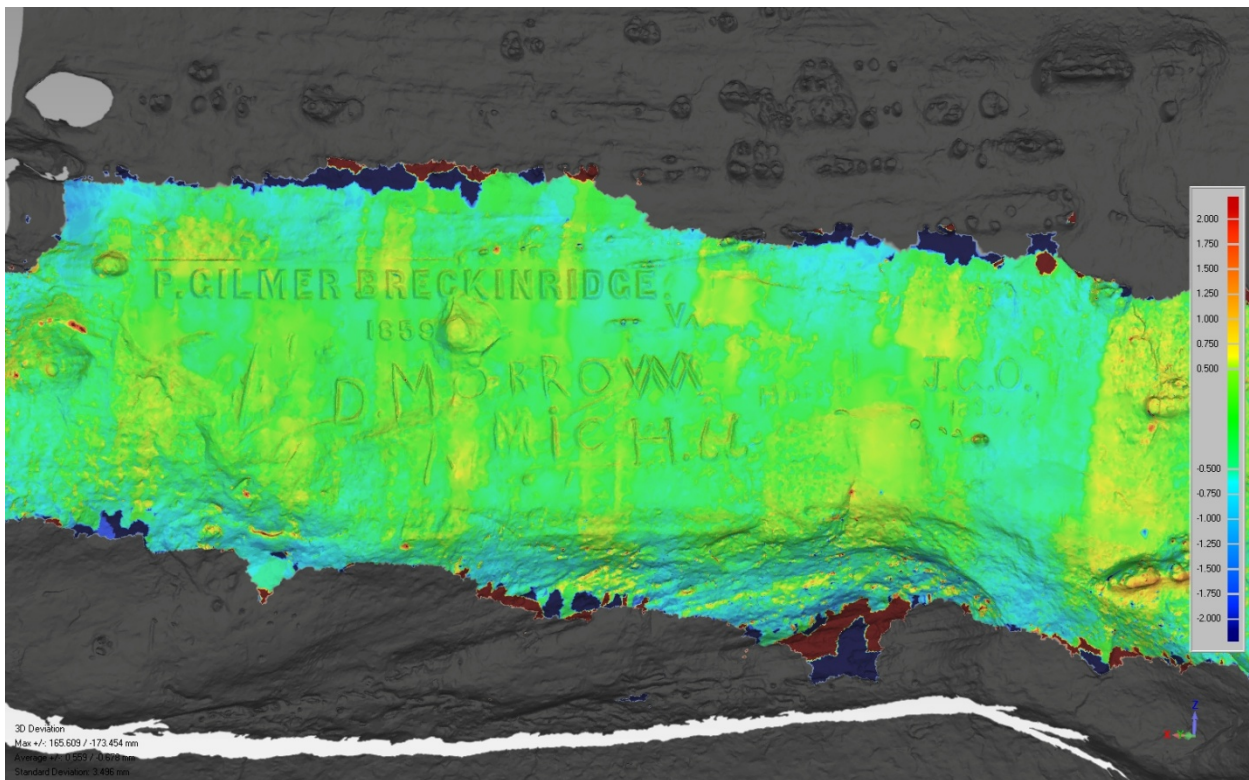
Evaluating the comparisons between the annual scans for panel 5 (Figures 17 and 18) is made more difficult by the presence of noise with these scans, but looking closely at the actual inscriptions, it seems safe to conclude that there might be a small amount of clay wash, particularly in the 2007 scan comparison (Figure 18) but otherwise this panel appears stable, much like panels 3 and 4. Panel 5 data is stored upon disk 2, in the Panel 5 folder.

Figure 17 – Panel 5 Comparison of 2006 and 2007 scan data

Figure 18 – Panel 5 Comparisons of 2007 and 2010 scan data

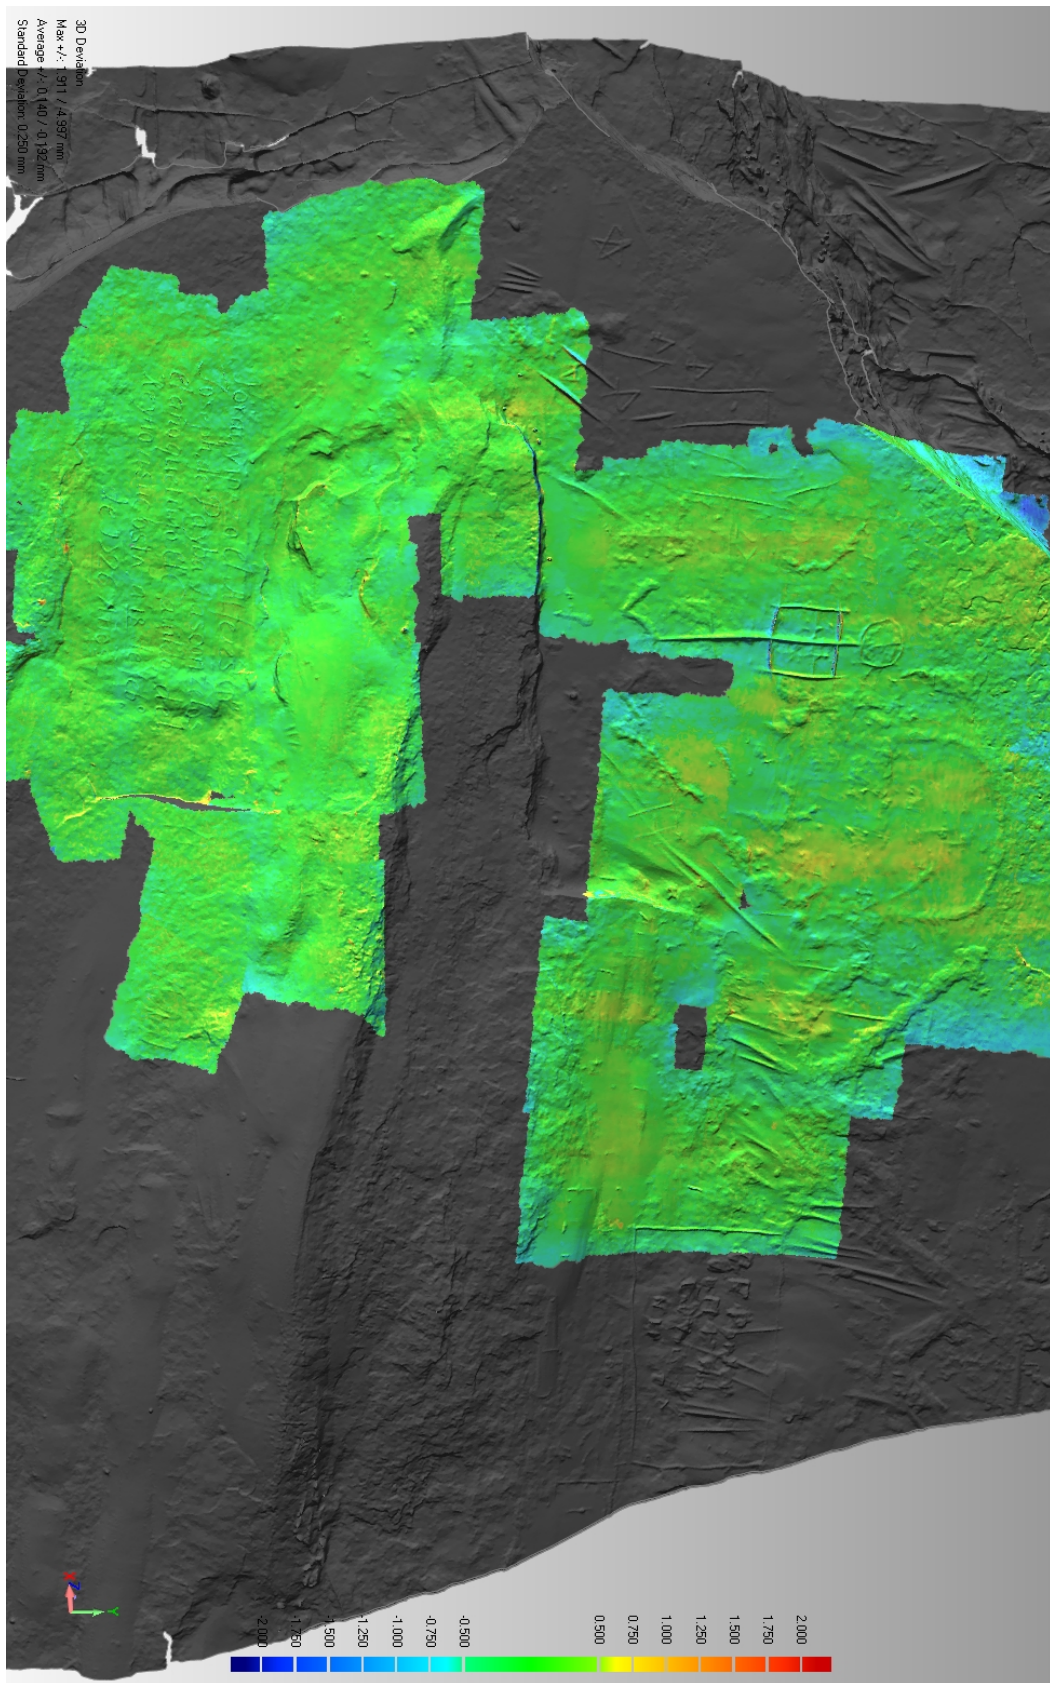
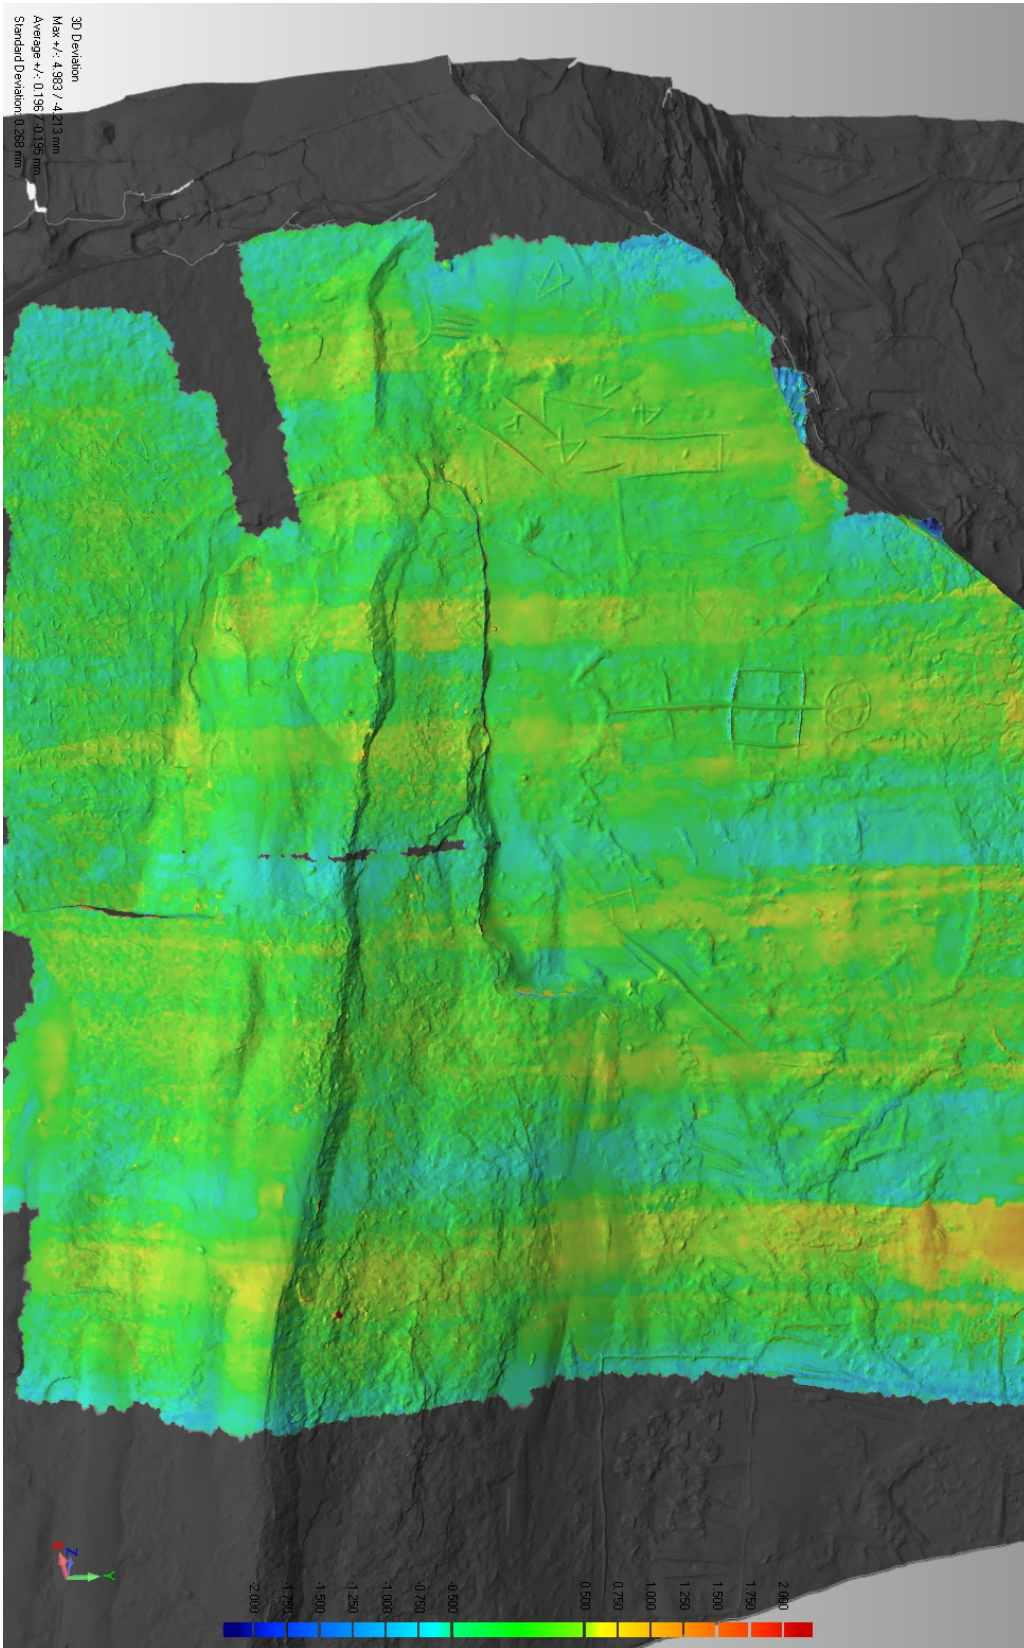
Given the above complicating factors, the scan data comparisons for 2006 and 2007 should be considered inconclusive. The standard deviations recorded for these scans were quite low, with values of .206 for 2006 and .192 for 2007, but the 2007 scan comparison (Figure 19) shows obvious banding that is not reflected in the 2006 scan, indicating problems with light and shadow during the scanning effort, and this banding is not reflected in the 2006 scan.

Figure 19 – Panel 6 Comparison of 2006 and 2010 scan worlds

Figure 20 – Panel 6 Comparison of 2007 and 2010 scan worlds

The 2007 scan, compared to the 2010 scan indicates that there has been very little change in the panel 6 surface during this time period (Figure 20). However, in the 2007 and 2010 scans, the Onaté inscription is barely visible, which calls the accuracy of both of these scans into question. If the 2007 – 2010 scan comparison is accurate, then the Onaté and Bishop of Durango inscriptions appear to remain stable.

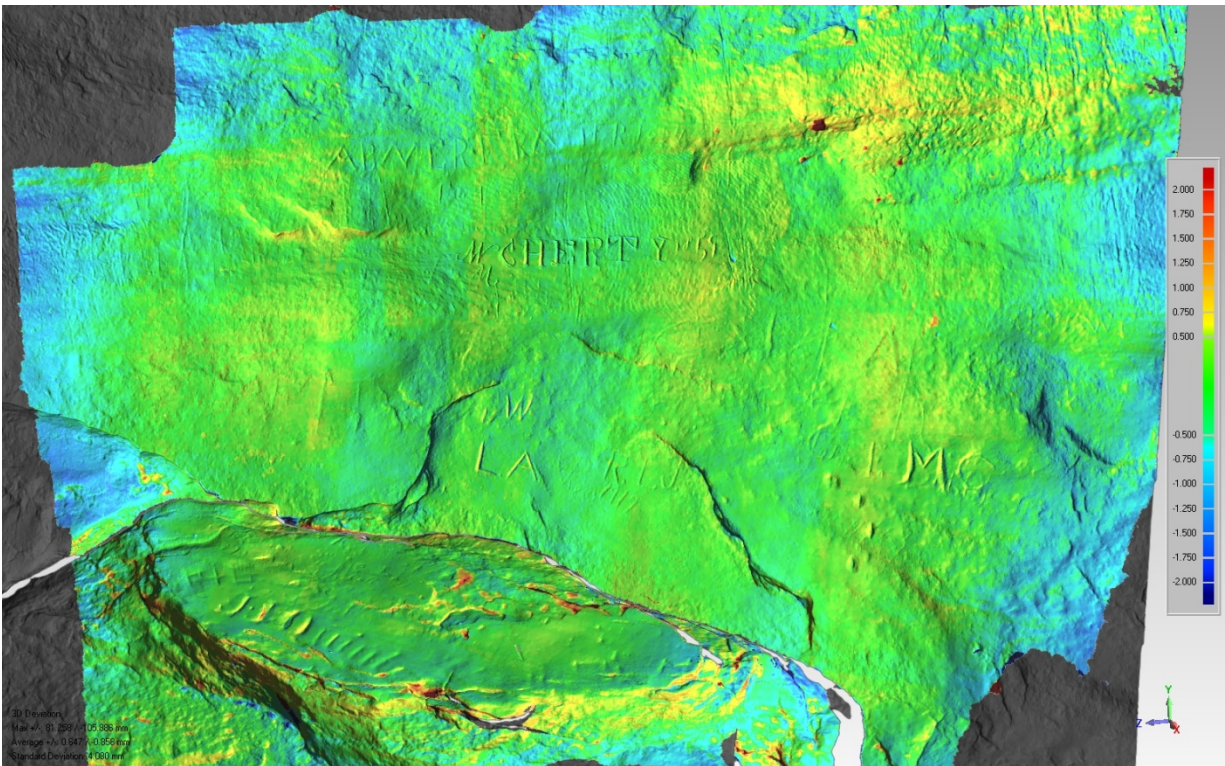
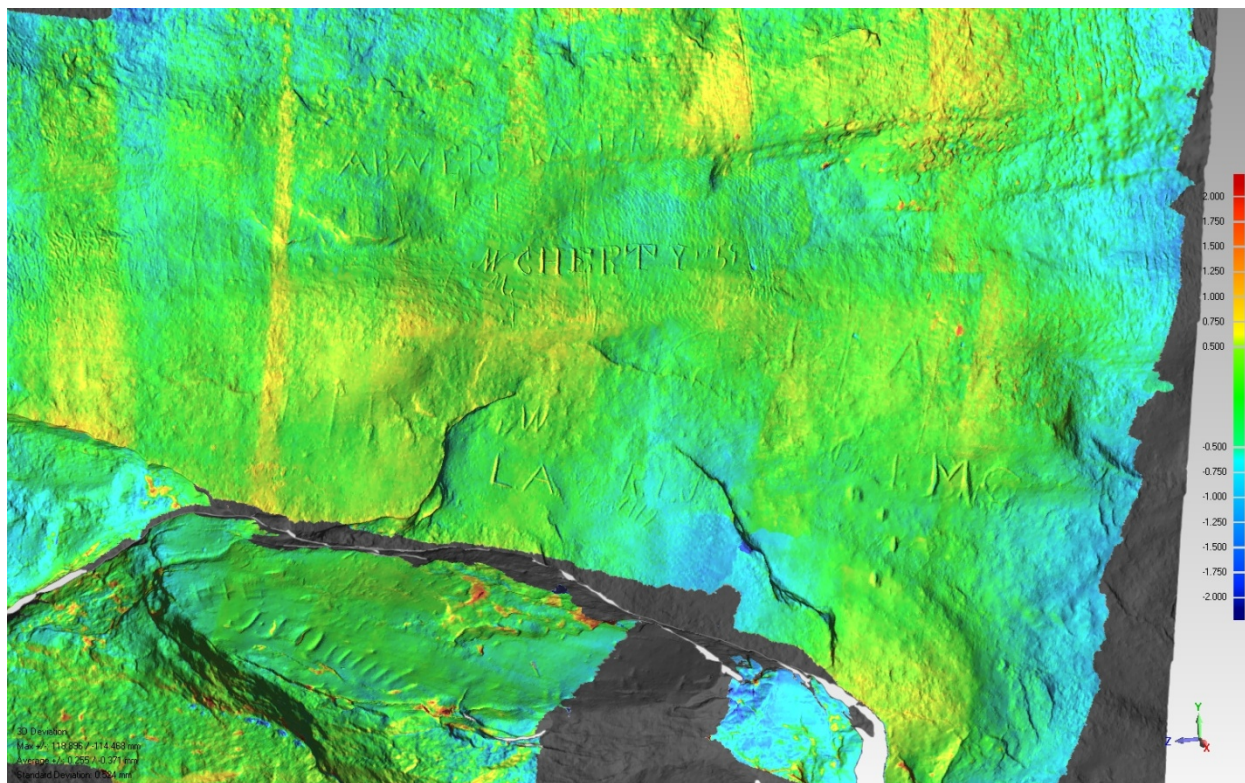
Figure 21 – Panel 7 Comparison of 2006 and 2007 scan worlds

The scanning and analysis of Panel 7 appears to be problematic. This panel includes the “Cherty” inscription from 1859, as well as a separate panel of inscriptions that resides upon a rock outcrop angled roughly thirty degrees out from the plane of stone that contains the Cherty glyph. These two panels represent a topology with a number of folds and crevices that were not always recorded by the vivid scanner. Because each year’s scan recorded different gaps in the scan worlds, the comparisons between years reflect a high degree of both vertical banding and statistical noise. The standard deviation value for the 2006 to 2010 comparison was .5 mm, which is at least tolerable for comparison, but the deviation for the 2007 to 2010 comparison was more than 4 mm, rendering the comparisons nearly meaningless. The

Figure 22 – Panel 7 Comparison of 2007 and 2010 scan worlds

If the 2006 and 2007 scans can be trusted (Figure 21 and 22), it would appear that there is a problem with clay wash deposition around the Cherty inscription. The apparent banding in these comparisons cannot be explained by the contrasting patterns of sunlight and shade that may have affected the scans on Panels 1 and 6. Both the 2007 and 2006 comparison indicate a new scratch just to the immediate left of the date on the Cherty panel that is due to vandalism.

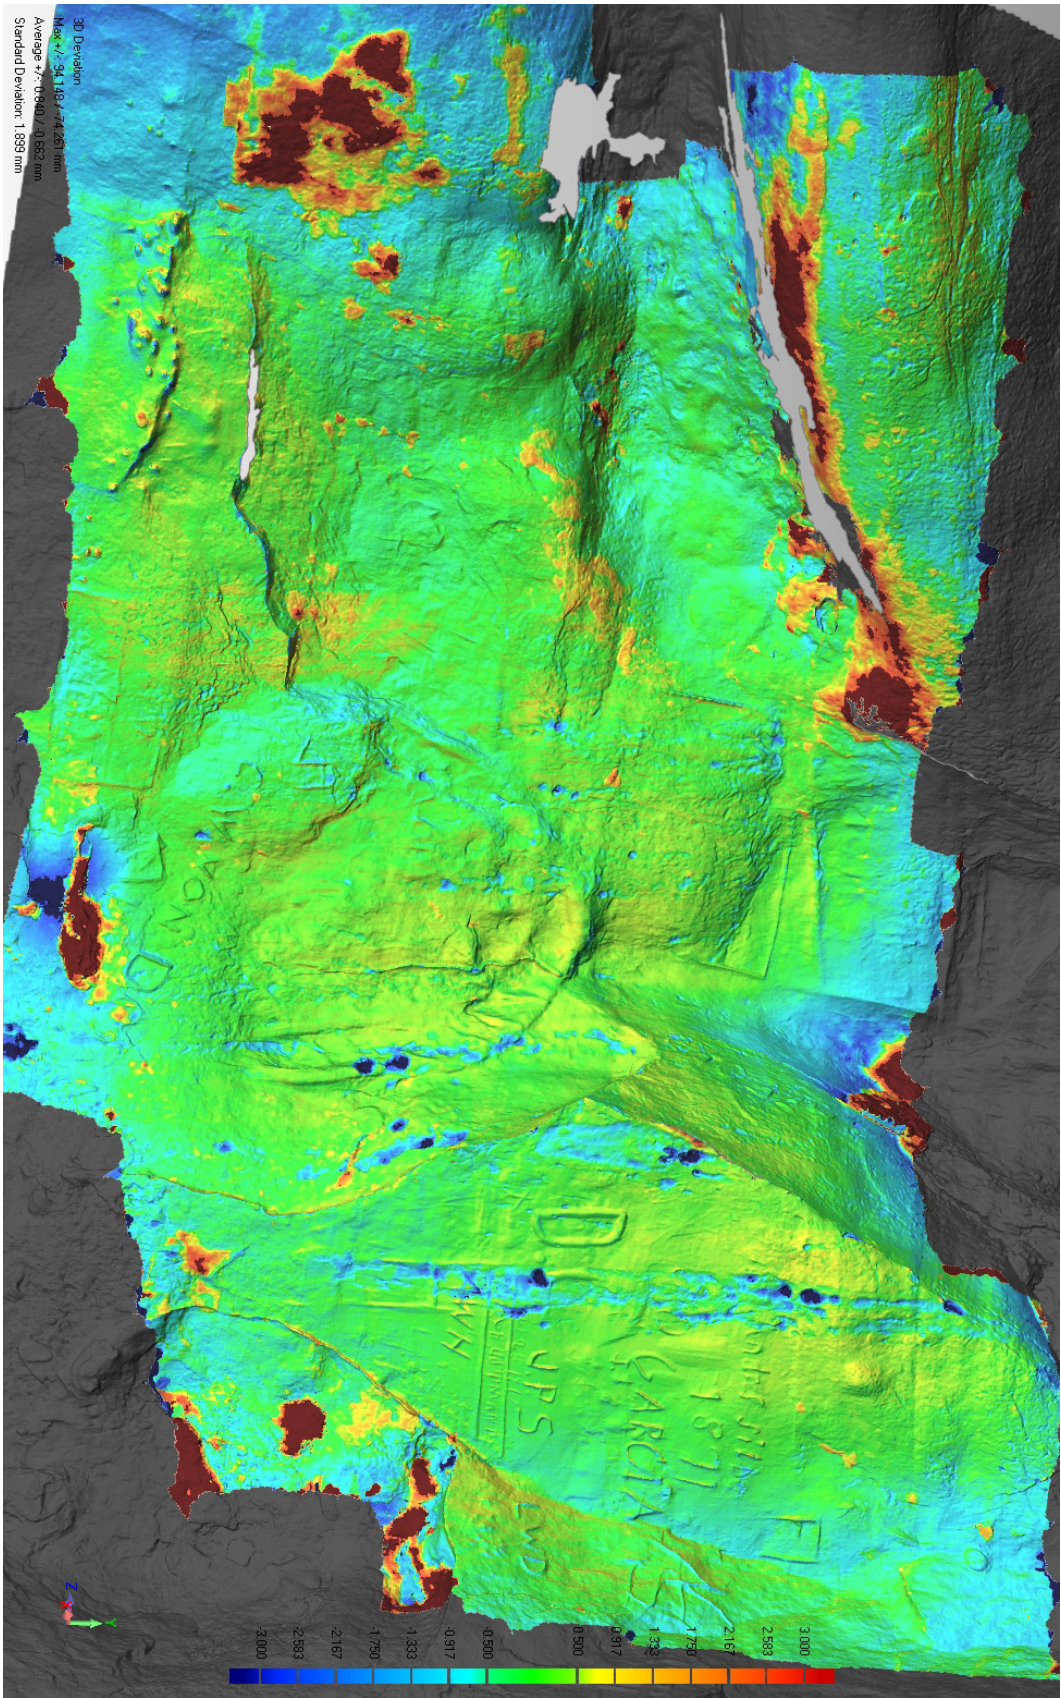
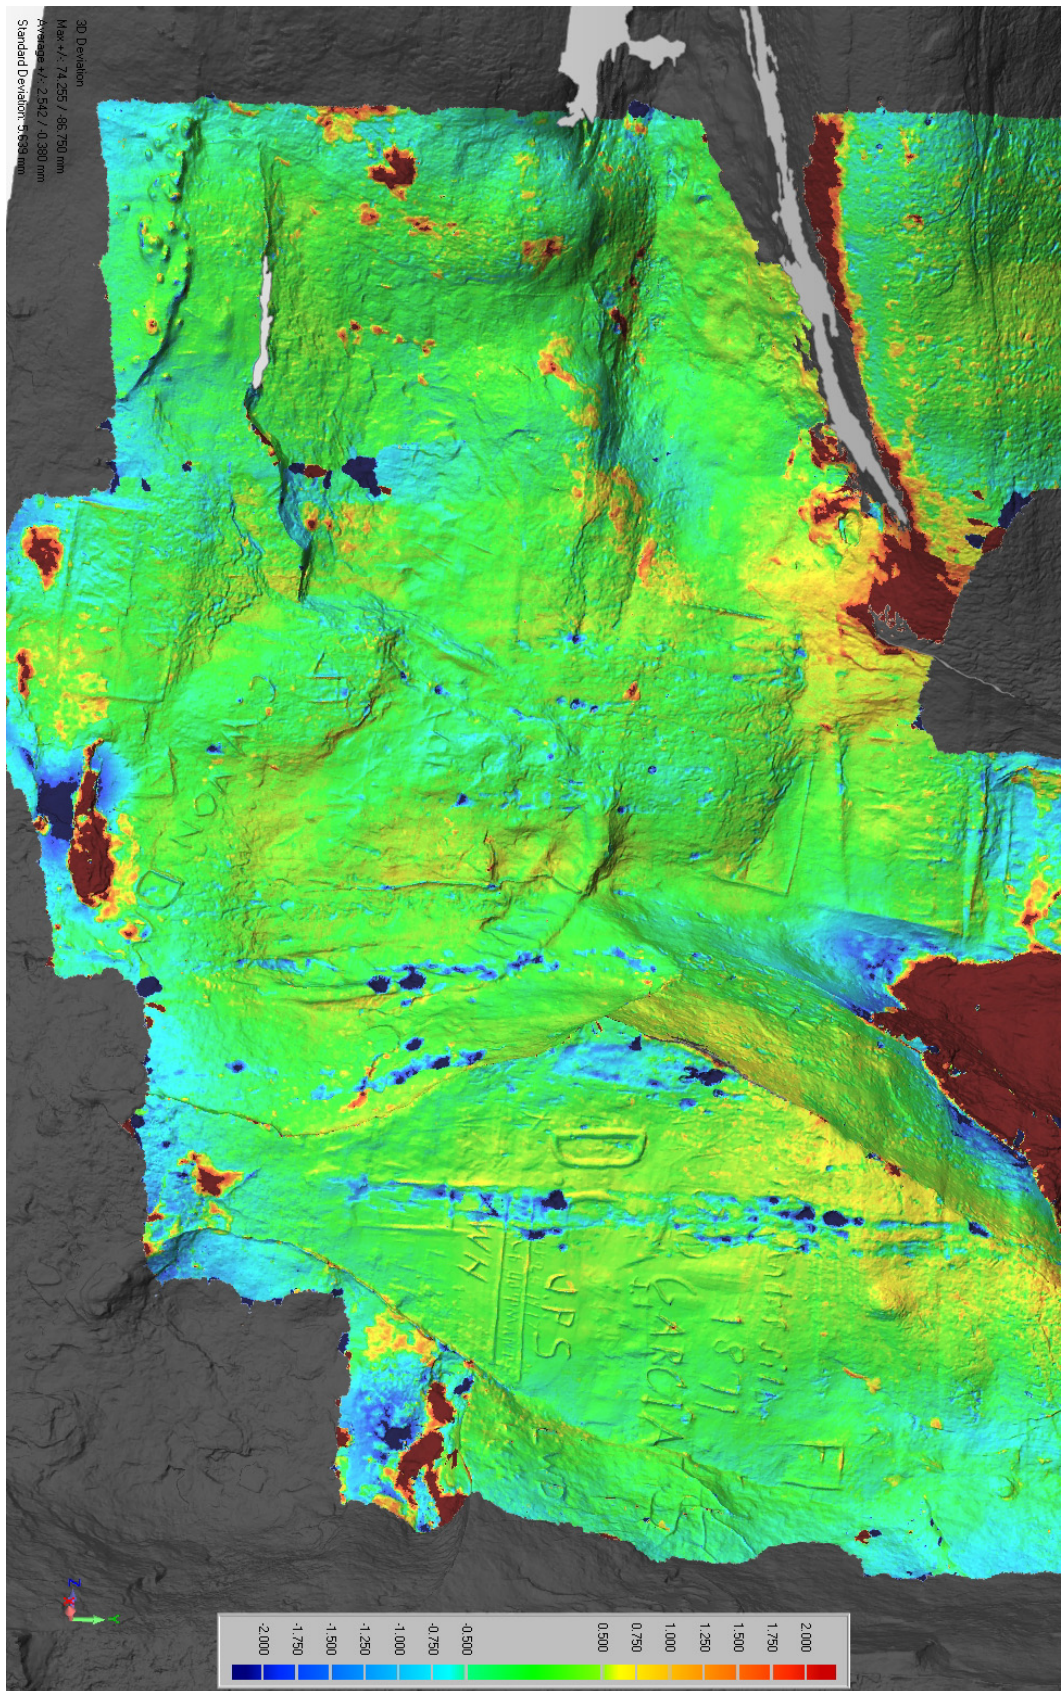
Despite the problem with statistical evaluation, the comparisons of scans from 2006 (Figure 23) and 2007 (Figure 24) indicate that Panel 8 is quickly disintegrating and in immediate need of some type

When evaluating the comparisons of scan worlds from this area, one needs to ignore the areas in dark red along the margins of the scan world. These areas indicate gaps in scan data, rather than the +3 mm of deposition that the comparison's scale would indicate. With this factor in mind, it is clear that there is a mixture of process working to ablate the Northeast point of Inscription rock, as previously described by Burris in 2007. Both the 2006 and 2007 scans indicate areas of severe spalling, granular disintegration, and clay wash deposition that are actively working to obliterate the historic inscriptions on this portion of the sandstone surface.

Figure 23 – Panel 8 (Northeast Point) comparison of 2006 and 2010 scan worlds

Figure 24 – Panel 8 (Northeast Point) comparison of 2007 and 2010 scan worlds

of stabilization, or at a minimum, extremely high resolution digital scanning to preserve the inscriptions that are rapidly being destroyed.

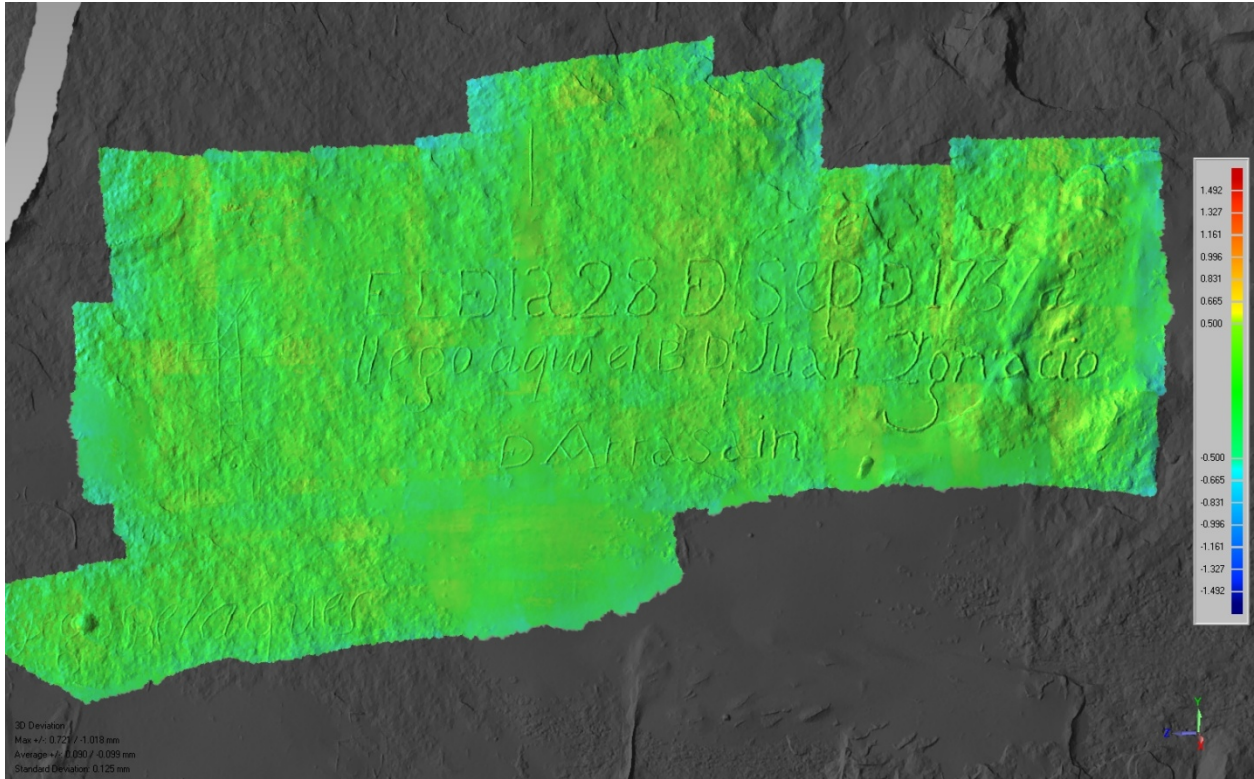
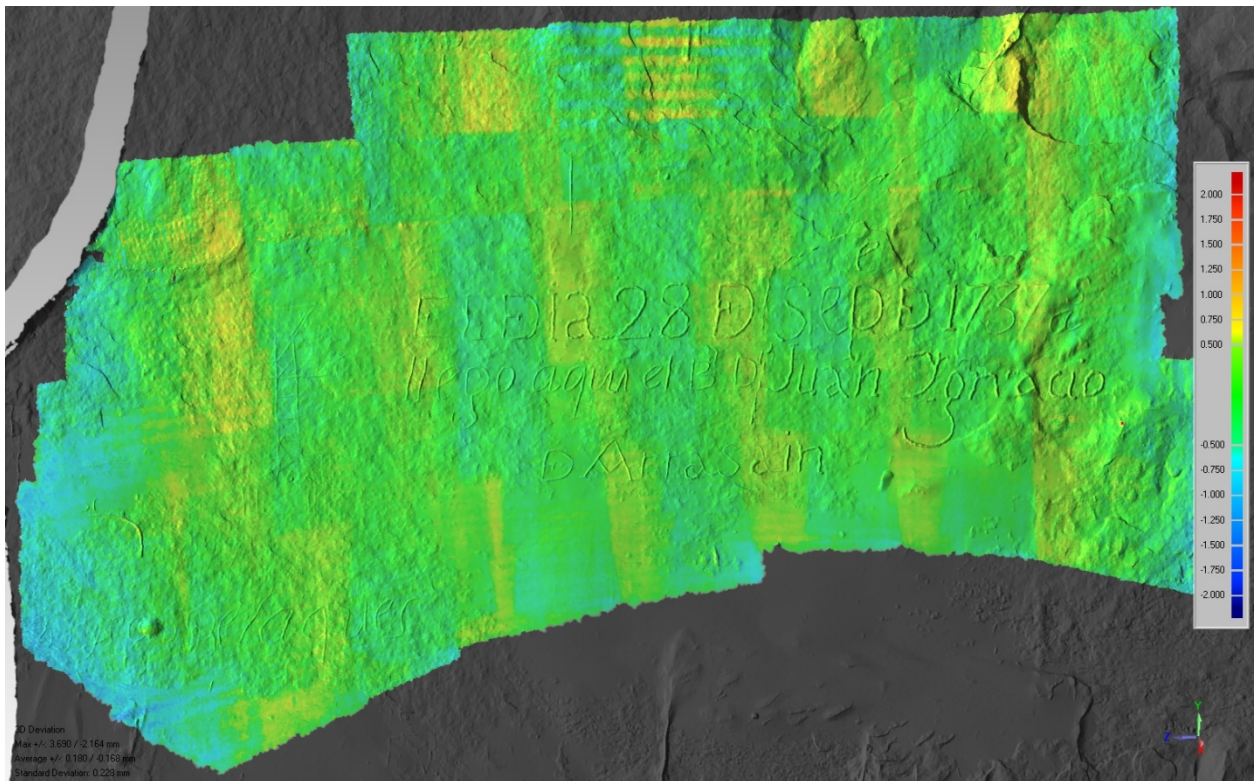
Figure 25 – Panel 9 Comparison of 2006 and 2010 scan worlds

Figure 26 – Panel 9 Comparison of 2007 and 2010 scan worlds

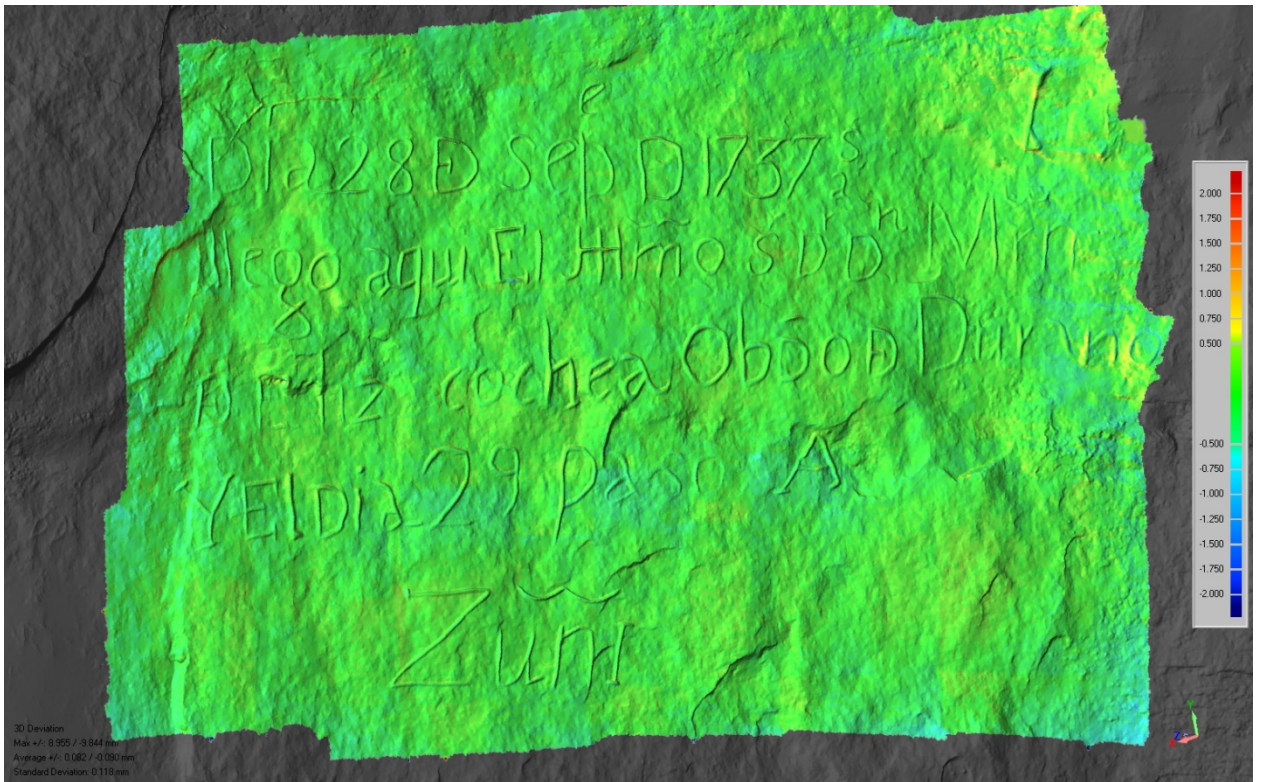
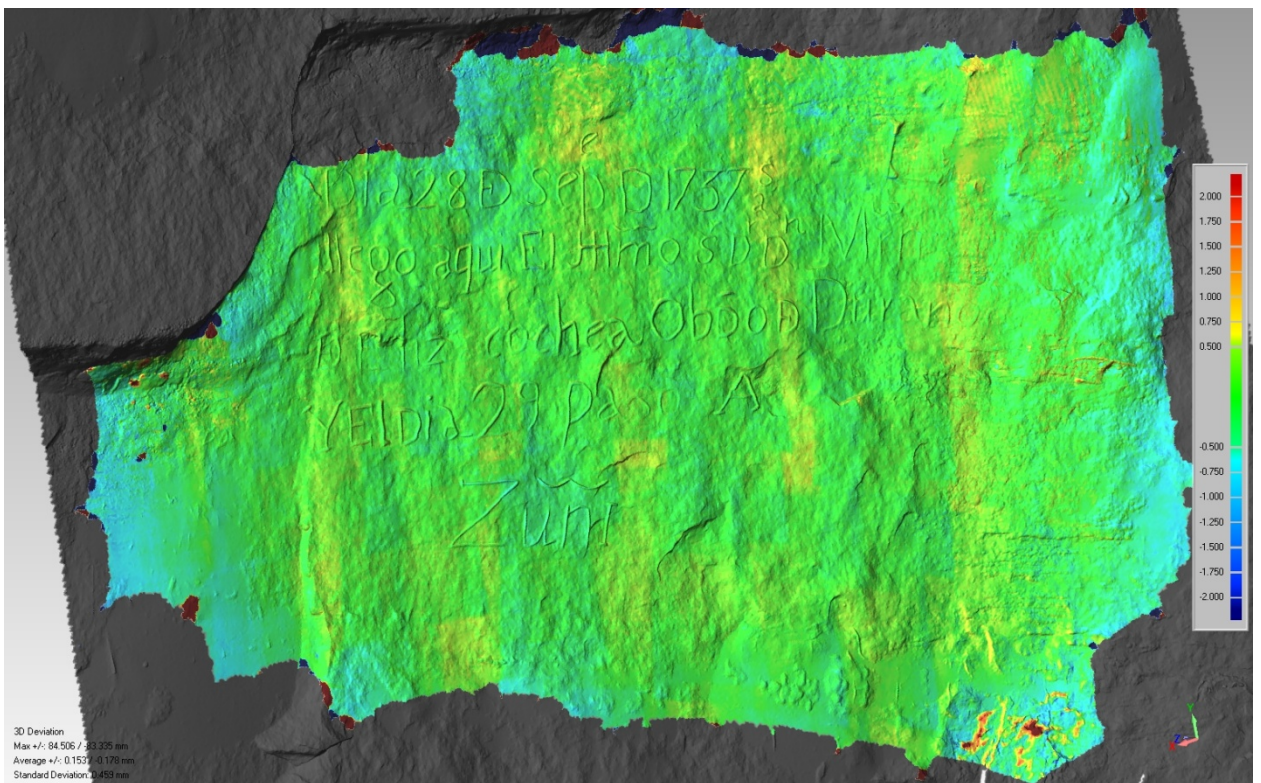
Panel 10 shares the same general setting, context, and date as Panel 9, so it is not surprising that this area also appears to remain in a stable and well preserved state. This stability can be seen in Figure 27, where other than some possible light deposition on the far left side of the scan world, the panel does not display any significant changes between the 2006 and 2010 scans. Again following the pattern established on Panel 9, the 2007 to 2010 comparison (Figure 28) shows a much higher standard deviation (.459 mm) and a consistent pattern of banding that appears too geometric to be anything other than statistical noise. All Panel 10 data files reside on Disk 3 in the folder Panel 10.

Figure 27 – Panel 10 Comparison of 2006 and 2007 scan worlds

Figure 28 – Panel 10 Comparisons of 2007 and 2010 scan worlds
