# **RIO NUEVO ARCHAEOLOGY, 2000-2003:**

**Investigations at the San Agustín Mission and Mission Gardens,  
Tucson Presidio, Tucson Pressed Brick Company, and Clearwater Site**

**Technical Report No. 2004-11  
Desert Archaeology, Inc.**

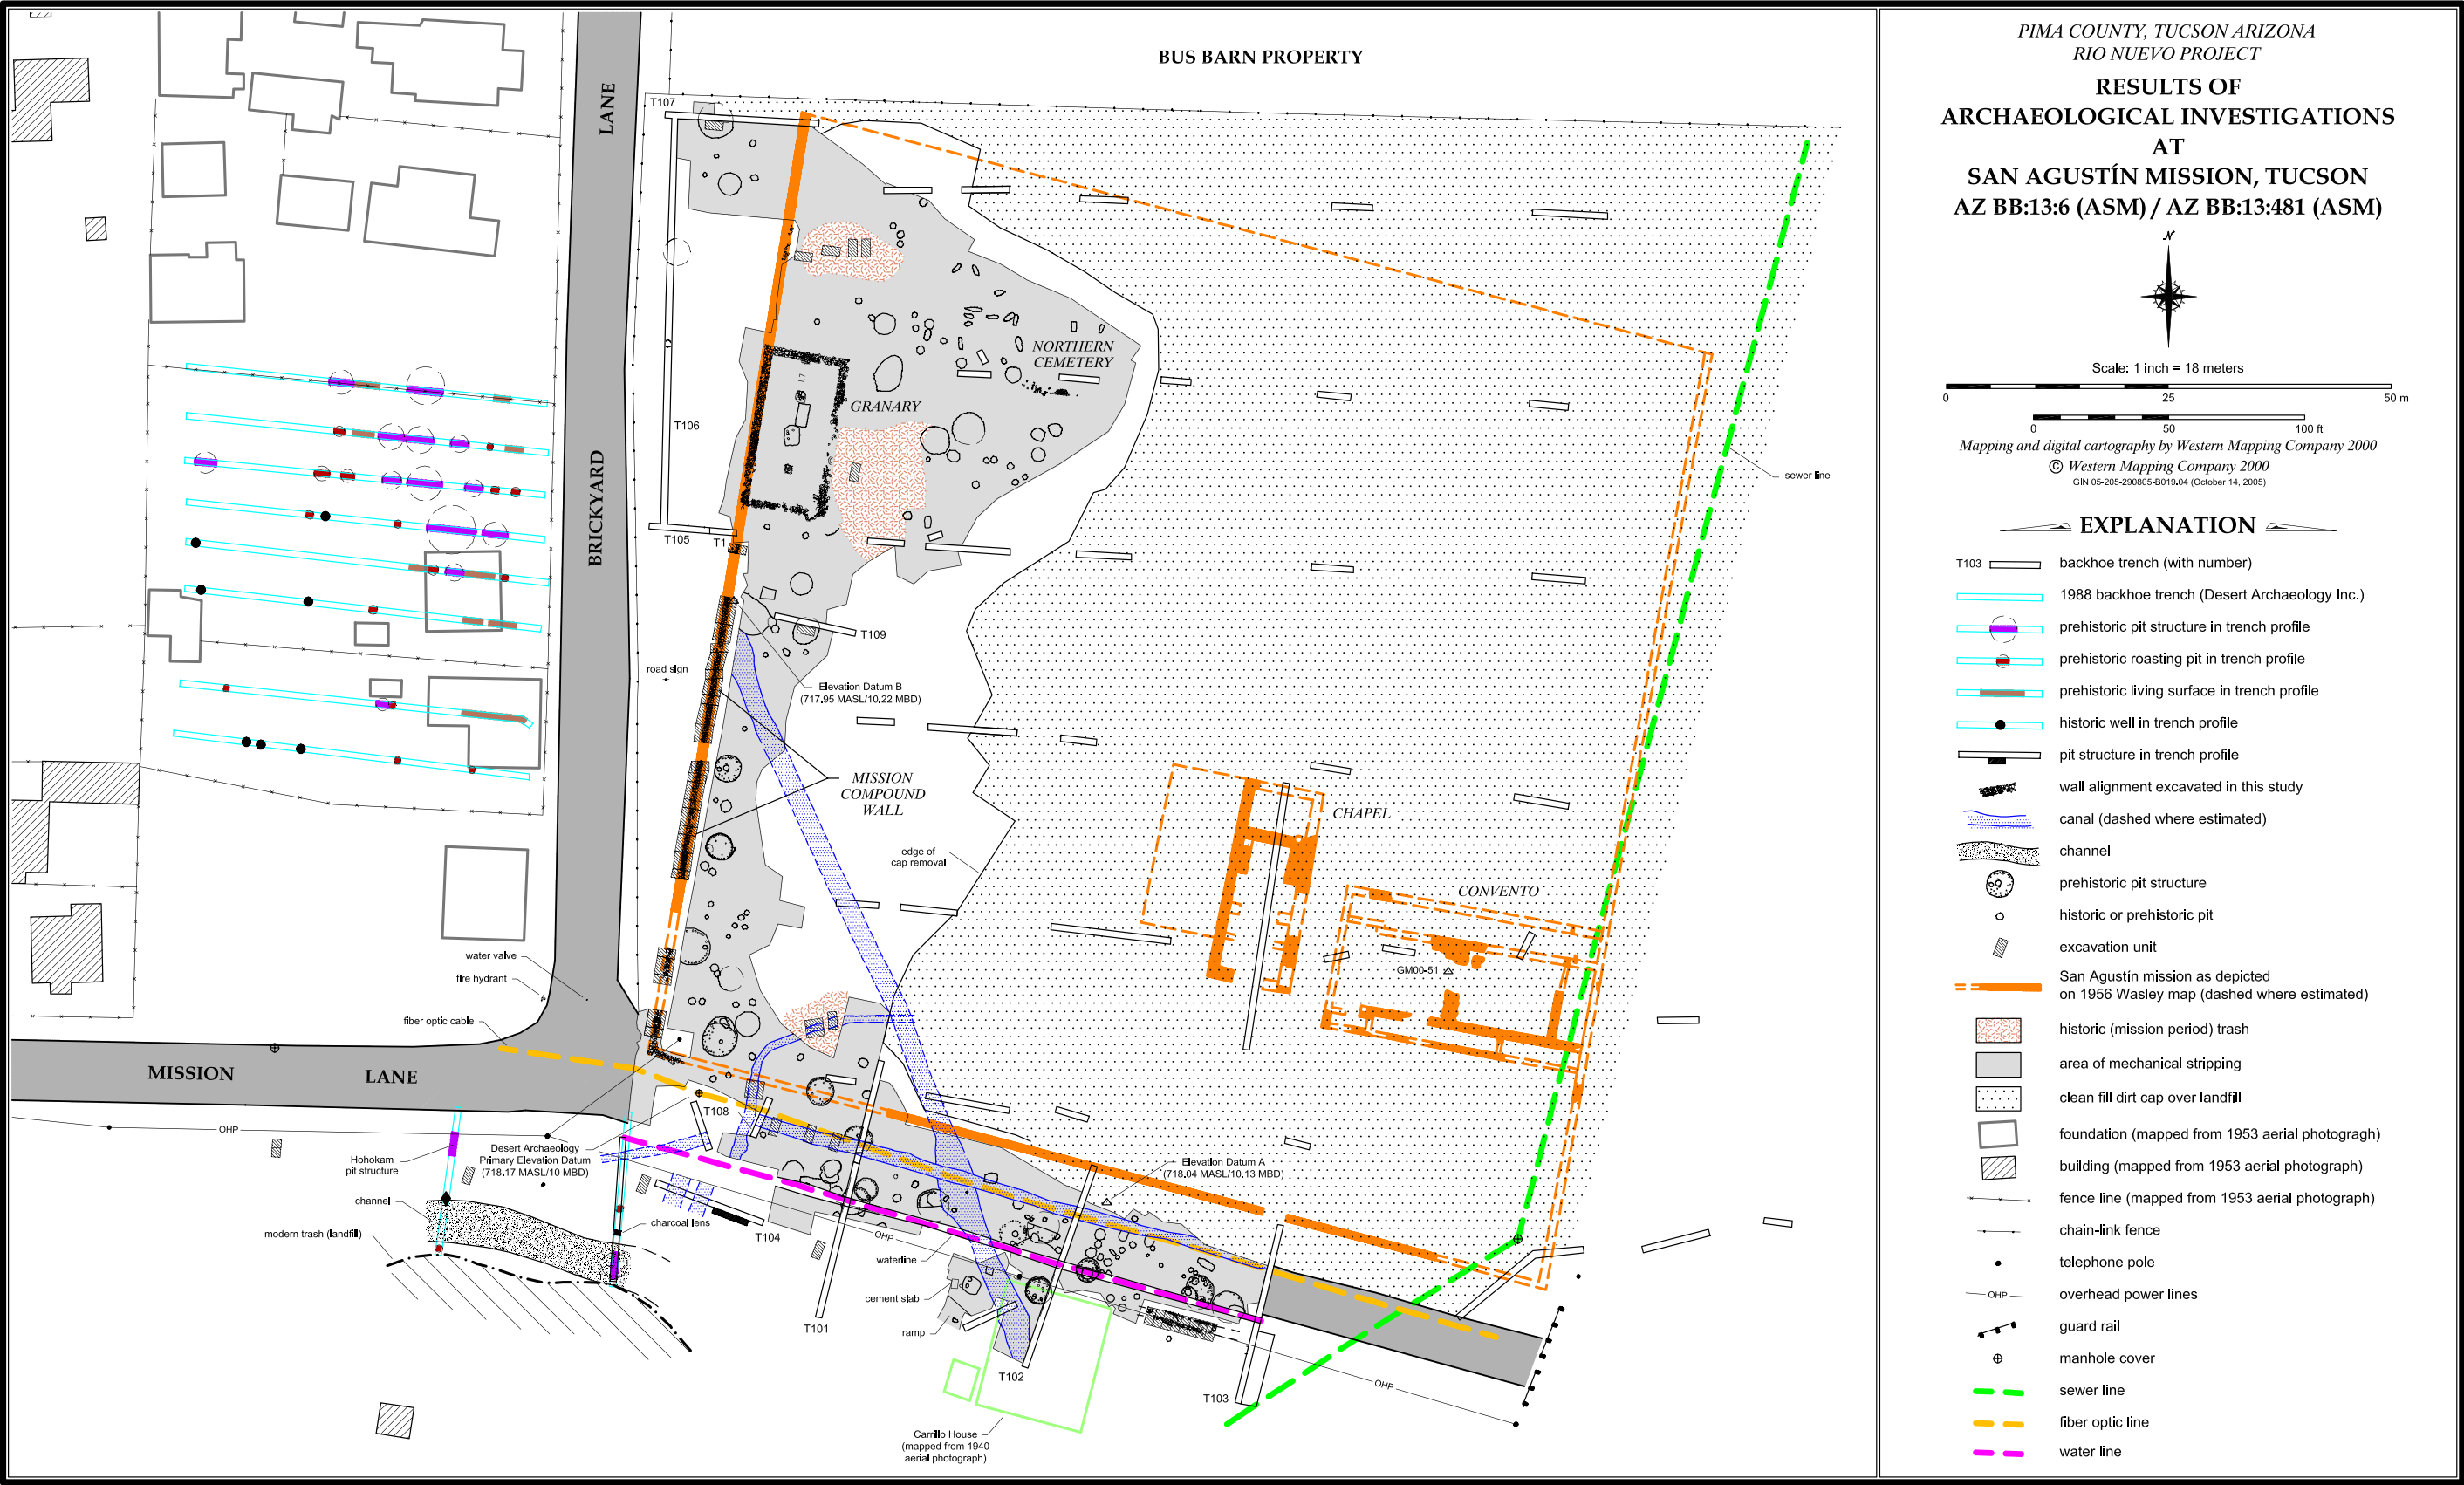
Figure 1.3. Map of archaeological features at the San Agustín Mission locus, AZ BB:13:6 (ASM).

Work also delineated the boundaries of the 1950s landfill (see Figure 1.3). The western side of the site was partially mined for clay for bricks, and a small amount of trash was discarded in the area. Toward the east, the landfill drops off dramatically and is approximately 6.0-7.5 m deep in the eastern one-third of the mission area. The southern boundary of the landfill begins within 3 m (10 ft) of the northern side of Mission Lane, and again drops steeply downward. Artifacts found within the edges of the landfill included newspapers from November 1957, bottles, dolls, and cloth. Once the top of the landfill was revealed, no attempt was made to excavate. The exception was the area within the convento and chapel, where exploratory trenches were monitored by the city's Department of Waste Management.

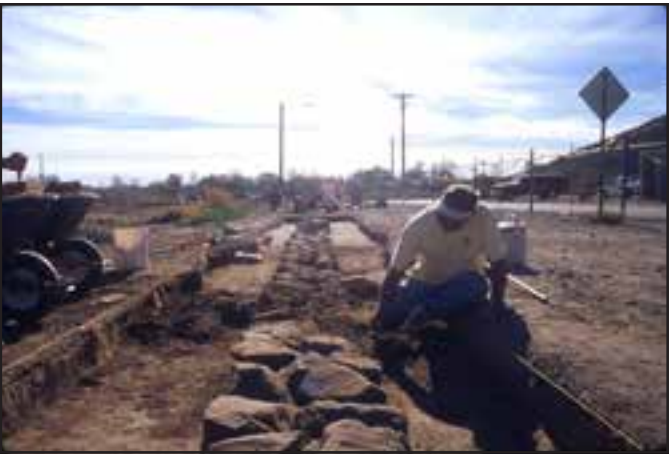
**Figure 1.4.** A volunteer clears a section of the western compound wall foundation at the San Agustín Mission, AZ BB:13:6 (ASM).

to two courses of rock preserved. Adobe was smeared over the rocks, forming a flat base upon which an adobe wall was built.

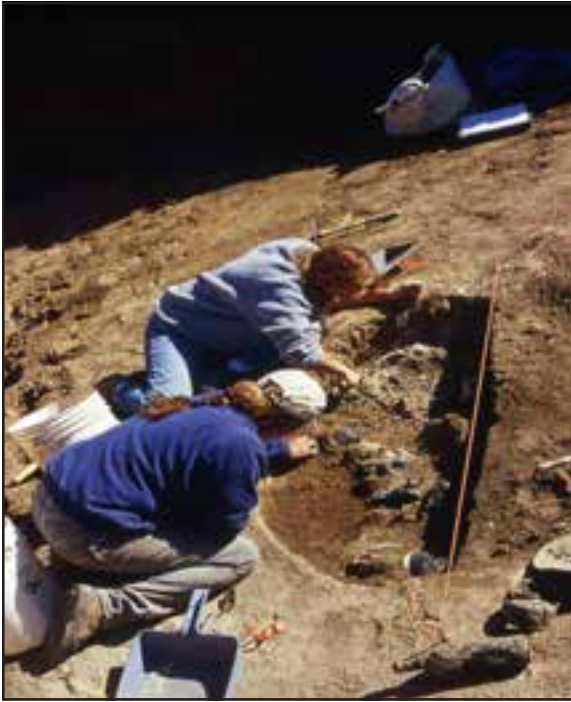
**Figure 1.5.** Archaeologists excavate the well filled with Chinese artifacts, the San Agustín Mission locus, the Clear-water site, AZ BB:13:6 (ASM).

Excavations revealed a hand-dug well and an adjacent pit containing artifacts discarded by the Chinese gardeners (Figure 1.5). These included an iron wok, soy sauce jugs, rice wine bottles, rice bowls, wine cups, fish bones, and cuttlefish bone (from a squid-like creature). Only one other Chinese gardener's

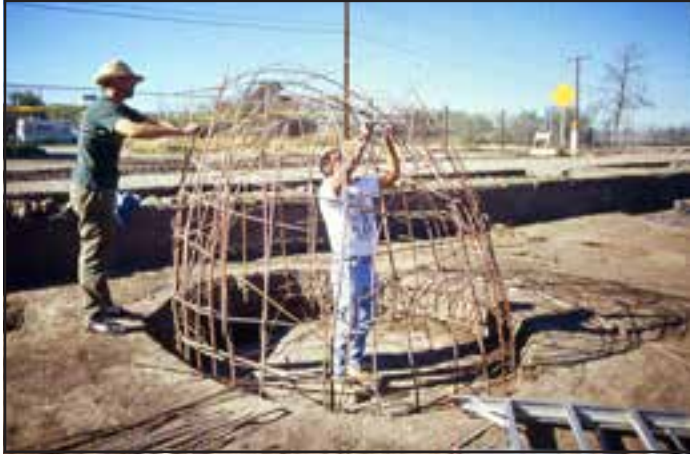
**Figure 1.6.** An Early Agricultural period pithouse was reconstructed in its original pit, the San Agustín Mission locus, the Clearwater site, AZ BB:13:6 (ASM).

On 3 February 2001, over 1,000 people toured the site, watching archaeologists at work, examining artifacts and exhibits, viewing a reconstructed pithouse (Figure 1.6) and a computer simulation of the mission, and witnessing demonstrations of spearthrowing and stone toolmaking. Visitors were enthusiastic about the archaeological project and expressed excitement about the proposed cultural park. Most stated an interest in the proposed reconstructions,

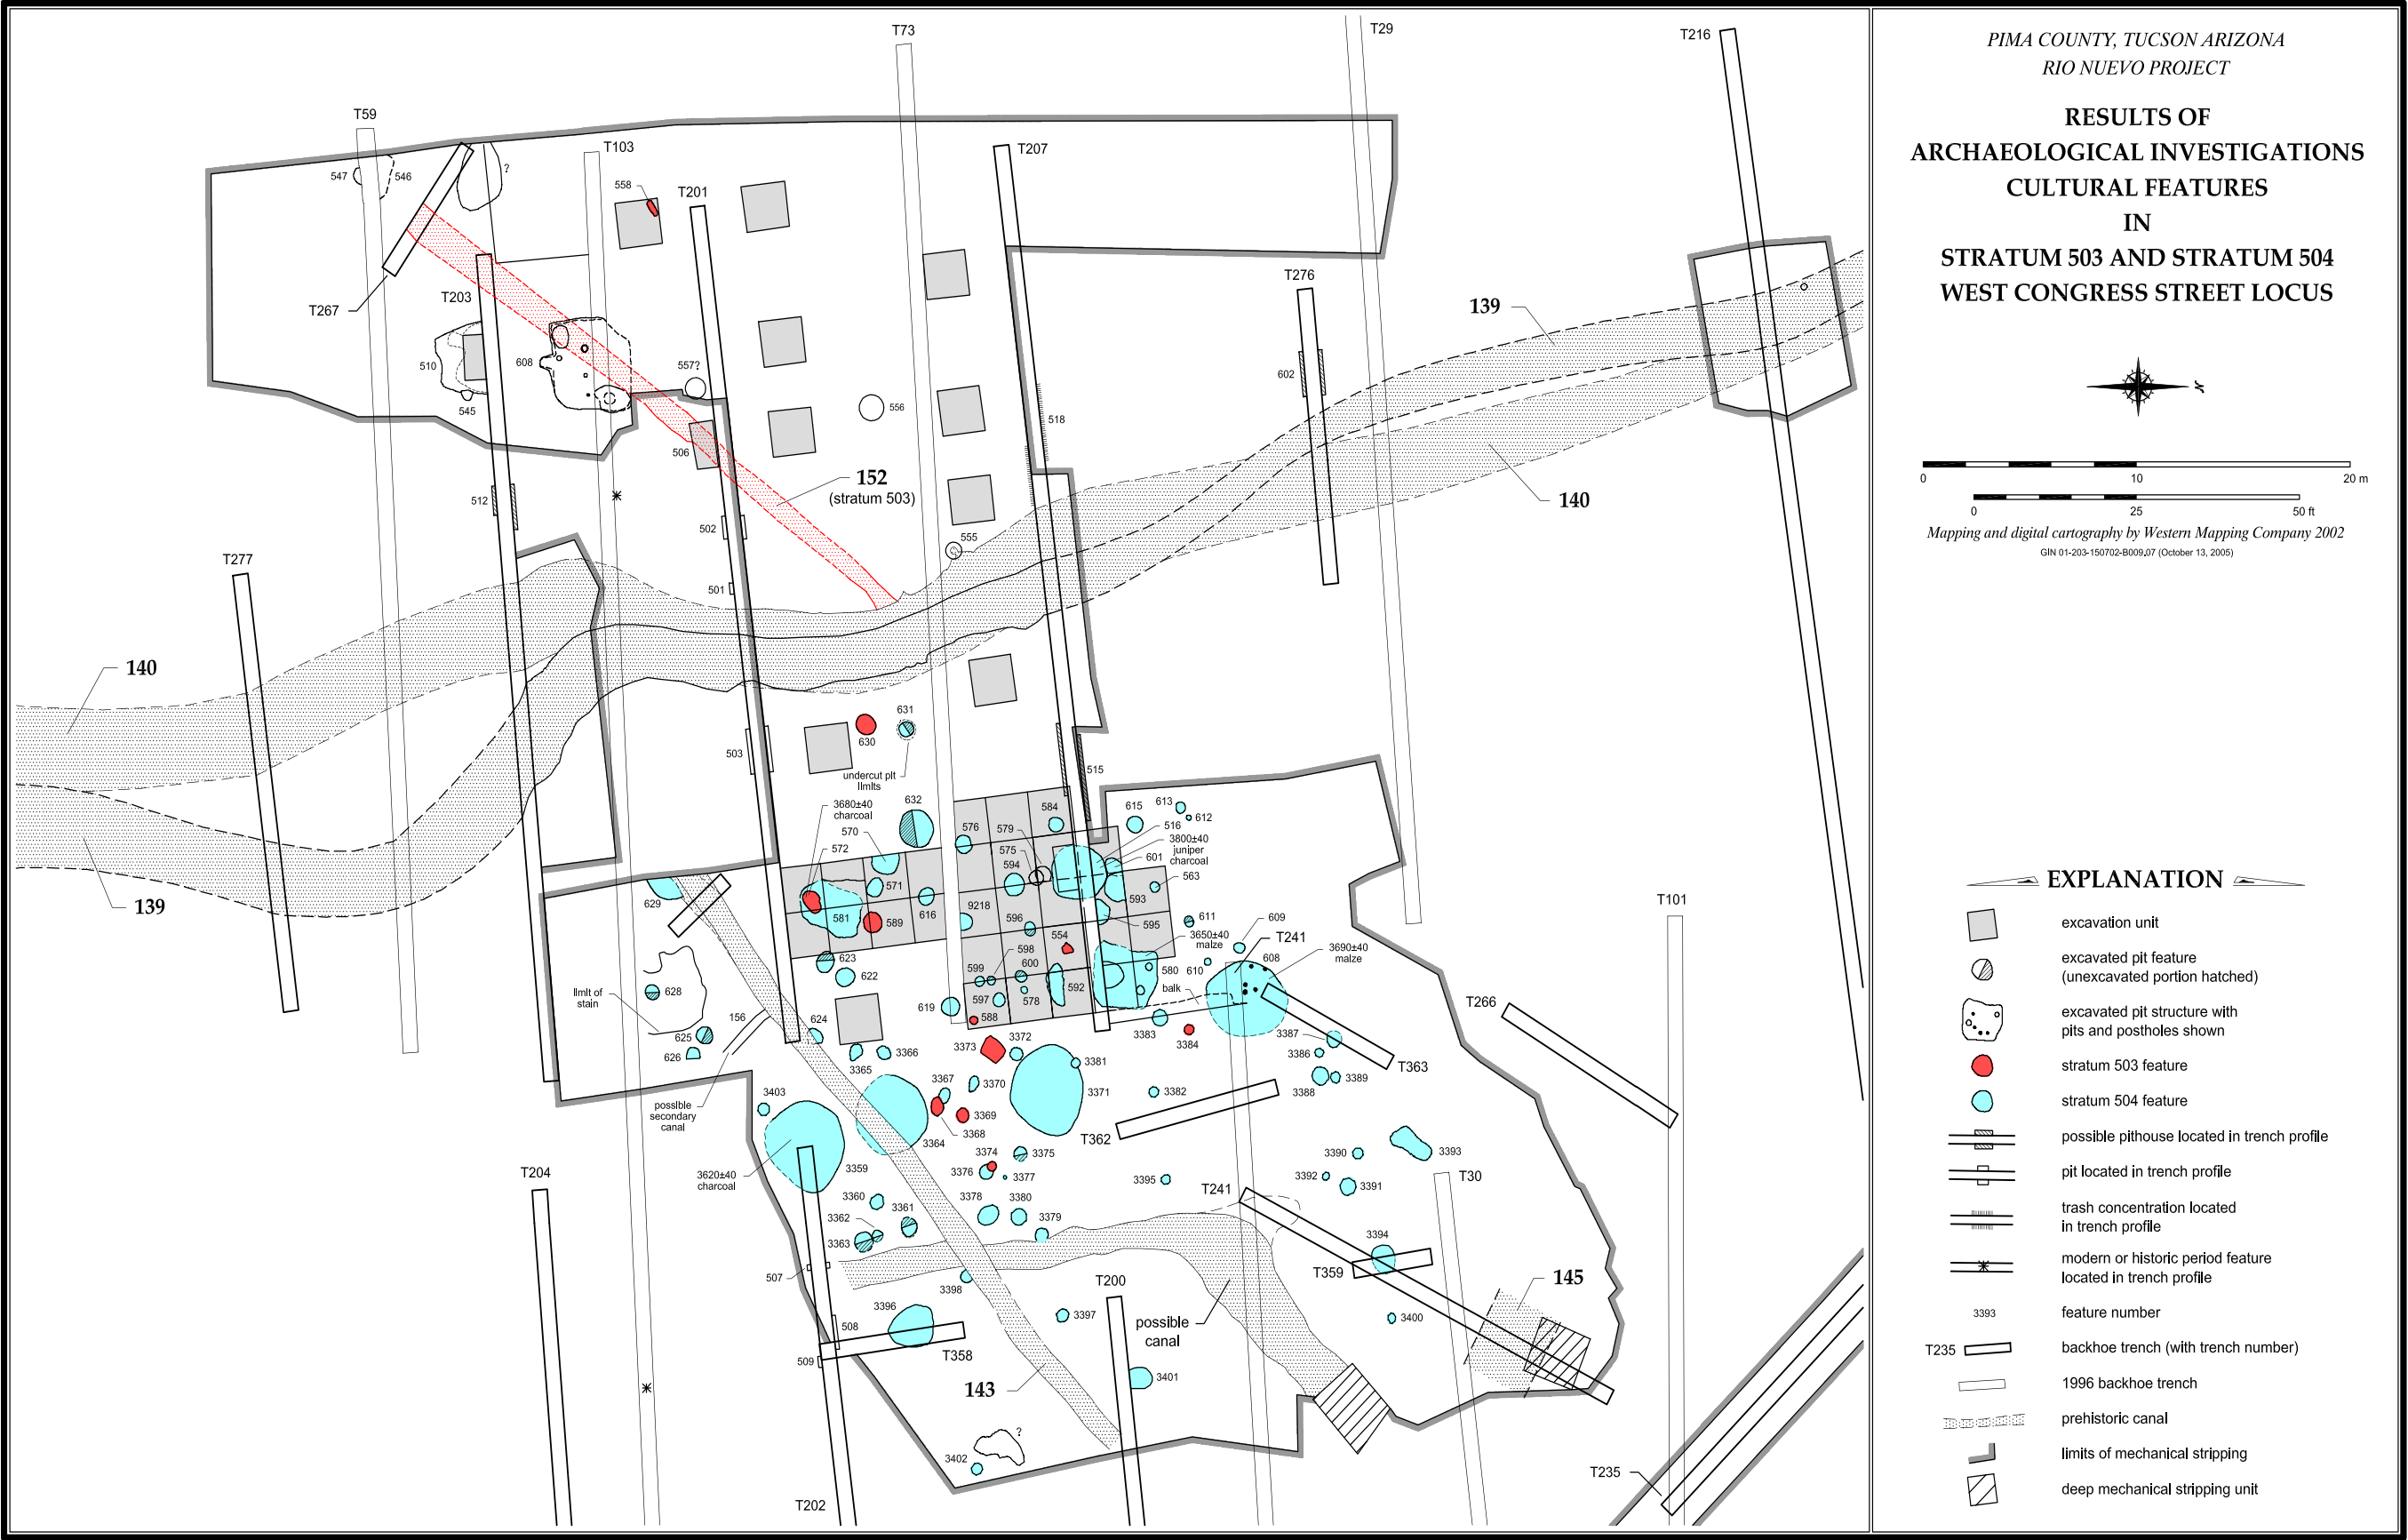
Figure 1.10. Map of archaeological features in strata 503 and 504, Block 5, Congress Street locus, the Clearwater site, AZ BB:13:6 (ASM).

The earliest occupation preserved in the Congress Street locus was a small farming settlement buried in a layer of alluvium (Stratum 504) approximately 1.5 m below the present ground surface (Figures 1.10-1.11). In one area, a cluster of seven pithouses and numerous storage pits were exposed and excavated. These features contained grinding tools made from river cobbles, flaked stone dart points resembling the San Jose or “Armijo” style of the Colorado Plateau, Cortaro points, a flat stone used for processing ochre, a few pottery sherds made of untempered, low-fired clay and decorated with incised patterns, fired-clay figurine fragments, and charred maize remains. Several maize samples have provided radiocarbon dates of roughly 2100 B.C. (calibrated). The pit structures and the maize are among the oldest that have been found in the Southwest, and the pottery

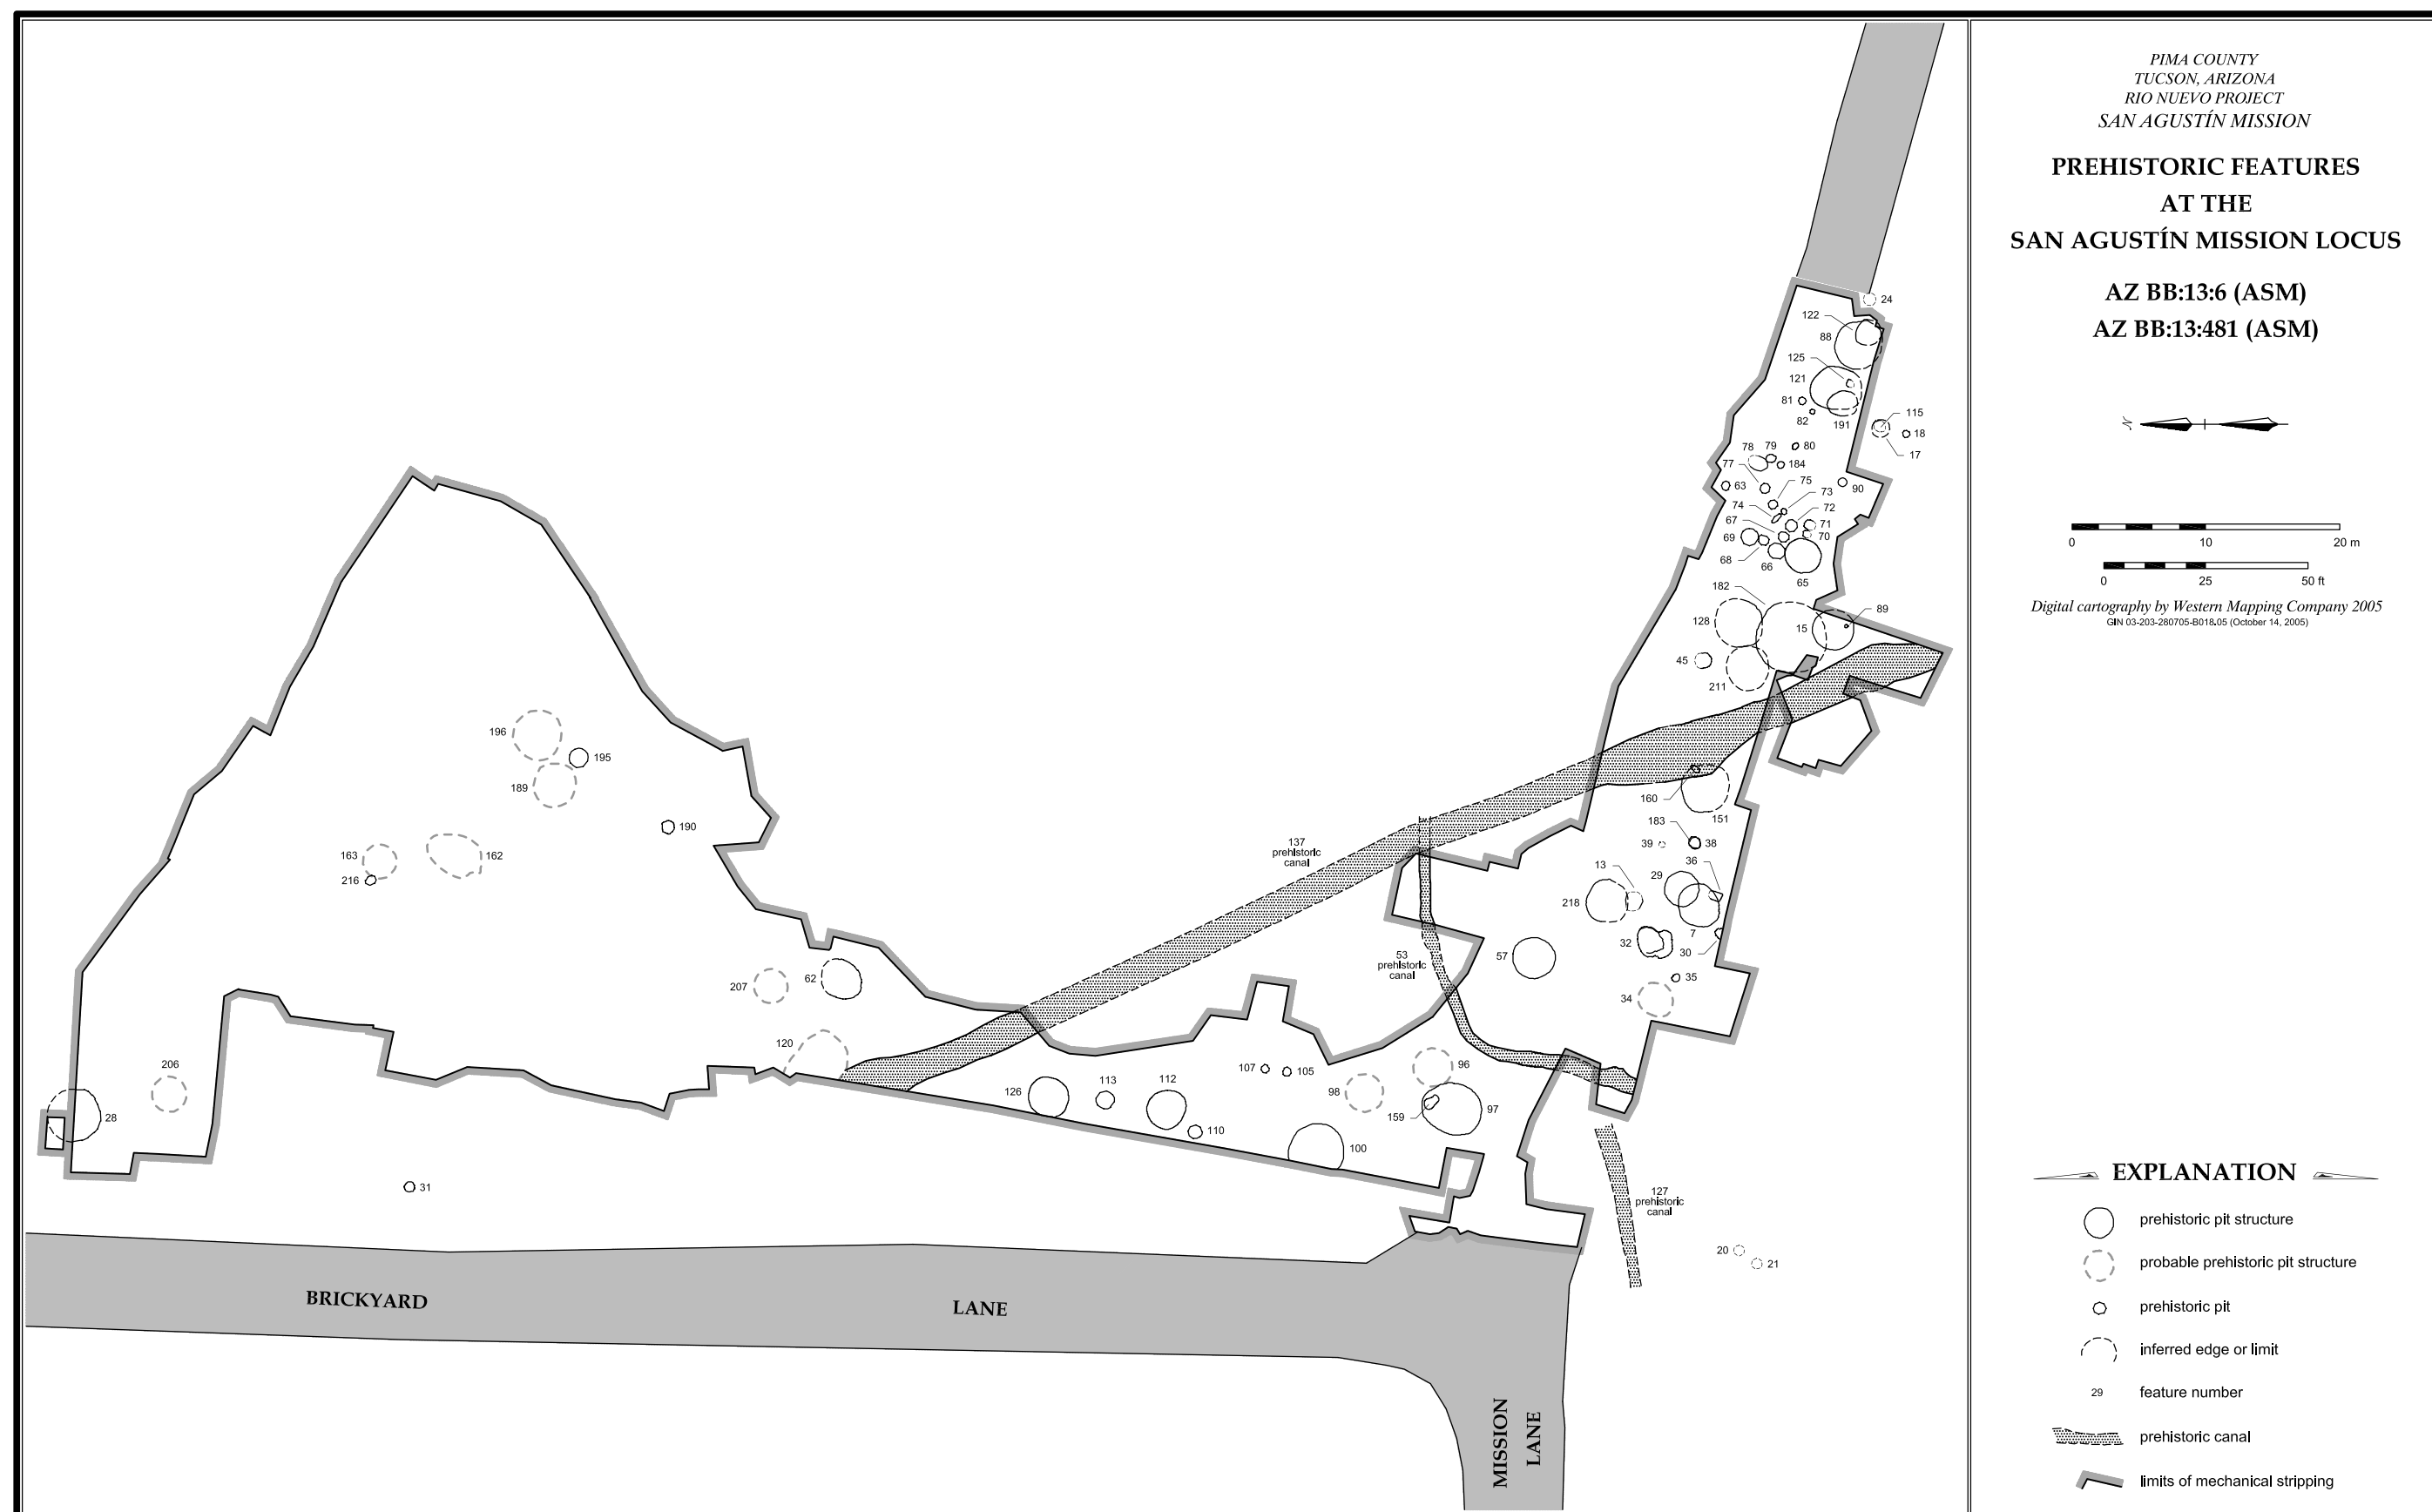
**Figure 4.1.** Prehistoric features at the San Agustín Mission locus, the Clearwater site, AZ BB:13:6 (ASM).

A variety of prehistoric features were discovered at the San Agustín Mission locus, most dating to the Cienega phase (800 B.C.-A.D. 50) of the Early Agricultural period (Figure 4.1).

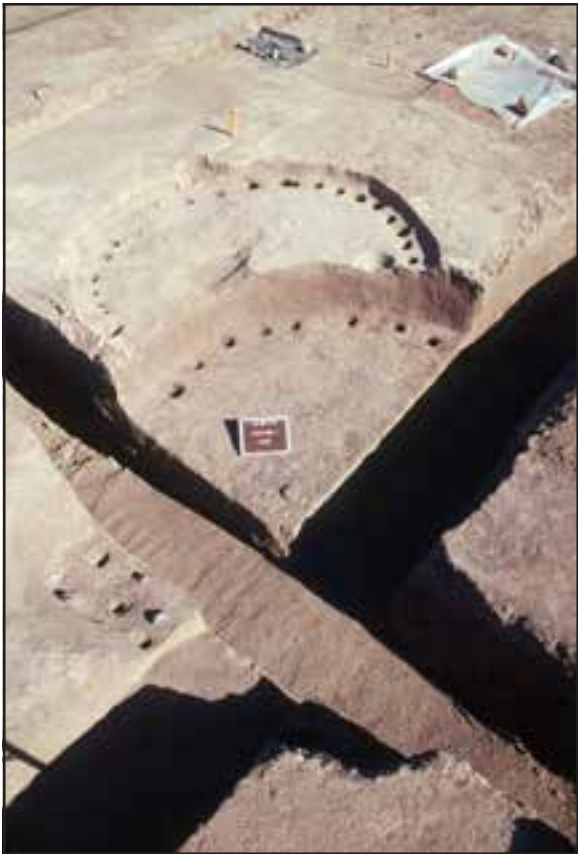
**Figure 4.2.** Features 7 and 29, Cienega phase pithouses, San Agustín Mission locus, the Clearwater site, AZ BB:13:6 (ASM).

This pit structure was initially discovered by mechanical trenching (Trenches 101 and 104), and was subsequently exposed by mechanical stripping (Figure 4.2). Only those portions of the structure that extended north of Trench 104 and east of Trench 101 were then excavated by hand.

This round pit structure measured 3.15 m east-west and approximately 2.70 m north-south. Except for 13 postholes that encircled the floor area, no other internal features were identified. Due to the disturbance caused by mechanical trenching and the incomplete excavation of the structure, only a partial posthole pattern was uncovered. Therefore, no orientation could be discerned. Feature 7 was probably used for habitation and burned sometime after its abandonment.

This structure was exposed by mechanical stripping north of Trench 104 (Figure 4.4; see also Figure 4.2). The structure was then completely excavated by hand.

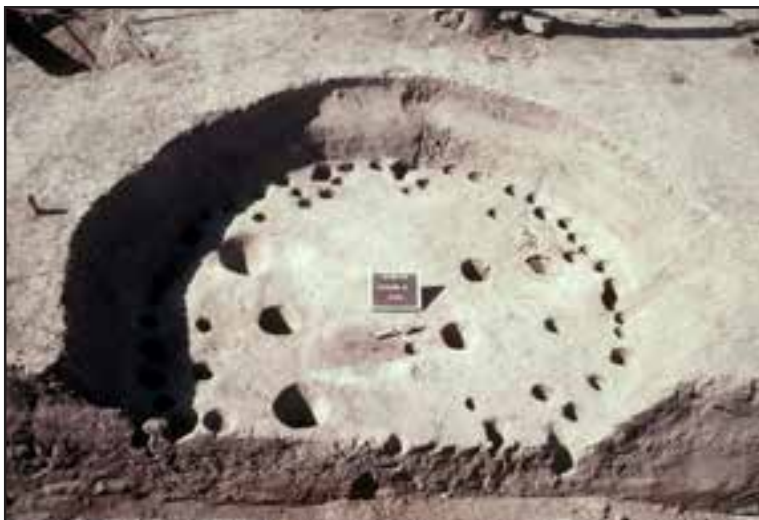
**Figure 4.3.** Feature 15, a Cienega phase pithouse, San Agustín Mission locus, the Clearwater site, AZ BB:13:6 (ASM).

by mechanical stripping (Figure 4.3). The entire feature, except a small portion removed by the trench, was excavated by hand.

This pit structure and all its interior features were excavated into a floodplain alluvium. Based on the presence of burned daub in its fill, the superstructure was likely constructed of wattle-and-daub. Based on the location of its interior postholes, the structure probably had walls constructed within the house pit and supported by a row of posts along the perimeter of the floor. Its roof may have been supported by a combination of these wall posts and at least four posts located within the interior area of the structure. There

was no evidence of plaster preparation of the structure's walls, floor, or internal features.

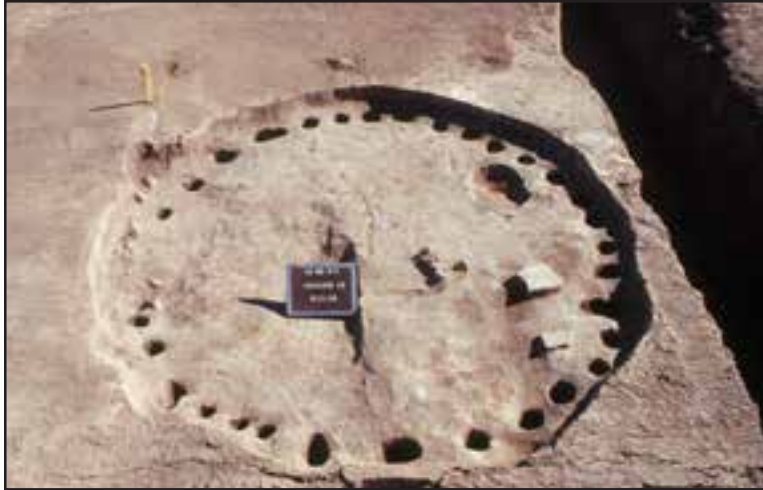
**Figure 4.4.** Feature 29, a Cienega phase pithouse, San Agustín Mission locus, the Clearwater site, AZ BB:13:6 (ASM).

This round structure, which measured 2.61 m east-west and 2.57 m north-south, contained a small hearth, Feature 29.01, and 34 interior postholes. A possible entry was defined by a small gap (circa 0.55 m wide) in the posthole pattern along its northern edge. However, this possible entry was also located directly above an underlying feature, Feature 8, whose fill may have obscured the visibility of postholes in the area. Therefore, the orientation of Feature 29 could not be definitively identified. The presence of a small hearth suggests use of the structure as a habitation feature.

centric row of posts along the floor perimeter. The structure was relatively small, and the roof was likely supported by these wall posts. Small pieces of burned daub were observed throughout the feature fill, and probably represent a superstructure constructed of wattle-and-daub. No preparation was visible on any of the pit structure's surfaces or internal features, and other than the superpositioning of four perimeter postholes, there was no other evidence of remodeling. These postholes were likely shifted to stabilize the wall or roof.

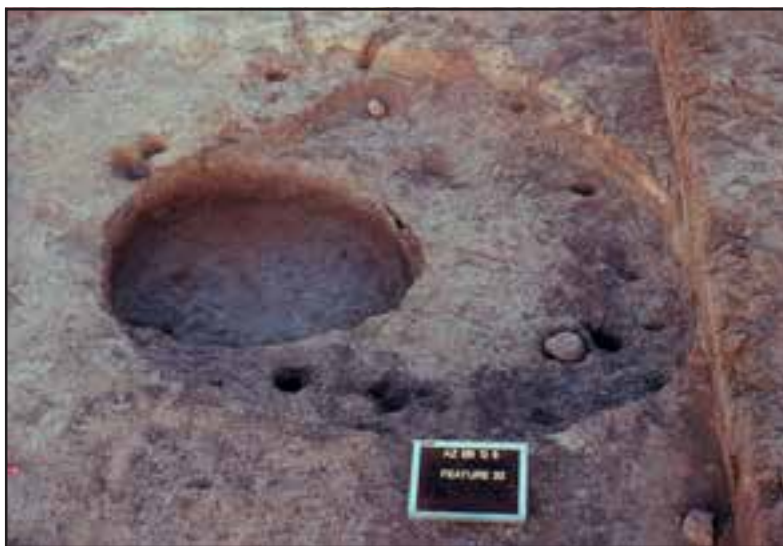
**Figure 4.5.** Feature 32, a Cienega phase pithouse, San Agustín Mission locus, the Clearwater site, AZ BB:13:6 (ASM).

This small pit structure was discovered during mechanical stripping, and then almost completely excavated by hand (Figure 4.5). A small portion of the structure extended beyond the stripped block and could not be excavated. This irregularly shaped (off-round) structure measured 2.25 m east-west and approximately 1.95 m north-south. It contained one large bell-shaped storage pit, Feature 32.01, and two

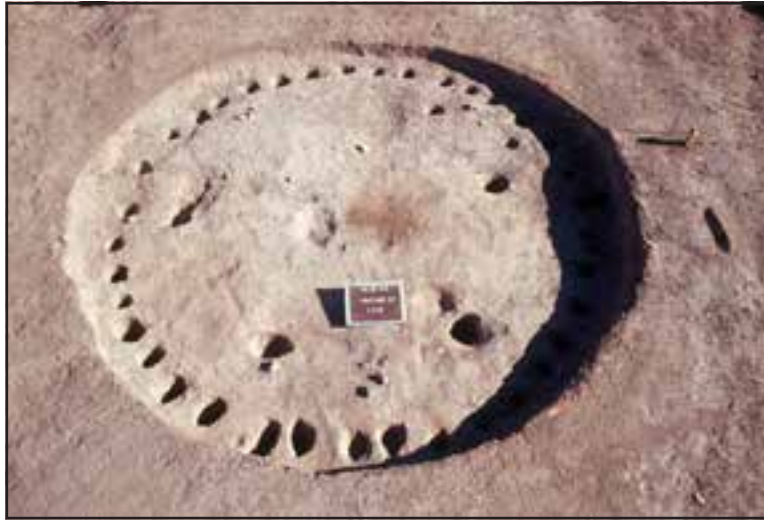
**Figure 4.6.** Feature 57, a Cienega phase pithouse, San Agustín Mission locus, the Clearwater site, AZ BB:13:6 (ASM).

This pit structure was discovered during mechanical stripping west of Trench 101 (Figure 4.6). It was then completely excavated by hand. The round pit structure, that measured 3.15 m north-south and 3.05 m east-west, contained one possible hearth, Feature 57.01, and 43 interior postholes. Its entry could not be identified, and the orientation is unknown. The presence

of a small hearth and the lack of storage pits suggests a habitation function prior to abandonment.

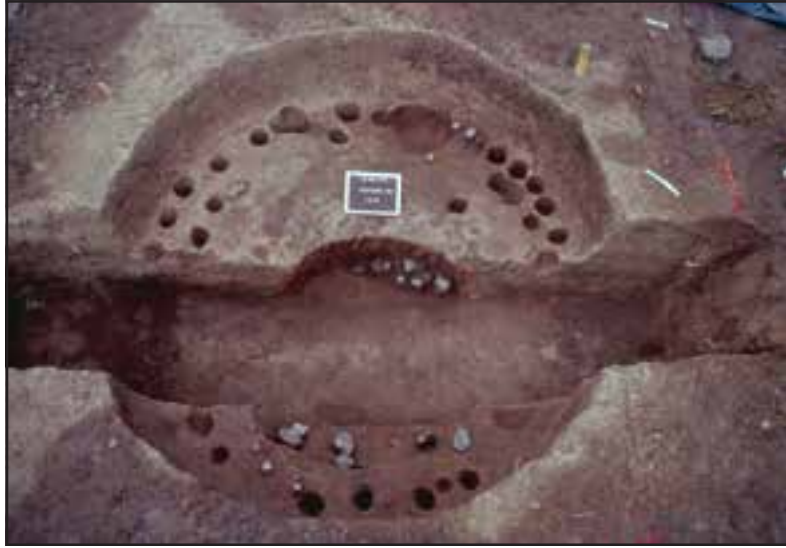
**Figure 4.7.** Feature 65, a Cienega phase pithouse with a fired central pit, San Agustín Mission locus, the Clearwater site, AZ BB:13:6 (ASM).

This pit structure was discovered during the re-excavation of a waterline trench, and then exposed by mechanical stripping (Figure 4.7). The entire structure was excavated by hand.

The round pit structure measured 2.7 m north-south, 2.5 m east-west, and contained a large central storage pit and approximately 38 postholes. Although a few gaps were visible within its posthole pattern, none could be definitively identified as an entry location, and orientation of the structure could

not be determined. The pit structure exhibited multiple lines of evidence of remodeling and repair, and it was probably utilized over an extended period of time. Its small size and the presence of a central storage pit suggested that it served a storage function before it was abandoned and catastrophically burned.

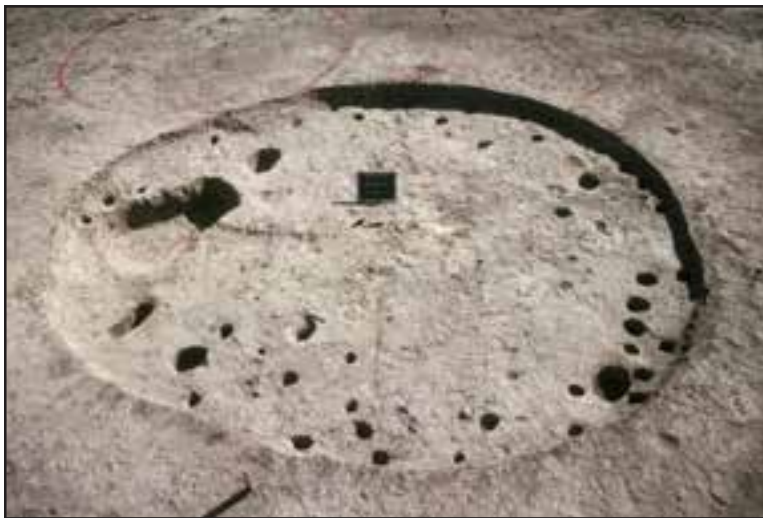
**Figure 4.8.** Feature 97, a Cienega phase pithouse, San Agustín Mission locus, the Clearwater site, AZ BB:13:6 (ASM).

This pit structure was discovered during mechanical stripping east of the mission wall (Figure 4.8). It was then completely excavated by hand. The round structure, which measured 4.55 m north-south and 3.75 m east-west, might represent two overlapping structures. Along its north-south axis, the feature appeared to be very elongated, and it was suggested that this portion represented a separate, intrusive pit structure. Therefore, while the excavated north-south dimension was 4.55 m, the actual distance is likely closer to 3.75 m, making the structure more circular. The excavated area contained 47 postholes and a small hearth, although the location of an entry could not be identified. The presence of a hearth and the lack of internal pits suggested a habitation function for this structure.

Feature 97 was constructed into a floodplain alluvium, and was intruded by at least three later features.

It may be intruded by a pit structure (which did not receive a feature number) located directly north. It is intruded by a burial, Feature 159, which cuts into both structures. Finally, its northeastern edge was cut by yet another pit structure, Feature 96.

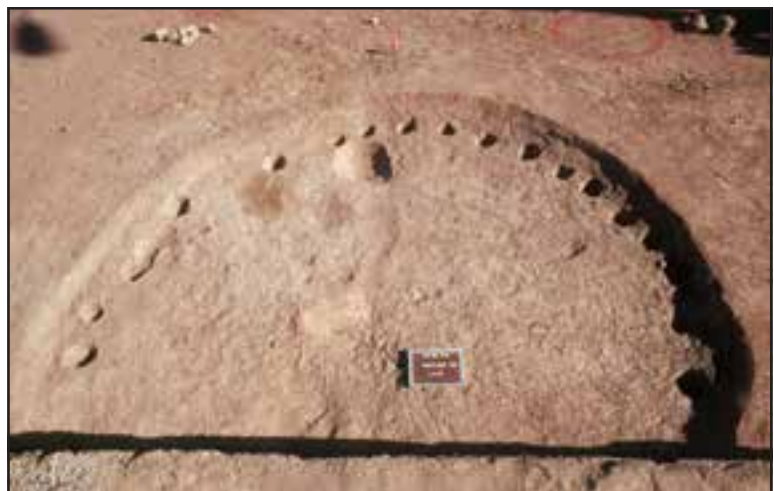
**Figure 4.9.** Feature 100, a Cienega phase pithouse, San Agustín Mission locus, the Clearwater site, AZ BB:13:6 (ASM).

This pit structure was discovered during mechanical stripping east of the mission wall (Figure 4.9). Unfortunately, a small portion of the structure was located directly beneath the wall and could not be exposed; therefore, the structure was only partially excavated by hand.

Based on the location of its 19 interior postholes, Feature 100 appears to have been constructed within the excavated house pit. No evidence of individual roof supports was identified, and the roof was likely supported by the wall posts. Some daub was visible

within the feature fill and might suggest a wattle-and-daub construction. None of the surfaces were prepared in any way. The overlapping of a few postholes indicates shifts in individual post locations and may represent some maintenance or repair.

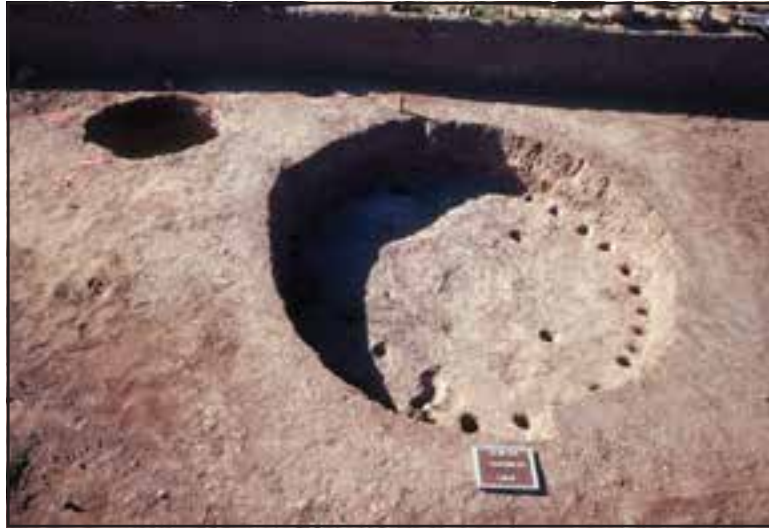
**Figure 4.10.** Feature 112, a Cienega phase pithouse, and Feature 110, a small pit, San Agustín Mission locus, the Clearwater site, AZ BB:13:6 (ASM).

This pit structure was discovered by mechanical stripping east of the exposed mission wall (Figure 4.10). It was subsequently completely excavated by hand. The round structure, which measured 3.0 m north-south and 2.9 m east-west, contained a shallow hearth and 34 interior postholes. Its orientation could not be determined, and there were no obvious gaps in the posthole pattern to suggest an entry location. The structure appeared to have been mostly cleaned out prior to a catastrophic burn. Due to the presence of a hearth and the lack of intramural pits, it probably served a habitation function.

A small hearth, Feature 112.01, and 34 postholes were the only internal features. Most of the postholes were located adjacent to the structure walls and along the floor perimeter. Three others were located within

the interior area of the structure and could represent roof supports. All the postholes ranged in size from 8 cm to 13 cm in diameter, and were from 5-38 cm deep. Seven of these postholes contained the remains of charred posts and were assigned subfeature numbers, 112.02-112.08.

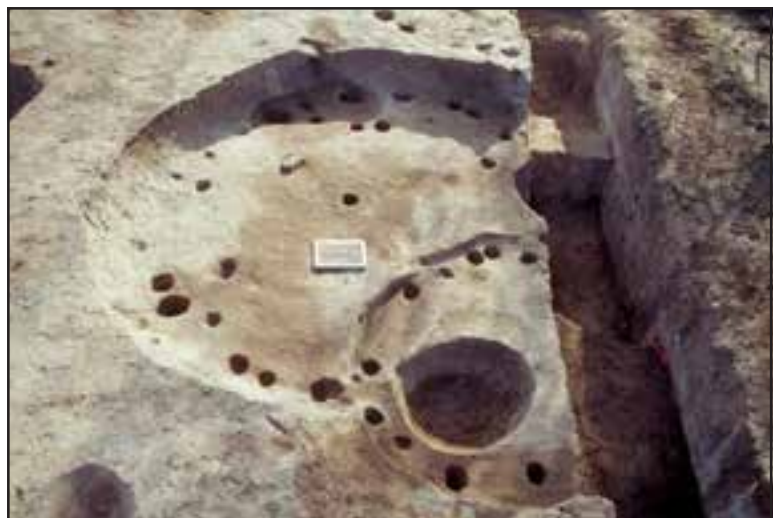
**Figure 4.11.** Features 121 and 191, Cienega phase pithouses, San Agustín Mission locus, the Clearwater site, AZ BB:13:6 (ASM).

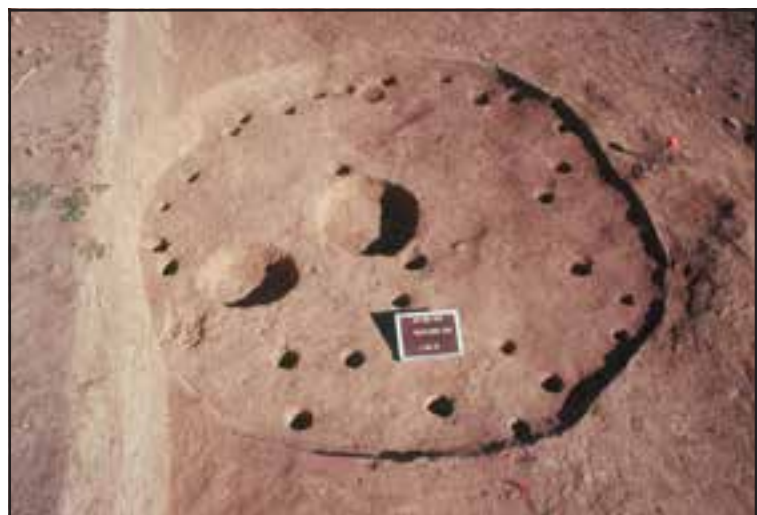
**Figure 4.12.** Feature 126, a Cienega phase pithouse, San Agustín Mission locus, the Clearwater site, AZ BB:13:6 (ASM).

Unfortunately, the presence of two floors was not immediately recognized in the western half of the structure; consequently, the upper floor was removed before it could be documented. Therefore, any posts originating from that floor surface were only identified on the lower floor surface, or not at all. Using the eastern half of the structure as a guide, the postholes on both floor surfaces appear to have followed the same general pattern and may have retained the same position on both floors.

Most of the postholes were located close to the pit walls and served as wall supports. A few others, most of which originated on the lower floor, were more randomly placed within the structure and may have served as roof supports. All the postholes ranged between 9 cm and 14 cm in diameter, and were from 6 cm to 20 cm deep.

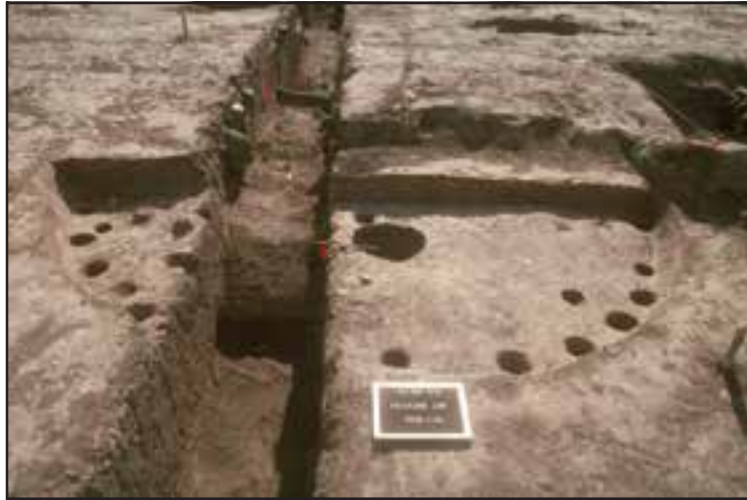
This pit structure was discovered during mechanical trenching (Trench 101), and then exposed by mechanical stripping (Figure 4.13). The southern half of Feature 218 was removed by a historic *acequia*

**Figure 4.13.** Feature 218, a Cienega phase pithouse, San Agustín Mission locus, the Clearwater site, AZ BB:13:6 (ASM).

Because the structure was only partially excavated and the entire feature stain could not be exposed due to the intrusive *acequia*, its dimensions could not be determined. Based on the size of the excavated portion, however, the structure likely had a diameter of at least 3.25 m. An entryway was not identified, and the orientation is unknown. The structure contained 16 postholes and one small pit. It likely served a primarily habitation function with some limited household storage.

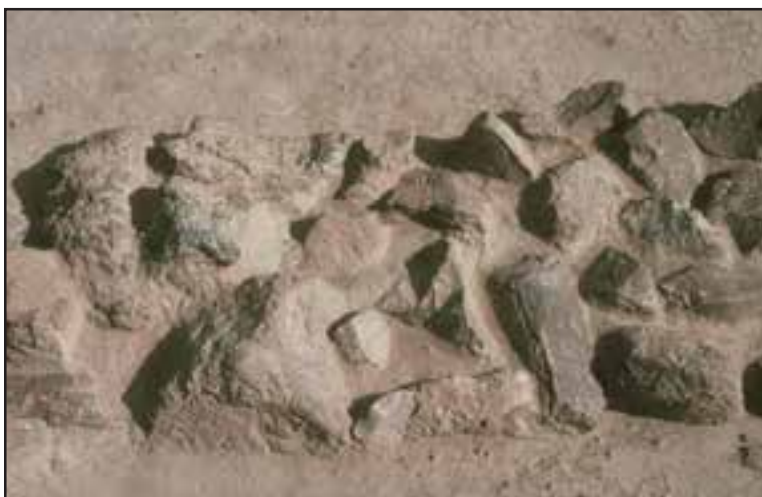
Feature 1 is the rock foundation of the western and southern walls that surrounded the mission complex (Figure 4.18; see also Figure 4.15). Approximately seven rocks were visible on the ground surface along the western wall when the project began. A series of excavation units were placed over the wall, excavated, and screened; a few units were excavated without screening. The area around the wall had been extensively disturbed, and a variety of modern, historic, and prehistoric artifacts were present in the sediment surrounding the foundation.

**Figure 4.18.** A close-up of Feature 1, the foundation of the western mission compound wall, San Agustín Mission locus, the Clearwater site, AZ BB:13:6 (ASM).

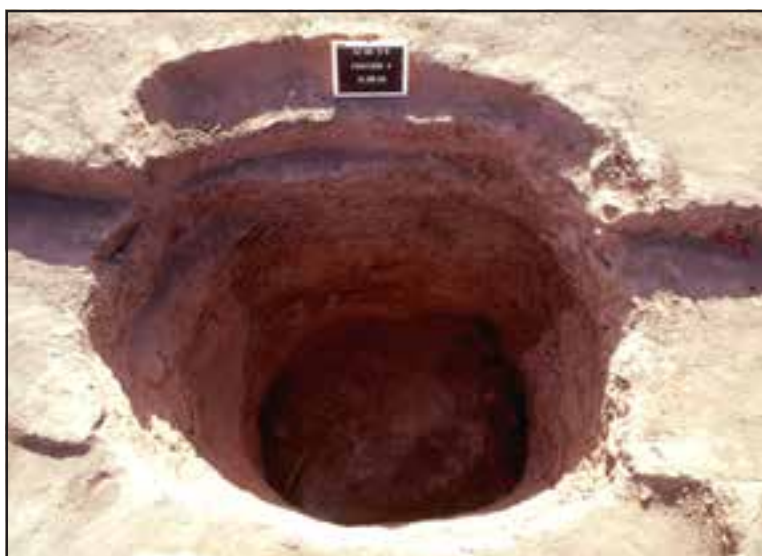
Feature 4 was a well found on the southern side of Mission Lane during backhoe scraping (Figures 4.19-4.20). The well was completely excavated in halves to the base of the feature, revealing that the groundwater table was at approximately 2 m below the modern ground surface during the time of its use before about 1880 (see below).

**Figure 4.19.** Feature 4, San Agustín Mission locus, the Clearwater site, AZ BB:13:6 (ASM), a well filled by Chinese gardeners in the 1890s, partially excavated.

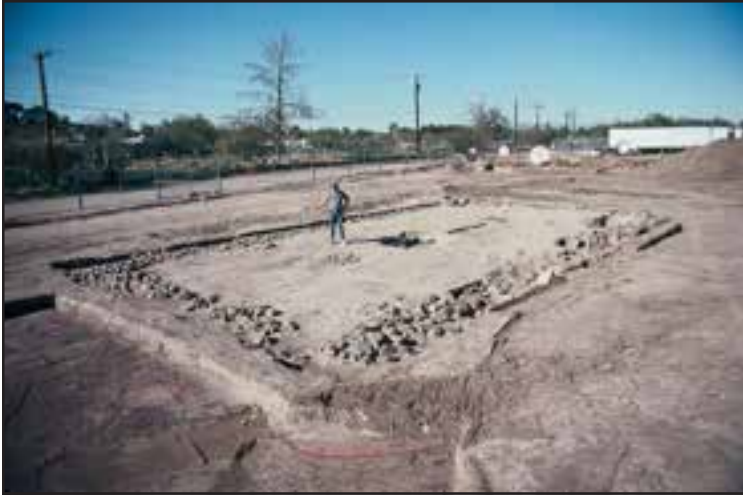
Feature 6 was the rock foundations of the mission granary (Figure 4.21; see also Figure 4.16). The foundation was discovered by examining photographs of the 1967 Arizona Historical Society excavations, lining up landmarks visible in the photographs with those present today, and then carefully

**Figure 4.21.** The foundations of the Tucson Mission granary, San Agustín Mission locus, the Clearwater site, AZ BB:13:6 (ASM).
