# **RIO NUEVO ARCHAEOLOGY, 2000-2003:**

**Investigations at the San Agustín Mission and Mission Gardens,  
Tucson Presidio, Tucson Pressed Brick Company, and Clearwater Site**

**Technical Report No. 2004-11  
Desert Archaeology, Inc.**

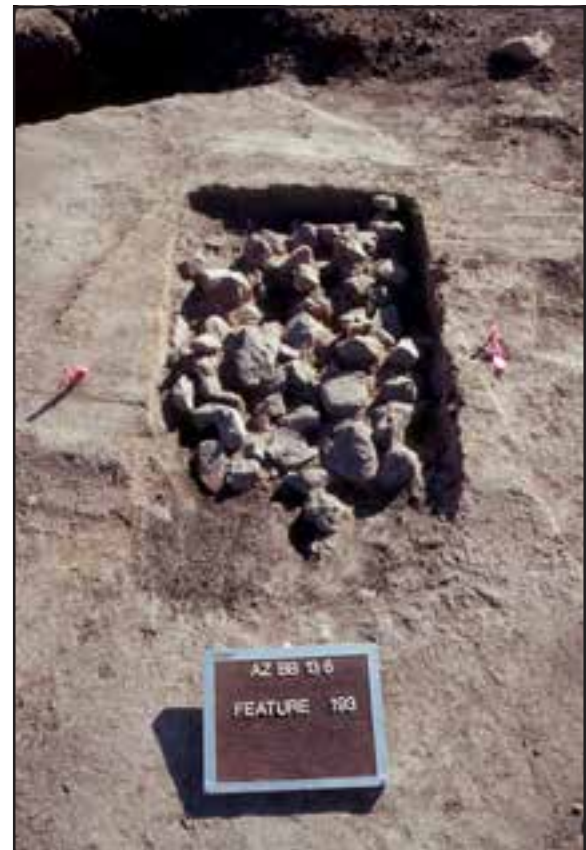
Feature 193 was a rectangular-shaped, mission-occupation roasting pit located east of the granary (Figure 4.22). It was fairly isolated, located near only one other feature, an Early Agricultural period burial, Feature 190. Feature 193 was 1.25 m long, 0.71 m wide, and 19 cm deep. The pit was initially bisected, and the northern half was excavated first. After a profile was drawn, the southern half was excavated; artifacts and samples were combined.

**Figure 4.22.** Feature 193, a Protohistoric period roasting pit, San Agustín Mission locus, the Clearwater site, AZ BB:13:6 (ASM).

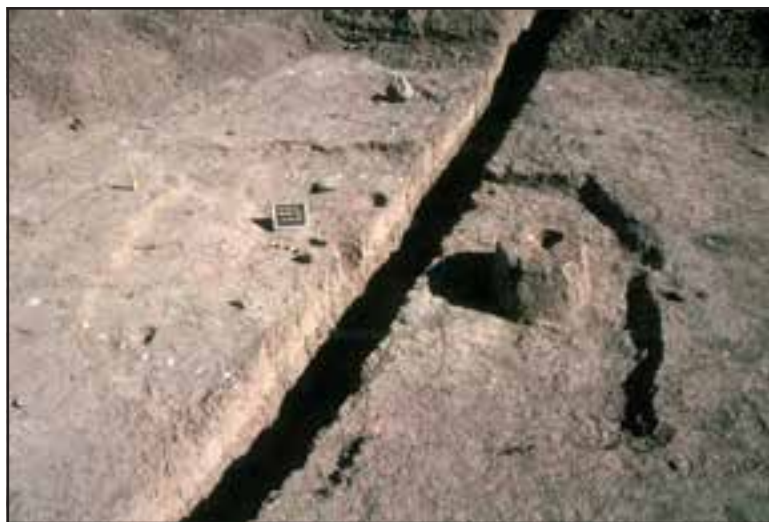
This pit structure was originally discovered in both the northern and southern profiles of Trench 301 (Figure 4.25). A control unit was excavated down to the floor of the structure, and the remainder of the structure was excavated by hand. Two later canals, Features 203 and 204, BB:13:481, intruded and destroyed the western and eastern walls of the structure. A small hearth, Feature 3072, also intruded on the upper levels of the fill.

**Figure 4.25.** Feature 3014, an Early Ceramic period pithouse, Mission Gardens locus, the Clearwater site, AZ BB:13:6 (ASM).

and 3014.03, were centrally located in the structure, and ranged in size from 20-26 cm in length, 17-20 cm in width, and 14-24 cm in depth. A burned post fragment was removed and collected from Feature 3014.01.

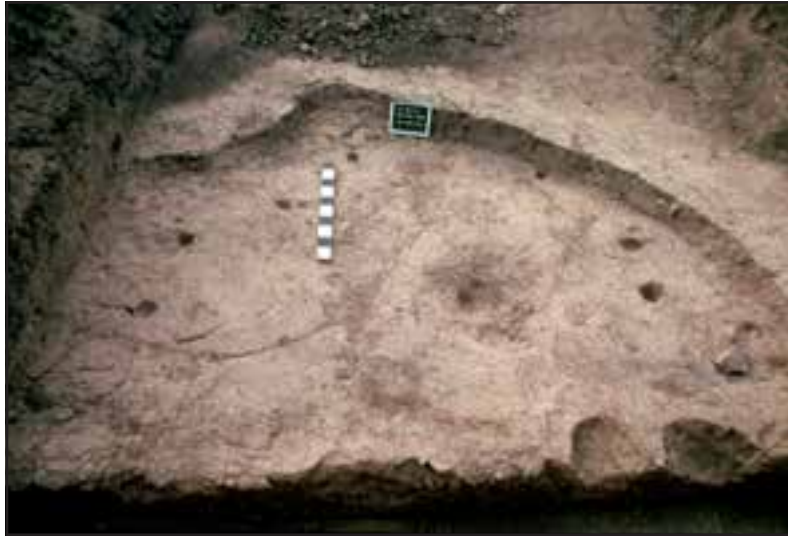
This possible pit structure was discovered in the northern profile of Trench 304 (Figure 4.26). A 1-m by 2-m control unit was excavated into the fill of the structure to identify the floor. The remainder of the feature was then excavated to identify the walls of the structure. However, only one small area of wall could be positively identified. The rest of the feature edge remained indistinct. An inhumation, Feature 3097, intruded on the western edge of the structure.

This pit structure was oval in shape, and measured about 4.34 m in length, 3.95 m in width, and 29 cm in depth. Three pits, a possible hearth area, and seven possible postholes were identified in the floor of the structure. No entry was discovered, and the orientation of the structure could not be determined. A single sherd was discovered on the floor. Oxidization of the floor and burned daub in the fill suggested the structure had burned.

**Figure 4.26.** Feature 3038, an Early Ceramic period pithouse, Mission Gardens locus, the Clearwater site, AZ BB:13:6 (ASM).

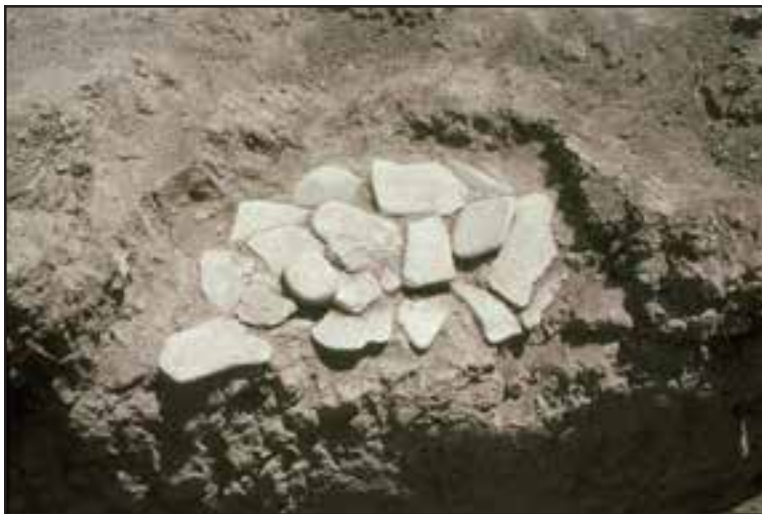
This small pit was discovered in the northern profile of Trench 305 (Figure 4.27). It measured 87 cm in length, 54 cm in width, and 10 cm in depth. The fill

**Figure 4.27.** Feature 3058, a Hohokam cache of ground stone hoes and preforms, Mission Gardens locus, the Clearwater site, AZ BB:13:6 (ASM).

of the pit was grayish-brown silty clay. Artifacts recovered from the fill included Native American sherds, a ground stone mano, and 20 slabs of tabular stone. The stone slabs were stacked in three layers on the bottom of the pit and appeared to have been cached for later use. They ranged from 14-19 cm long and 10-15 cm wide. The feature dates to the Hohokam occupation of the area.

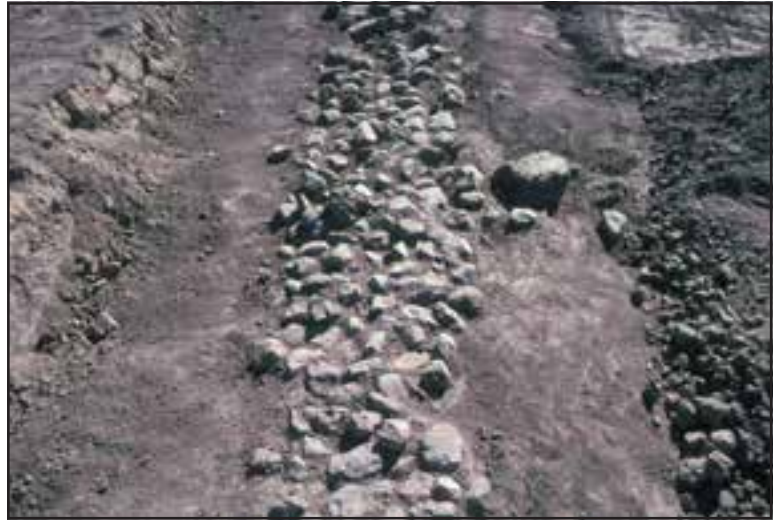
Feature 3026 was the foundation of the eastern Mission Gardens wall (Figures 4.28-4.29). It was traced from just south of Mission Lane to the southeastern corner of the garden walls. It was at least 127.5 m long, and ranged in width from 0.8 m to 1.0 m. The foundation was between three and five rocks wide, with two to three courses of rock surviving in most areas. In some areas, small rocks were used as chinking between the larger rocks. The wall was gen-

**Figure 4.28.** Feature 3026, the foundations of the eastern gardens wall, Mission Gardens locus, the Clearwater site, AZ BB:13:6 (ASM).

erally constructed by using larger rocks at the base and smaller rocks along the top to create a flat surface for adobe bricks to be placed on.

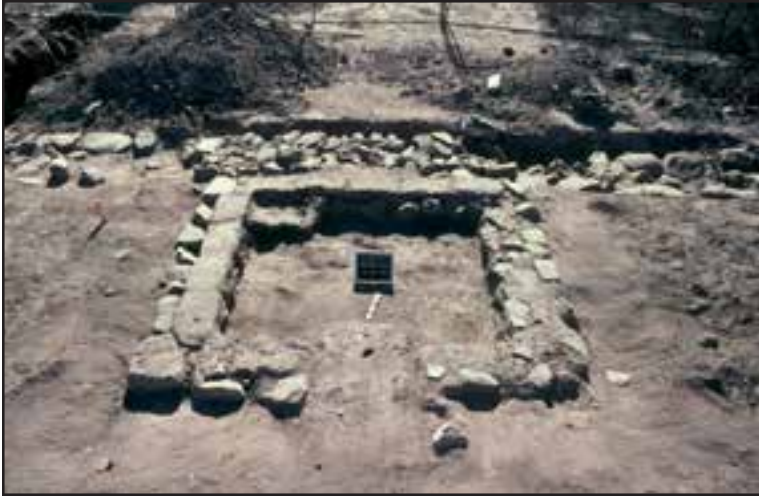
Feature 3095 was a small outbuilding located along the southern wall of Mission Gardens (Figure 4.31). The small structure was built from adobe bricks that measured 46 cm long, 30 cm wide, and at least 7 cm thick. Each wall was made from roughly five bricks, which had been reinforced after construction with a line of A-Mountain rocks along the exterior face. A doorway was present in the center of the northern wall, measuring 75 cm wide. The interior of the building was heavily burned, as was the floor, indicating the structure had been burned. No in situ artifacts were present; the items found inside were primarily 1950s trash that had drifted over from the nearby landfill. This outbuilding is associated with the dwelling, Feature 3028.

**Figure 4.31.** Feature 3095, a Historic era outbuilding foundation, Mission Gardens locus, the Clearwater site, AZ BB:13:6 (ASM).

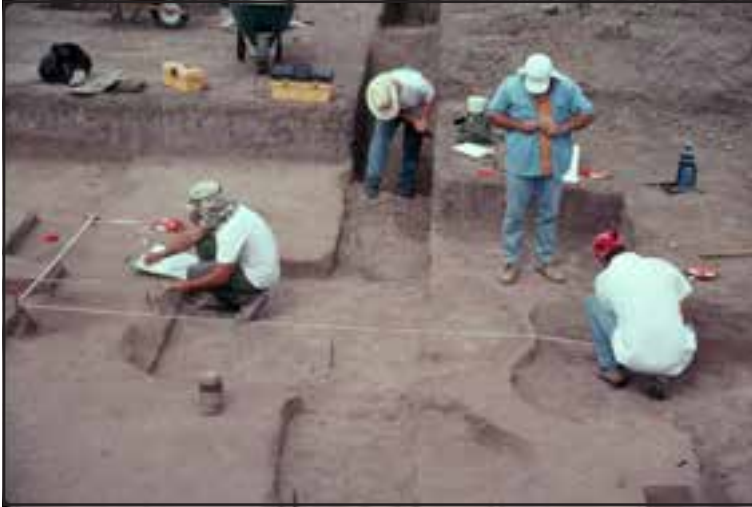
Feature 516 was discovered within Trench 207 and was initially tested in a 1-m by 2-m control unit, Unit 198, originating 90 cm below the modern ground surface. The area around the feature was subsequently mechanically stripped to the top of Stratum 503, and the structure was exposed during excavation of four 2-m by 2-m control units—Units 492, 493, 512, and 513—within Stripping Block 5. The entire structure was then excavated by hand (Figure 4.33).

This oval structure originated in Stratum 504, and measured 2.54 m north-south and 2.08 m east-west. It appears to have been of a simple, insubstantial construction and was preserved as a shallow basin-shaped depression with no internal features. The absence of these features made the location of an entry difficult to identify, and the orientation of the structure could not be determined. This feature probably functioned as a habitation structure utilized only temporarily as part of a seasonal occupation.

**Figure 4.33.** Feature 516, an Early Agricultural period pithouse in Stratum 504, the Congress Street locus, the Clearwater site, AZ BB:13:6 (ASM).

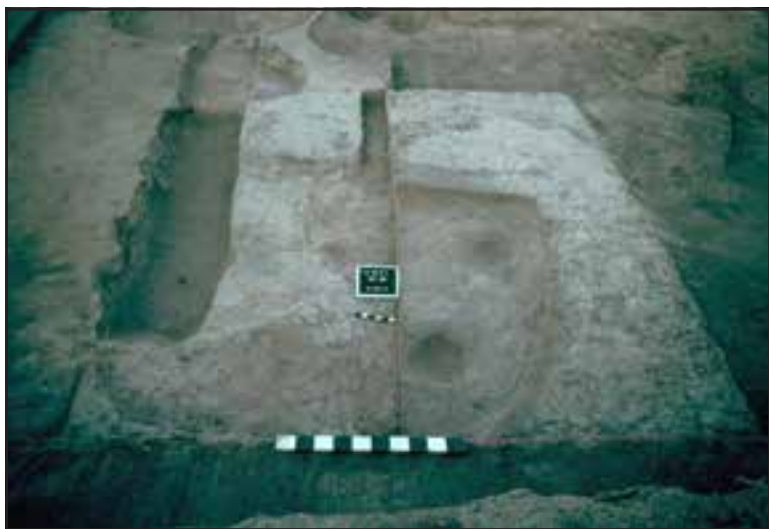
Feature 580 was initially cut during mechanical trenching (Trench 207), and then exposed during the excavation of four 2-m by 2-m control units—Units 533, 553, 534, and 554—located within Stripping Block 5. The entire structure was subsequently excavated by hand (Figure 4.34).

**Figure 4.34.** Feature 580, an Early Agricultural period pithouse, the Congress Street locus, the Clearwater site, AZ BB:13:6 (ASM).

This structure was filled with roughly 10 cm of homogenous silty-sandy clay. This fill appeared to be naturally deposited sediment with a moderate amount of charcoal, some ash, daub, and 10 pieces of fire-cracked rock. No other artifacts were found in the fill or on the floor.

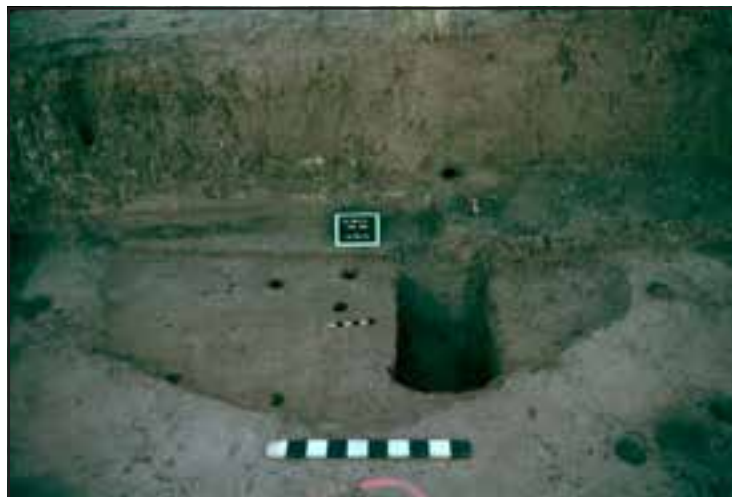
This pit structure was located within Stripping Block 5, within a small cluster of structures that included Features 516 and 580. It was also in close proximity to three extramural pits, Features 609, 610, and 611. Feature 608 does not appear to underlay, overlay, or intrude any other features.

**Figure 4.36.** Feature 608, an Early Agricultural period pithouse, the Congress Street locus, the Clearwater site, AZ BB:13:6 (ASM).

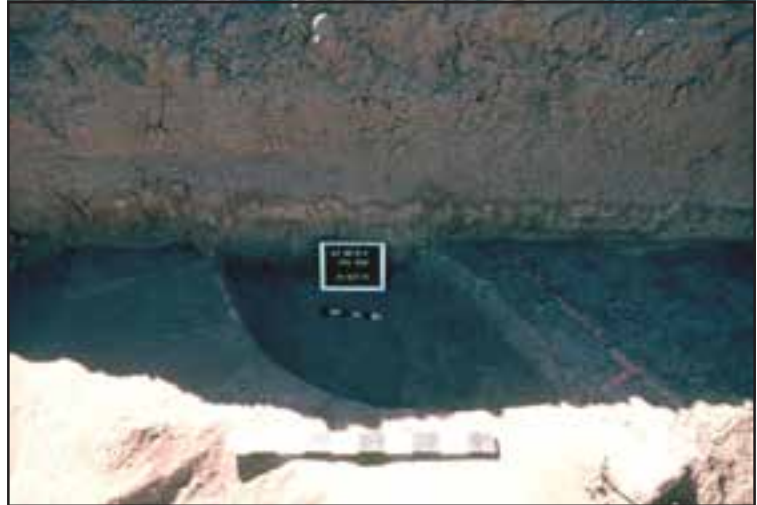
**Figure 4.37.** Feature 629, an Early Agricultural period pithouse, the Congress Street locus, the Clearwater site, AZ BB:13:6 (ASM).

Feature 629 was discovered during mechanical stripping of Block 5. This exposed only its eastern half, which was then completely excavated by hand (Figure 4.37).

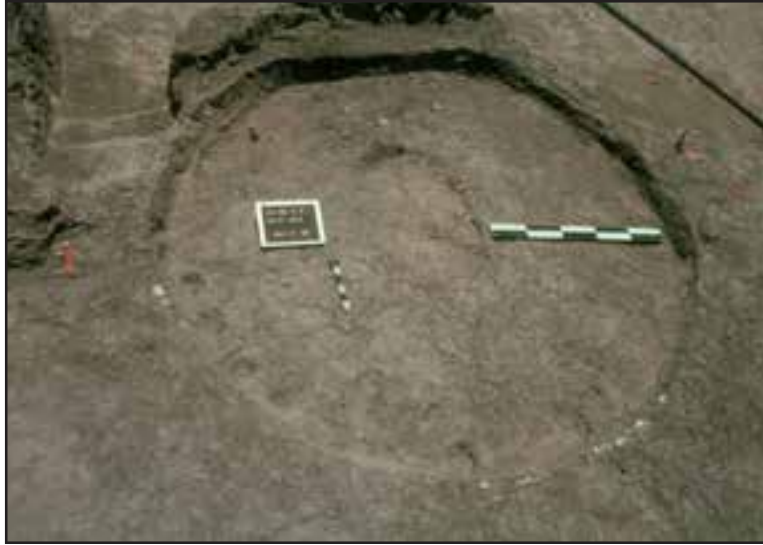
Nine possible postholes were discovered in the floor of the structure. Seven of these postholes were excavated and each measured 10 cm in diameter and 5 cm deep. The two unexcavated postholes also measured 10 cm in diameter. All the postholes were found around the interior edge of the northern half of the structure.

Feature 3220.01 was an elliptical pit with a basin-shaped profile that was discovered in the center of the floor. It measured 95 cm in length, 65 cm in width, and 9 cm in depth. Two pieces of flaked stone and about 20 pieces of fire-cracked rock were discovered in the fill, with four of the fire-cracked

**Figure 4.38.** Feature 3220, a Cienega phase pithouse, Brickyard locus, the Clearwater site, AZ BB:13:6 (ASM).

rocks measuring over 5 cm in diameter. Five of the pieces of fire-cracked rock recovered were also ground stone fragments. Some small patches of oxidation were found in the fill and on the bottom of the pit, possibly suggesting its use as a small roasting pit or informal hearth.

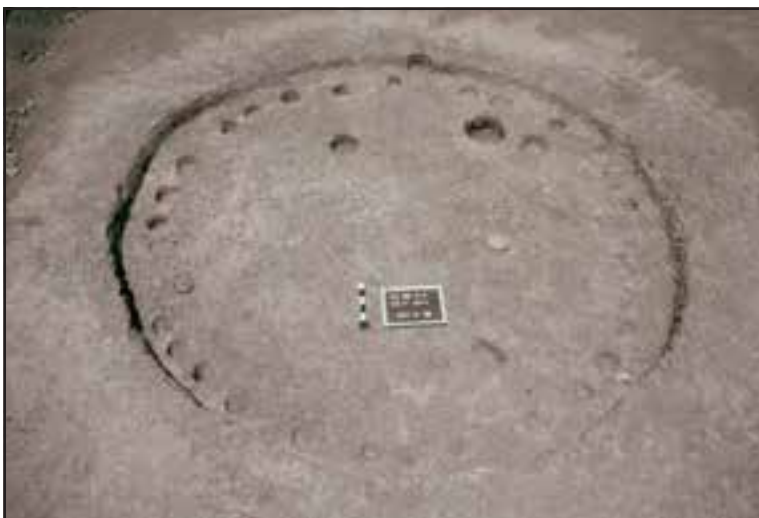
Roughly 20 cm of fill was excavated between the stripped surface and the upper floor of the pit structure. The top 10 cm of this fill was composed of flood silt and contained no artifacts. About 37 small pieces of fire-cracked rock were present. The remaining 10 cm of fill above the upper floor was a mixture of light silts and dark clays, with some charcoal flecking and small pieces of oxidized daub. The density of fire-cracked rock increased to approximately 110 pieces, and artifacts were discovered, including a few pieces of flaked stone, some unworked bone, and a small sherd. When encountered, the upper floor appeared to be a surface of sterile clay with postholes and a possible hearth. When silty areas in the upper floor were investigated, the possibility of a lower floor was discovered. Another 10 cm of fill existed between the upper floor surface and the lower floor surface. This fill was a mix of alluvium, colluvium, and cultural trash. Charcoal flecking was abundant, and some 15 large (greater than

**Figure 4.39.** Feature 3245, a Cienega phase pithouse, Brickyard locus, the Clearwater site, AZ BB:13:6 (ASM).

5 cm in diameter) pieces of burned daub with reed impressions were found. Artifact density was higher in this fill than in any previous layer of fill. A Cienega style projectile point was found 3 cm above the lower floor.

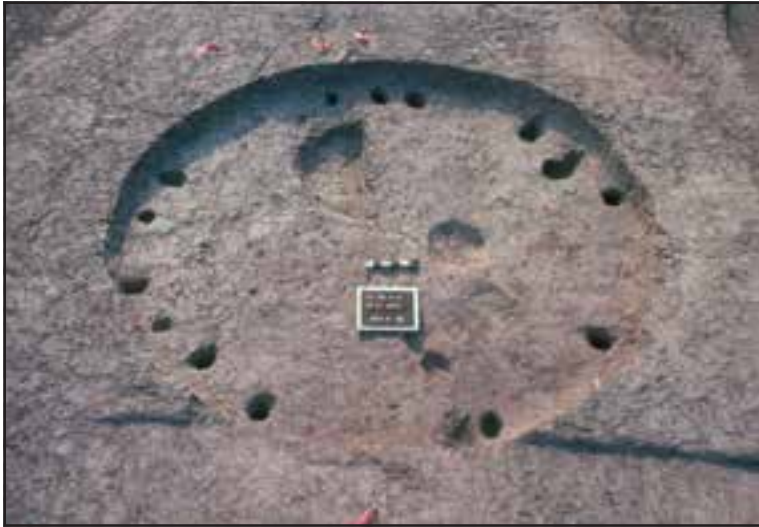
Feature 3260 was discovered during mechanical stripping and was completely excavated by hand (Figure 4.40). This pit structure was slightly ovoid and measured some 2.93 m in diameter. Features discovered within the pit structure included 14 postholes and a hearth. Another pit, Feature 3315, was discovered just beneath the floor of the pit structure and may have been an intramural pit. The entry was not identifiable, and orientation of the pit structure could not be determined. The structure was burned, and no artifacts were found on the floor. This structure may have been used for habitation.

**Figure 4.40.** Feature 3260, a Cienega phase pithouse, Brickyard locus, the Clearwater site, AZ BB:13:6 (ASM).

About 16 cm of fill was excavated between the stripped surface and the floor. No discrete strata existed in the fill, although charcoal flecking and pieces of burned daub became more abundant lower in the fill. A thin layer of charcoal and ash less than 1 cm thick was discovered just above the floor. The floor was oxidized in some areas.

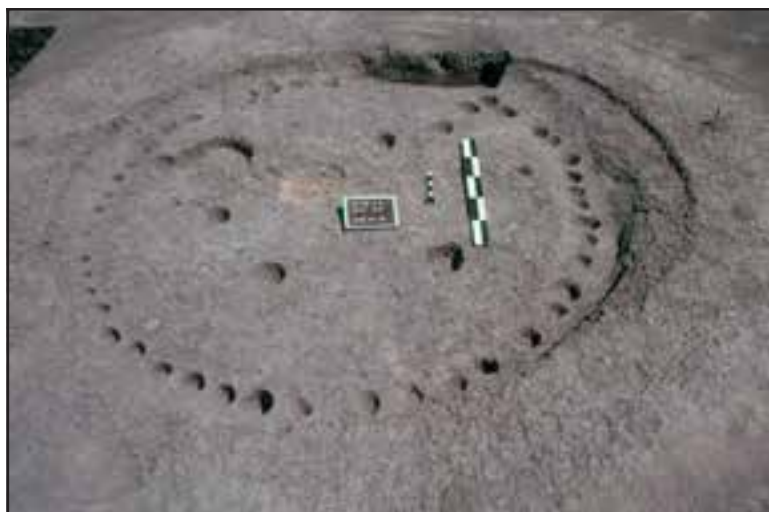
Feature 3264 was discovered during mechanical stripping, and was subsequently completely excavated by hand (Figure 4.41). This round pit structure measured 3.7 m in diameter. Features discovered within pit structure Feature 3264 include 52 postholes and a hearth. No entry was discovered, and no breaks in the pattern of postholes existed, except where the structure is intruded on by a historic-era outhouse, Feature 3258, on the northern side. Consequently, orientation of the structure could not be determined. Pit structure Feature 3264 was built into the fill of Feature 3294, an earlier pit structure that was lying beneath it. A possible de facto artifact assemblage was discovered on the floor. The pit structure was not burned.

Fifty-two postholes were discovered in the floor. They ranged in size from 6 cm to 17 cm in diameter, and from 3 cm to 15 cm in depth. All but 10 were arranged around the interior of the structure wall. These 10 roughly formed another ring inside the first, closer to the center of the pit structure. Three of the postholes in the inner ring (SS, TT, and Feature 3264.02) overlapped slightly, and may have represented adjustments to, or maintenance of, the superstructure supports. Artifacts were found in the fill of six of the 52 postholes. These artifacts included unworked animal bone, pieces of flaked stone, and a stone tool.

**Figure 4.41.** Feature 3264, a Cienega phase pithouse, Brickyard locus, the Clearwater site, AZ BB:13:6 (ASM).

The postholes near the pit edge were located during investigations of what appeared to be a silt-filled floor groove in the otherwise dark clay floor. Excavation of the silt revealed that this feature was actually a ring of postholes that had been constructed into a silt deposit in the fill of the lower house, Feature 3294.

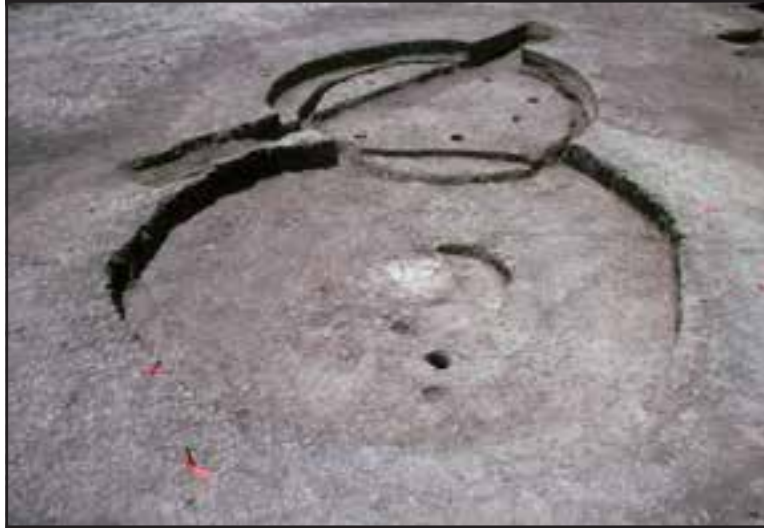
Feature 3270 was discovered during the excavation of a later pit structure, Feature 3262. After hand-excavation of the later pit structure, the remainder of the fill in Feature 3270 was also excavated by hand (Figure 4.42). Feature 3270 was a slightly ovoid-shaped pit structure measuring approximately 4.3 m in diameter. Internal features discovered within the pit structure included 9 postholes, 2 possible hearths, a large bell pit, and 2 small intramural pits. No entry was discovered, and the orientation of the pit structure could not be determined. The upper stratum of feature fill was removed from roughly half of this structure when a later pit structure, Feature 3262, was constructed. Feature 3270 burned, and a possible de facto artifact assemblage was revealed on the floor.

**Figure 4.42.** Features 3270 and 9168, Early Agricultural period pithouses, Brickyard locus, the Clearwater site, AZ BB:13:6 (ASM).

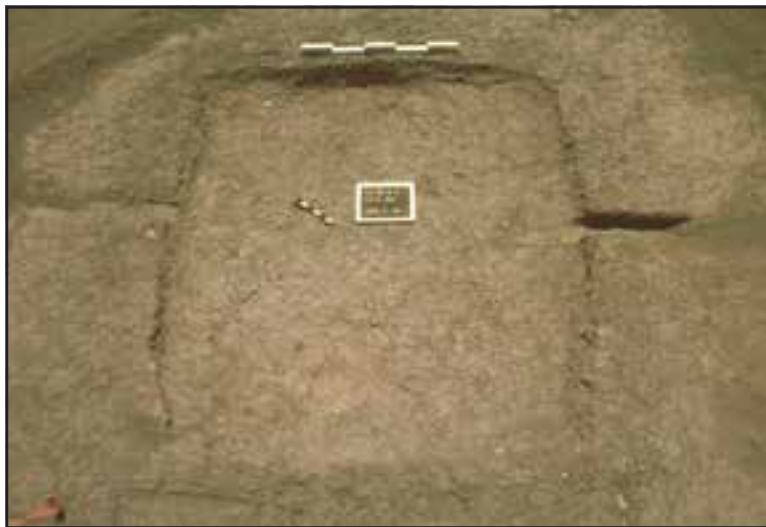
Feature 3293 was discovered during mechanical stripping and was then completely excavated by hand (Figure 4.44). This pit structure was rectangular with rounded corners. It measured about 2.55 m in length and 2.05 m in width. A utility trench for the modern brickyard cuts this structure along its north-south axis. A plastered hearth was discovered in the floor of the pit structure. No entry was located, and the orientation of the pit structure could not be determined. There was evidence the structure burned, and a possible de facto artifact assemblage was found on the floor.

Feature 3293.01 was a roughly circular, plastered hearth that measured 26 cm in length, 25 cm in width,

**Figure 4.44.** Feature 3293, an Early Ceramic period or Hohokam pithouse, Brickyard locus, the Clearwater site, AZ BB:13:6 (ASM).

and 8 cm in depth. In cross section, the hearth was basin shaped, with sloping walls on the western edge and vertical walls on the east. Plaster was present on the vertical eastern wall of the hearth and was roughly 2 cm thick. Fill of the hearth was almost pure ash and was collected entirely as a flotation sample.

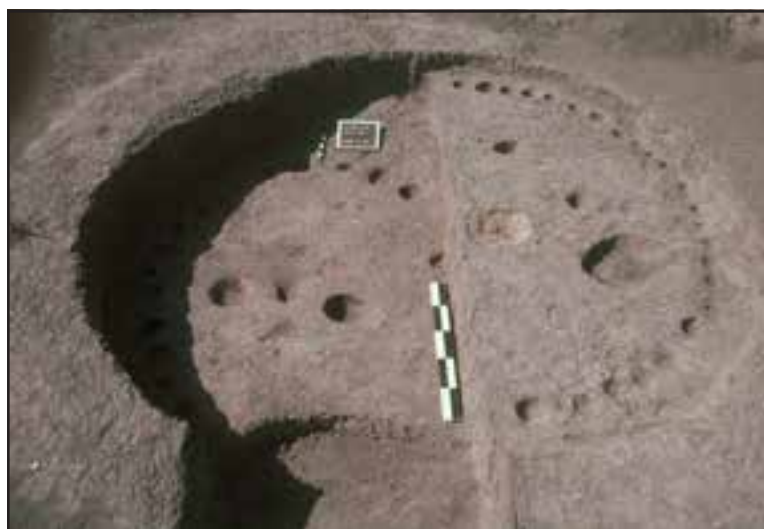
Feature 3294 was discovered during excavation of Feature 3264, a later, intrusive pit structure. Feature 3264 was built into the fill of Feature 3294. Excavation of Feature 3294 by hand continued, and it is estimated that about 50 percent of the lower structure was excavated to the floor (Figure 4.45). Only that portion of Feature 3294 under the eastern half of Feature 3264 was excavated. From the portion of the feature that was exposed, it was estimated to have been a round pit structure measuring about 2.5 m in diameter. No entry was discovered, and orientation could not be determined. Features found within the

**Figure 4.45.** Feature 3294, a Cienega phase pithouse, Brickyard locus, the Clearwater site, AZ BB:13:6 (ASM).

structure included 20 postholes and a possible hearth. No artifacts were discovered on the floor, but there was evidence the structure had burned.

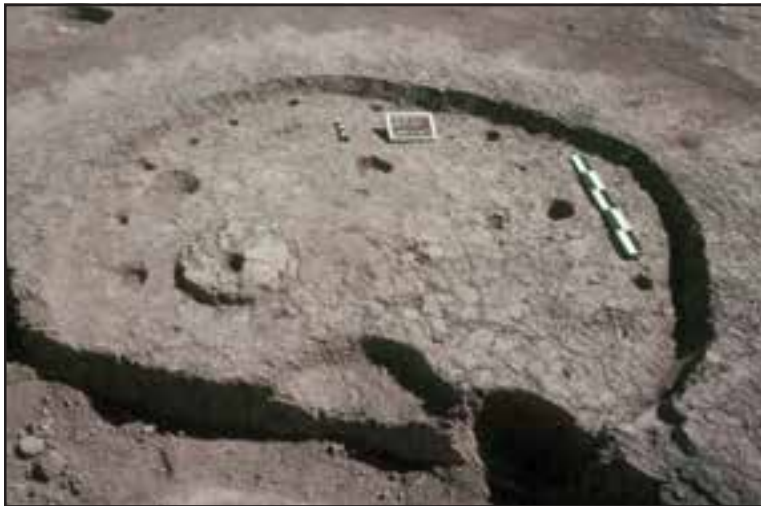
**Figure 4.46.** Feature 3296, a Cienega phase pithouse, Brickyard locus, the Clearwater site, AZ BB:13:6 (ASM).

Eleven postholes were found on the floor of the pit structure. They ranged in size from 8 cm to 21 cm in diameter and 4 cm to 18 cm in depth. Nine of the postholes were arranged around the interior of the structure wall. Three of the postholes were located about halfway between the wall and the center of the structure. These three postholes, A, I, and K, were also slightly larger than the other nine postholes.

Feature 3296.01 was an oxidized patch of the floor that may have served as an informal hearth area. The oxidization measured roughly 30 cm in diameter and had no depth. It was located just southeast of the center of the structure.

Feature 3296.02 was an intramural roasting pit that measured 37 cm in length, 36 cm in width, and 10 cm in depth. It became visible on the western side of the structure, just at the level of the floor, which suggested it was an intramural feature. The fill was comprised primarily of fire-cracked rock, although some ash and oxidized soil was present.

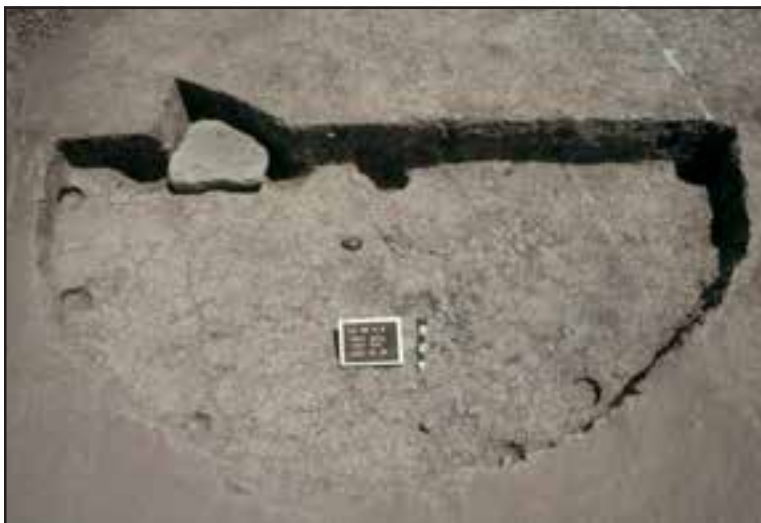
**Figure 4.47.** Feature 3323, a Cienega phase pithouse, Brickyard locus, the Clearwater site, AZ BB:13:6 (ASM).

Feature 3323 was discovered during backhoe stripping under a brick pad, Feature 3201, from the modern brickyard. After it was found, the northern half of the pit structure was excavated by hand (Figure 4.47).

This pit structure was constructed into the floodplain alluvium. It is intruded on by Feature 3324, a small pit. During modern use of the area as a brickyard, a large brick pad, Feature 3201, was constructed over the

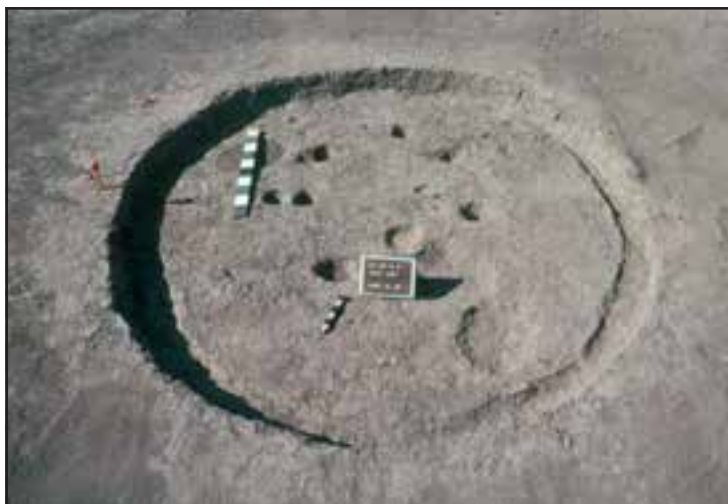
**Figure 4.48.** Feature 3327, a Cienega phase pithouse, Brickyard locus, the Clearwater site, AZ BB:13:6 (ASM).

Feature 3327 was found during backhoe strip-ping. After its discovery, the pit structure was completely excavated by hand (Figure 4.48). The pit structure was roughly circular and measured approximately 3.4 m in diameter. Six postholes, a floor groove, a hearth, and two intramural pits were revealed in the floor of the pit structure. An underlying feature, Feature 3357, originally thought to be another earlier pit structure, was found to be an inhumation. No entry was discovered, and the orientation of the structure could not be determined. The structure was burned, and a large de facto artifact assemblage was found on the floor.

Six postholes were discovered in the floor of the pit structure. They were all roughly circular and ranged in size from 12-14 cm in length, 12-15 cm in width, and 9-13 cm in depth. The postholes were found arranged in a circle halfway between the center of the pit structure and the wall. They may have represented roof support posts for the superstructure.

Feature 3327.01 was a roughly circular, highly oxidized hearth with a basin-shaped profile. It was 21 cm in diameter and 6 cm deep. Located just northwest of the center of the pit structure, the hearth was filled with ash. The fill contained no artifacts.

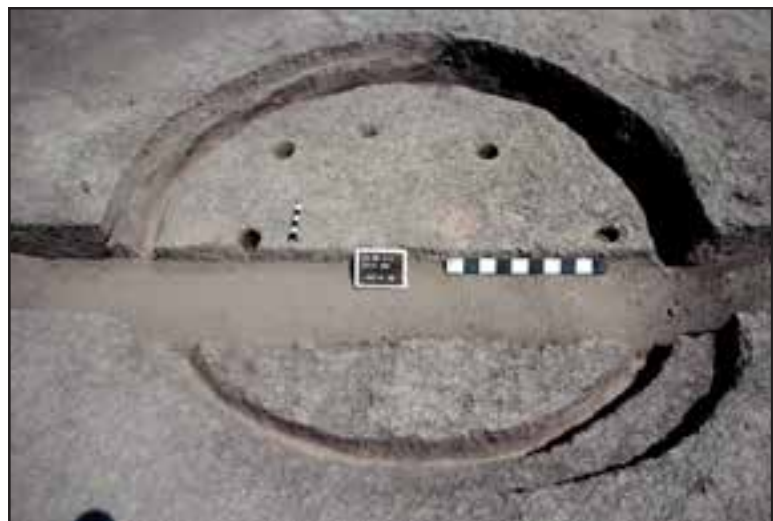
**Figure 4.49.** Feature 9168, a Cienega phase pithouse, Brickyard locus, the Clearwater site, AZ BB:13:6 (ASM).

Approximately 21 cm of fill was excavated between the stripped surface and the floor of the pit structure. The upper 12 cm of fill was a light clayey silt with some charcoal flecking and pieces of daub. A few of the pieces of daub were slightly oxidized, but most were unburned. The lower 9 cm of fill was a mixture of light silts and dark clays. Charcoal flecking

increased with depth, as did the concentration of daub, most of which was unburned. The floor of the pit structure was not burned.

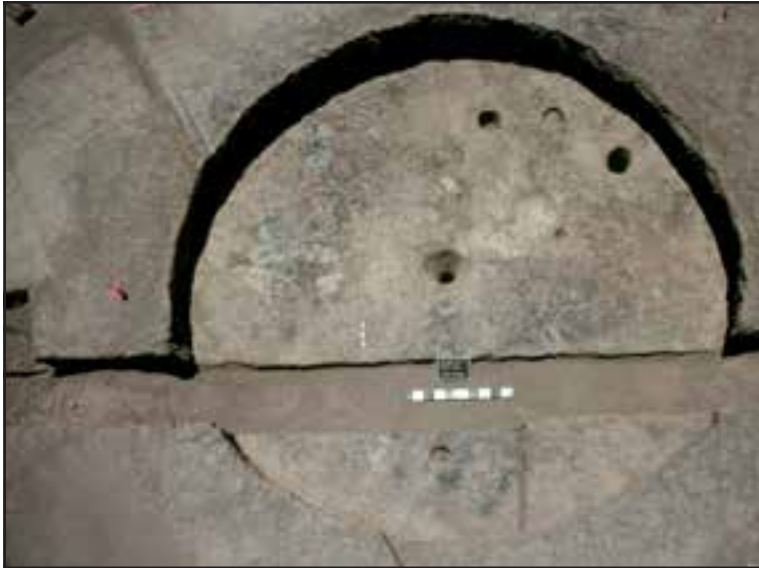
**Figure 4.50.** Feature 9357, a Cienega phase “bighouse,” Brickyard locus, the Clearwater site, AZ BB:13:6 (ASM).

Feature 9357 was first discovered in backhoe Trench 112 during earlier testing of the site, and it was recorded as Feature 357. During subsequent excavation, the feature was completely exposed using mechanical stripping and rerecorded as Feature 9357. After it was exposed, the structure was completely excavated by hand (Figure 4.50).

Feature 9357.02 was a large posthole that measured 40 cm long, 38 cm wide, and 63 cm deep. It was located almost directly in the center of the structure. The size and location of the posthole suggested that it represented the central support post of the structure. A fragment of in situ burned post was collected from the posthole.

A possible entryway was exposed in the southwestern quadrant of this pit structure. It was represented by a slightly raised area of extremely compacted silty clay that measured about 1.3 m in length and 90 cm in width. It extended from the wall to

roughly one-third the distance to the central post. The area may have represented a small earthen ramp or step used when entering or exiting the structure. Further evidence that this may have served as an entrance was provided by the presence of two postholes, Features 9357.03 and 9357.04, on either side of the area.

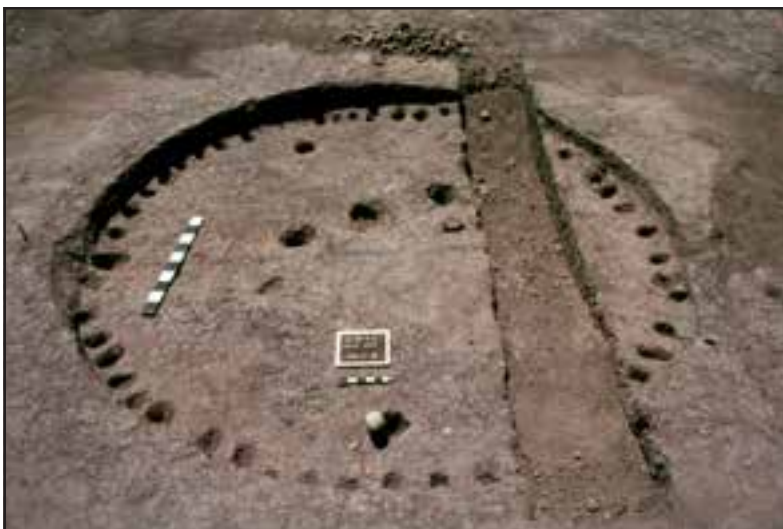
**Figure 4.51.** Feature 9372, a Cienega phase pithouse, Brickyard locus, the Clearwater site, AZ BB:13:6 (ASM).

Feature 9372 was originally discovered in the profile of backhoe Trench 114. The entirety of the feature was then exposed through mechanical stripping and excavated by hand (Figure 4.51). This feature was a round structure measuring some 4.09 m in diameter. Forty-six postholes and one intramural pit were found inside the structure. No entry was identifiable, and orientation of the pit structure could not be determined because the backhoe trench interrupted the posthole pattern. The structure burned, and a small, possibly *de facto* artifact assemblage was found on the floor. This feature was probably the remains of a habitation.

The high concentrations of charcoal and daub indicated the superstructure was of wattle-and-daub construction. The walls of the pit structure extended at least 19 cm above the floor, although they may have been slightly truncated by mechanical stripping. Neither the walls nor the floor showed evidence of being plastered or prepared in any way. The postholes may have held wall support posts, although it is unknown if they were all in use at the same time. Other than the large number

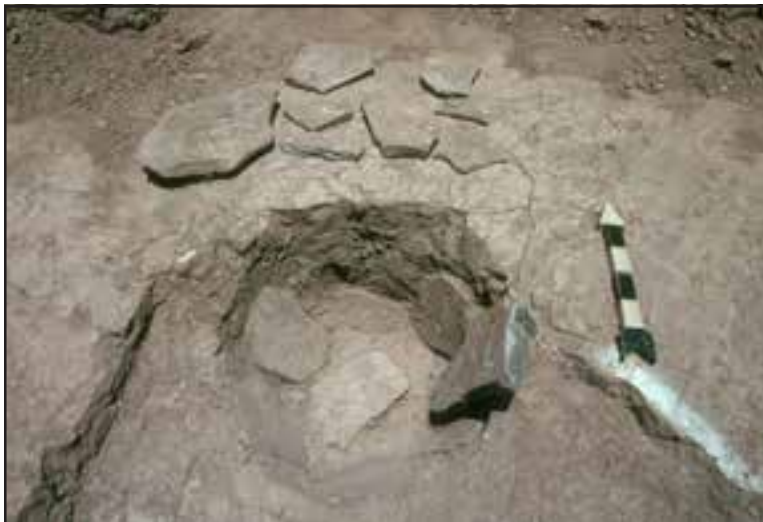
**Figure 4.52.** Feature 3316, a slab-lined pit, Brickyard locus, the Clearwater site, AZ BB:13:6 (ASM).

This circular slab-lined pit was discovered during mechanical stripping, and was then completely excavated by hand (Figure 4.52). It intruded into the fill of Feature 3312, an earlier pit structure. The pit was basin shaped and measured 50 cm in length, 49 cm in width, and 37 cm in depth. Slabs of limestone lined the margins of the pit, with an additional slab

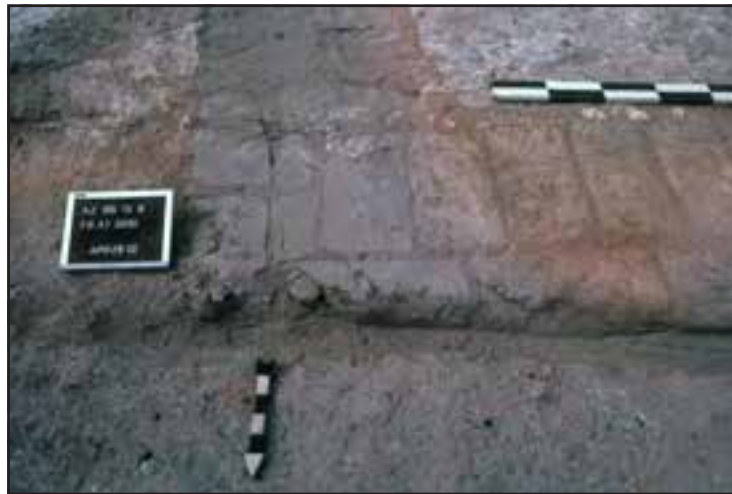
**Figure 4.53.** Feature 3200, a scove kiln foundation, Brickyard locus, the Clearwater site, AZ BB:13:6 (ASM).

This adobe foundation was discovered during backhoe stripping around Feature 3201, a large brick surface (Figure 4.53). After it was exposed, the foundation was uncovered by hand. The foundation consisted of two courses of adobe bricks placed side by side. Portions of the southeastern corner of the wall were uncovered during earlier excavations (Diehl 1996), and were recorded as Feature 1004 at that time. Using Sanborn Fire Insurance maps, the adobe bricks were determined to be the foundation for a scove kiln. This information was consistent with oxidization found on the inner course of bricks. Considered as a whole, the kiln foundation measured roughly 33 m long and 11 m wide. The foundation wall was about 85 cm wide along its length.

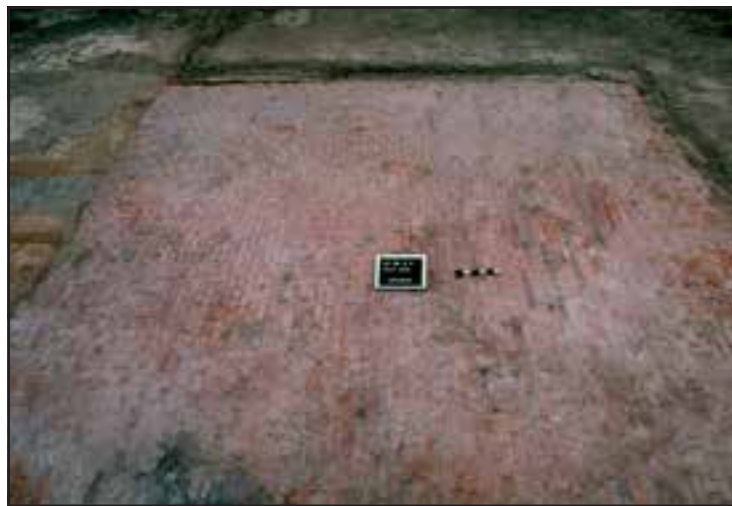
**Figure 4.54.** Feature 3201, a brick surface, Brickyard locus, the Clearwater site, AZ BB:13:6 (ASM).

This brick surface was discovered during backhoe stripping at the site, and was subsequently completely excavated by hand (Figure 4.54). The surface consisted of closely fit, dry-laid bricks lying on their

long ends. The brick surface measured 27.90 m in length and 4.75 m in width. It was lined on the northern, western, and eastern sides by wooden planks. The southern side of the feature was heavily disturbed by an overlying concrete surface, Feature 3203, and the foundations of a pug mill, Feature 3202. Ripper marks were visible near the disturbed area of the brick pad and many of the bricks were deformed. This brick surface is practically identical to another brick surface discovered during previous testing (Diehl 1996) and recorded as Feature 1001. The two brick surfaces, Features 1001 and 3201, may have been part of the same surface at some time.

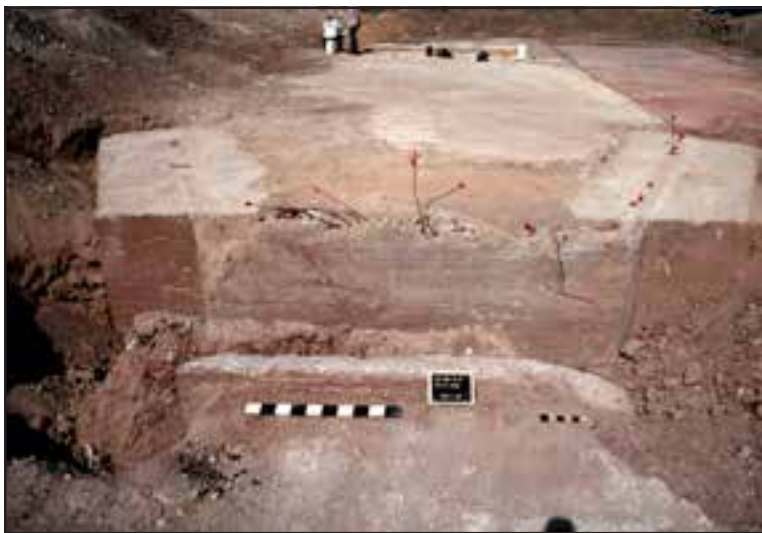
**Figure 4.55.** Feature 3202, the foundation of a pug mill, Brickyard locus, the Clearwater site, AZ BB:13:6 (ASM).

Feature 3202 represented the remains of the foundation for one of the brickyard's pug mills (Figure 4.55). The foundation consisted of walls of poured concrete constructed into a pit excavated below the ground surface. The concrete foundation walls contained heavy rebar, some of which protruded out of the top of the foundation. The foundation wall on the eastern side was straight along its length, and

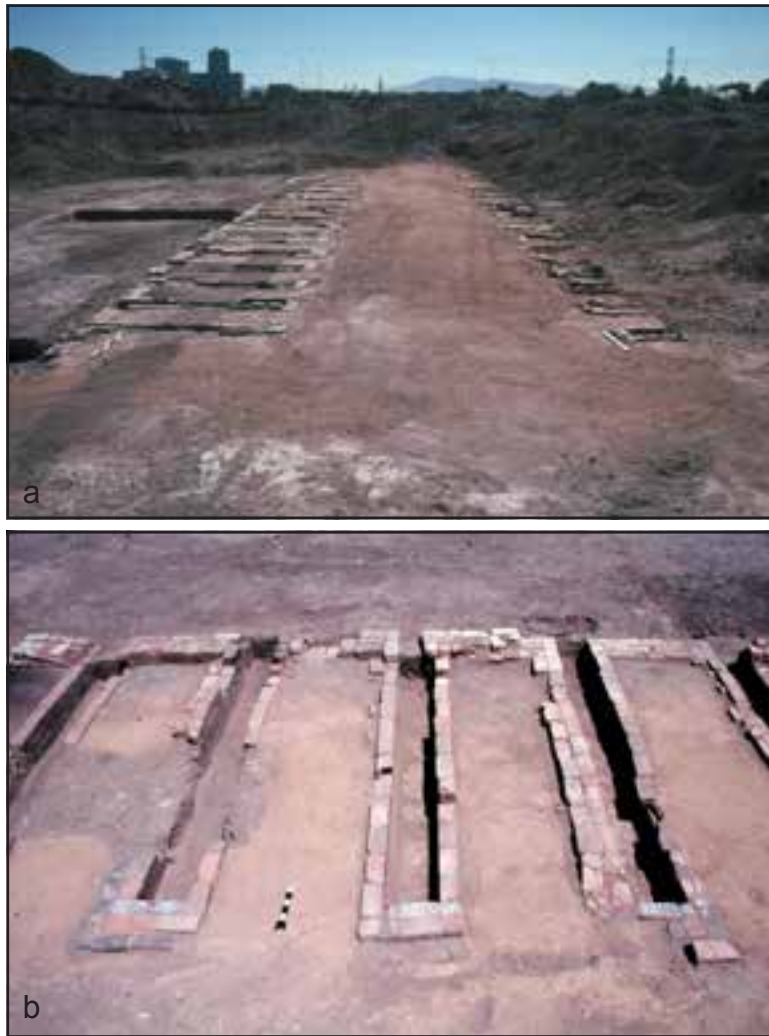
Figure 4.56a-b. Feature 3204, scove kiln, Brickyard locus, the Clearwater site, AZ BB:13:6 (ASM).

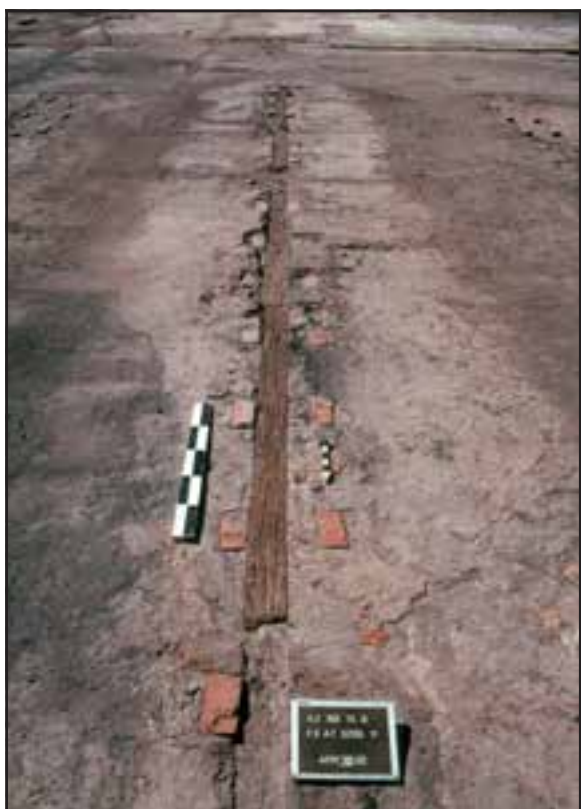
**Figure 4.57.** Feature 3205, the brick drying rack, Brickyard locus, the Clearwater site, AZ BB:13:6 (ASM).

These remnants of brick drying racks were discovered during backhoe stripping of an area within the brickyard (Figure 4.57). Eighteen linear arrangements of wooden planks were excavated in an area north of the scove kiln, Feature 3204, and the Transformer House. The wooden planks were flanked by pairs of bricks, one on either side of the plank. These bricks occurred at fairly regular intervals the entire length of the plank. Based on photographs of the site, the plank and brick arrangements were thought to represent footers for brick drying racks.

The rack footers covered an area 56 m wide, and the average length of the footers was about 20 m. All the footers were arranged in essentially a roughly north-south alignment. The central and easternmost footers were the best preserved, and many still contained large portions of intact wooden planking. The wooden planks measured 15 cm in width and 4 cm in thickness, but varied greatly in length. Each footer was composed of several pieces of planking along its length. The bricks on either side of the plank were pressed, and extruded bricks varied from gray to bright red in color. The bricks measured 23 cm in length, 12 cm in width, and 8 cm thickness. A few of

the footers had “caps” on either end, composed of two to three bricks turned perpendicular to the direction of the footer.

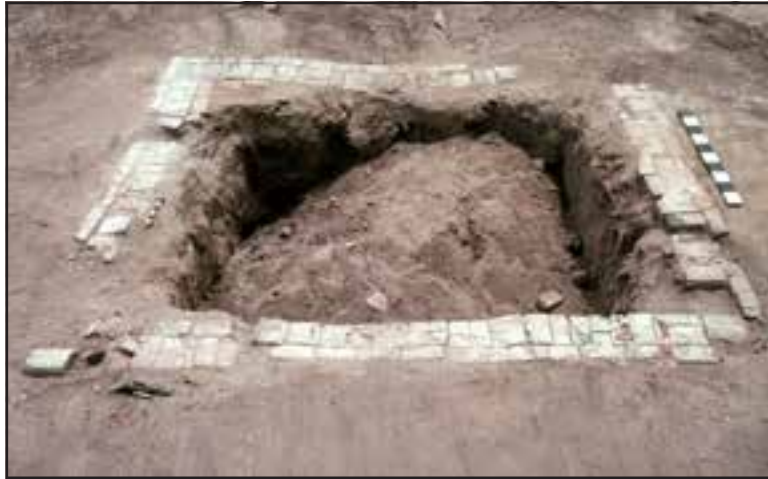
**Figure 4.58.** Feature 3207, the brickyard well, Brickyard locus, the Clearwater site, AZ BB:13:6 (ASM).

This historic-era well was found during mechanical stripping of the site (Figure 4.58). After it was discovered, the well was excavated with the backhoe down to a depth of roughly 3.5 m without reaching the bottom. The dimensions and construction details of the well were recorded before it was filled in for safety reasons.

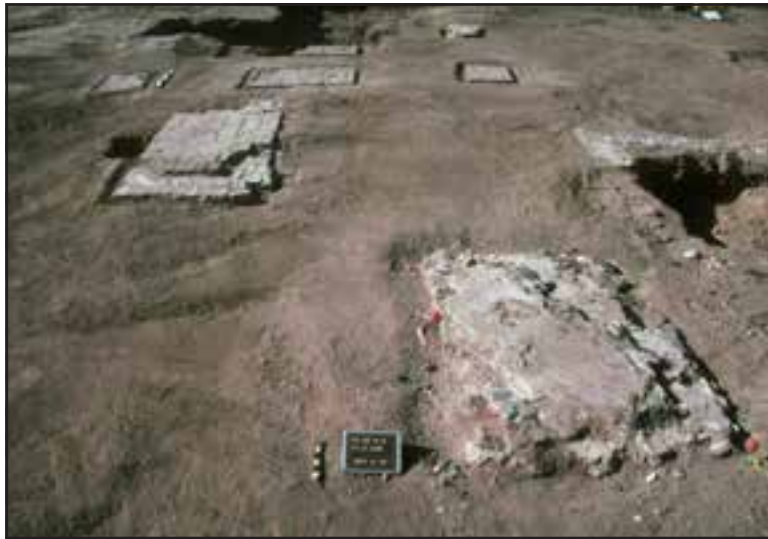
**Figure 4.59.** Feature 3208, brick equipment mounts, Brickyard locus, the Clearwater site, AZ BB:13:6 (ASM).

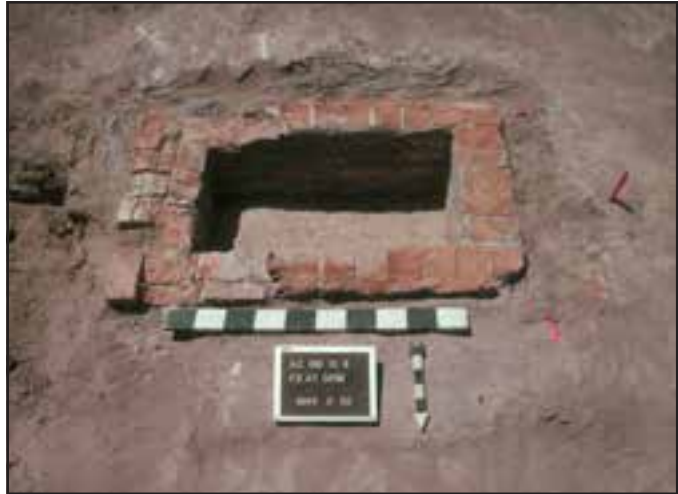
Figure 4.60. Feature 3209, a brick-lined pit, Brickyard locus, the Clearwater site, AZ BB:13:6 (ASM).

This brick-lined pit was discovered during mechanical stripping of the site (Figure 4.60). It was rectangular in shape, and measured 1.45 m in length, 95 cm in width, and 37 cm in depth. The bottom of the pit was a flat surface of concrete. The top courses of the brick walls were slightly impacted by a utility trench constructed after the pit had been filled.

This pit overlay and intruded on the northeastern portion of the belowground work area, Feature 3216. It was constructed sometime after the work area had been abandoned and filled. This pit was very similar in size and construction to another brick-lined pit, Feature 3209, discovered at the site. It is unknown if the two pits served the same purpose, or if they were in use at the same time.

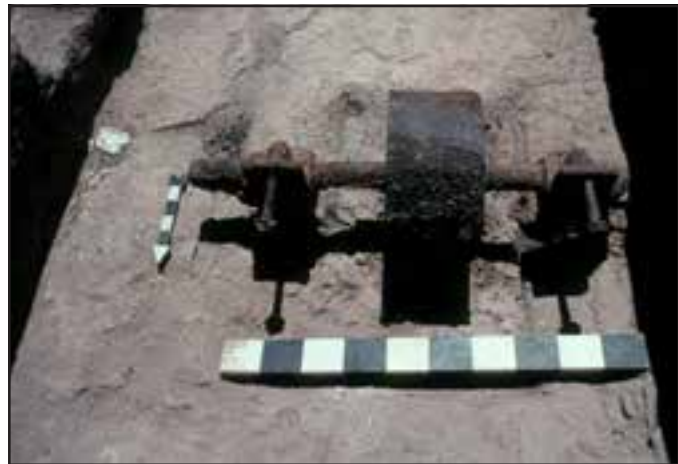
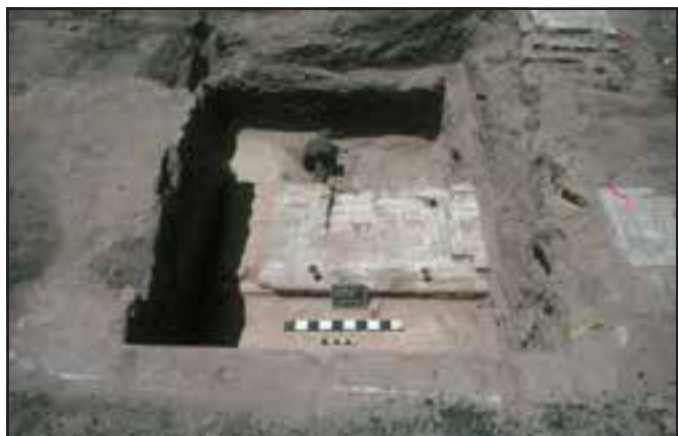
This feature was initially discovered during mechanical stripping, and was then completely excavated by hand (Figures 4.61-4.64). The machinery of a pug mill was placed below ground in a pit that measured 3.90 m in length and 2.95 m in width. The pit was separated into two distinct areas, both of which appeared to have housed separate parts of the machinery. These areas were excavated as subfeatures of the overall pit.

Feature 3210.01 was the deeper of the two areas at 2.80 m long, 1.55 m wide, and 2.38 m deep. This area was lined by wooden planks that formed the walls of the lower pit. The fill of the subfeature contained abundant amounts of historic trash that included metal, bricks, and raw material for brickmaking. Also recovered from this fill were several

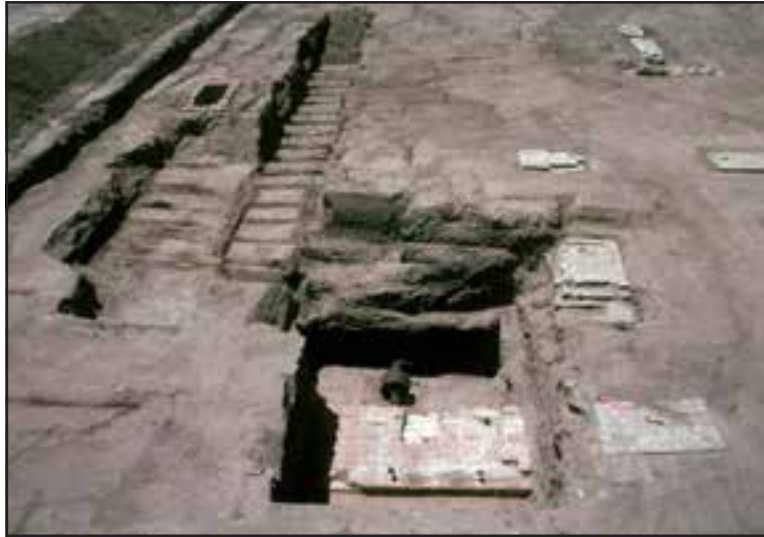
**Figure 4.63.** Features 3210 and 3213, the early pug mill and subsurface railroad track, Brickyard locus, the Clearwater site, AZ BB:13:6 (ASM).
