# **RIO NUEVO ARCHAEOLOGY, 2000-2003:**

**Investigations at the San Agustín Mission and Mission Gardens,  
Tucson Presidio, Tucson Pressed Brick Company, and Clearwater Site**

**Technical Report No. 2004-11  
Desert Archaeology, Inc.**

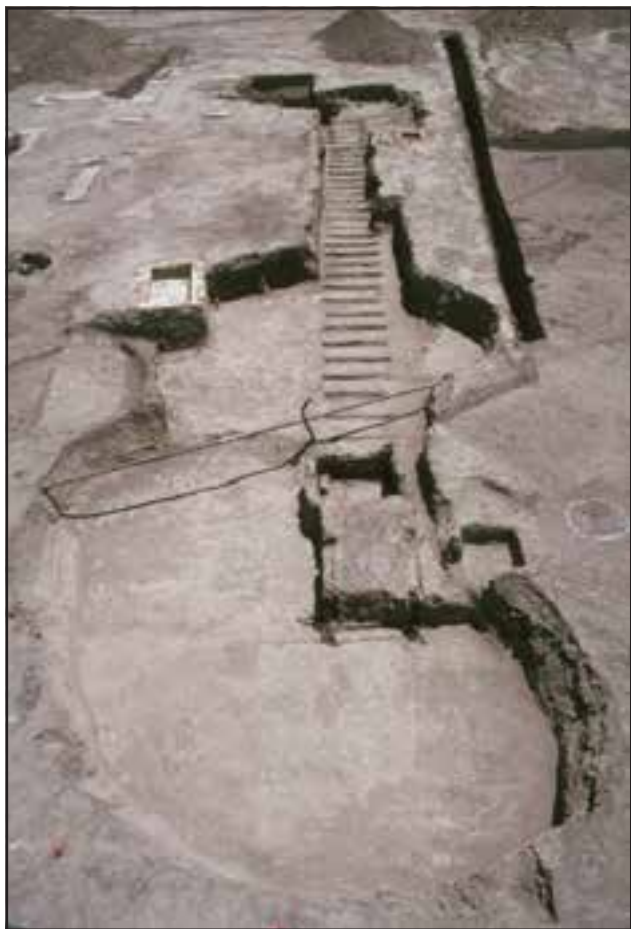
**Figure 4.64.** Features 3210, 3213, and 3216, the early pug mill, the subsurface railroad track, and a work area, respectively, Brickyard locus, the Clearwater site, AZ BB:13:6 (ASM).

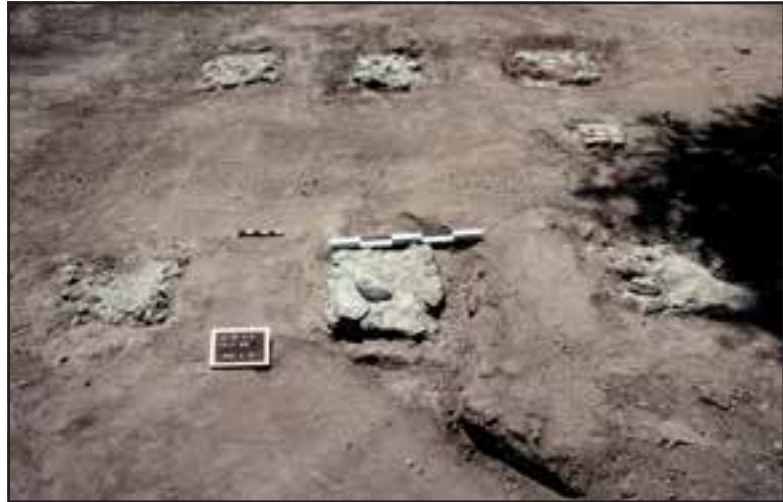
**Figure 4.65.** Feature 3212, a house foundation, Brickyard locus, the Clearwater site, AZ BB:13:6 (ASM).

This house foundation was discovered during mechanical stripping (Figure 4.65). The foundation consisted of six roughly square blocks of concrete arranged in two parallel lines of three blocks each (Features 3212.01, 3212.02, 3212.03, 3212.05, 3212.06, and 3212.07). A small square formed from five bricks was thought to be the foundation for some stairs, Feature 3212.04. Also in close proximity was a large, mostly buried conglomeration of medium-sized cobbles, Feature 3212.08. The function of these cobbles was unknown.

Historic aerial photographs of the brickyard showed a house at this location, and the size and arrangement of the concrete pads were consistent with

the foundation of a structure. Interviews conducted with the former residents of the house also confirmed that the concrete pads were the foundations of the house structure.

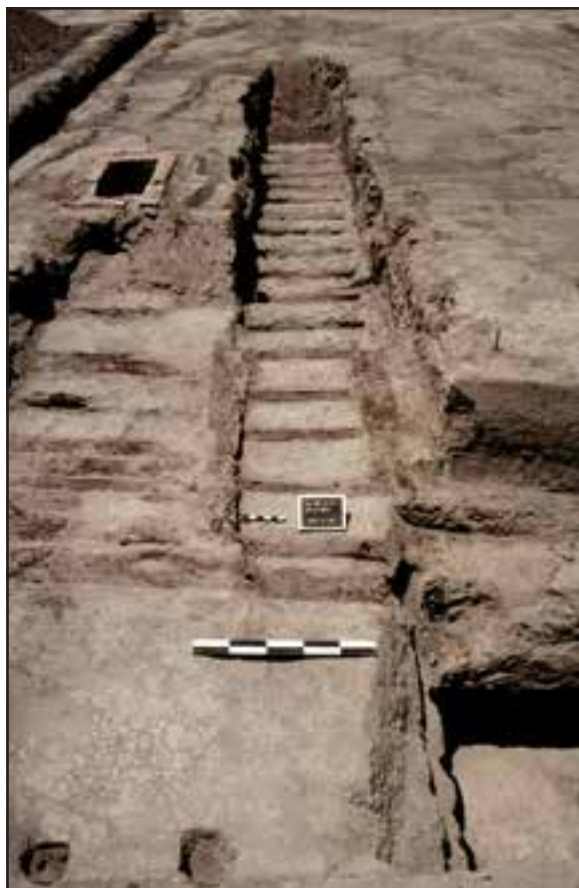
**Figure 4.66.** A close-up of the subsurface railroad track, Feature 3213, Brickyard locus, the Clearwater site, AZ BB:13:6 (ASM).

This subsurface rail track was discovered during mechanical stripping (Figure 4.66; see also Figure 4.63). Fill of the rail bed was partially removed with the backhoe, but the base of the rail bed was then cleared by hand. The rail line was 21 m long and 2 m wide, and was at a depth of 65 cm below the stripped surface. The rail line began on the eastern side adjacent to the remains of Feature 3210, a brick press, and ended on the western side in a belowground work area, Feature 3216.

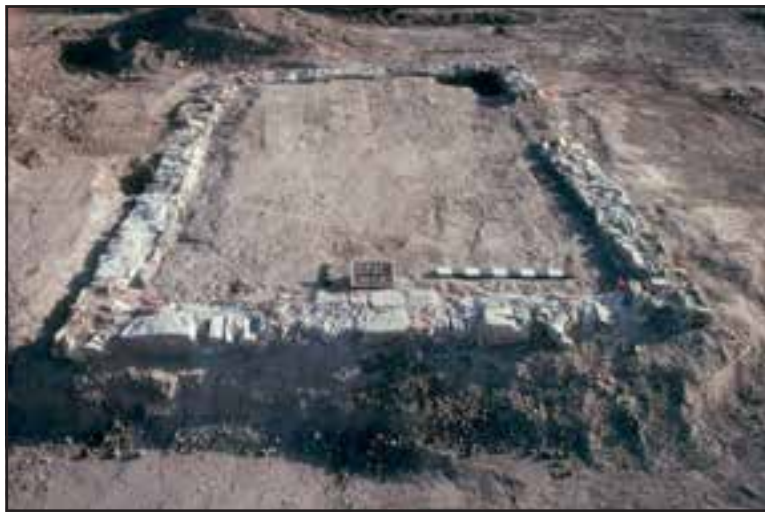
**Figure 4.67.** Feature 3256, the foundation of the brickyard office, Brickyard locus, the Clearwater site, AZ BB:13:6 (ASM).

This mixed rock and brick foundation was discovered during mechanical stripping (Figure 4.67). The remains of the foundation were cleared by hand after its discovery. It measured 6.0 m in length and 4.2 m in width. The foundation probably represented what remained of the brickyard office. The office was likely constructed sometime in the 1930s, and remained standing until at least 1952, where it can be seen in an aerial photograph of the site.

The foundation was constructed of several different types of brick, as well as masonry stones held together by mortar. Two courses of the foundation remained, and a measurement from the top of the remaining foundation to the base was 15 cm. A possible entryway was located in the eastern side of the foundation. The opening in the foundation measured about 1.35 m in length.

The area enclosed by the foundation was left unexcavated, because the stripped surface was thought to already be below the historic floor level of the building. The lack of construction debris associated with the foundation suggested the office had been dismantled before the foundation was buried. The only artifacts collected from the foundation were several pieces of decorative ceramic cornice that may have once been part of the structure.

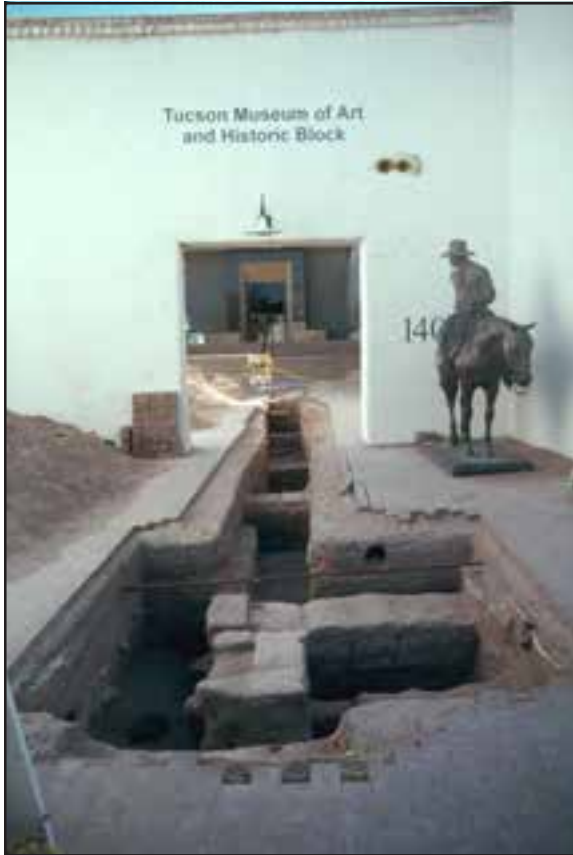
**Figure 4.70.** Overview of the excavations at the Tucson Museum of Art complex, Tucson Presidio, AZ BB:13:13 (ASM).

Plans for construction of a room bridging a gap in the National Register-listed Fish-Stevens-Duffield House led to archaeological excavations at the historic-era house in February 2002. The Tucson Museum of Art plans called for placement of a long drainage pipe through the center of the area, removing water from an inner courtyard out to Main Street. Six excavation units of varying size, totaling 14 m in length, followed the alignment of the pipe. All the trenches were 80 cm wide. When the project was completed, the western end of the dig was expanded to provide additional details about several adobe structures discovered in that area (Figures 4.69-4.70).

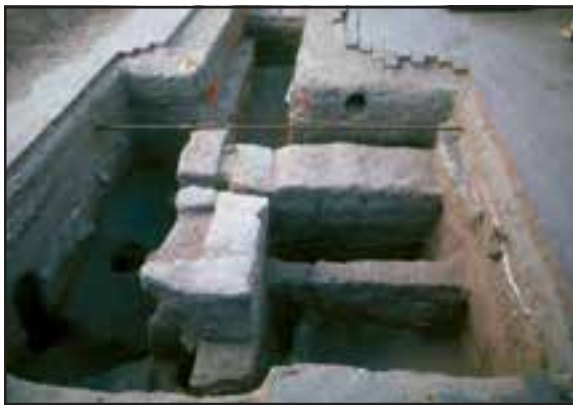
**Figure 4.71.** Archaeological features at the western end of the Tucson Museum of Art project area trench, Tucson Presidio, AZ BB:13:13 (ASM).

The earliest structure, Feature 331, was found in the west side of the trench (Figures 4.71-4.72). The portion exposed consisted of an L-shaped adobe brick wall identified in excavation Units 200, 217, and 229.

The northern and eastern walls of the building were partially present within the excavation area, extending into the western and southern sidewalls. The adobe walls had cobble foundations upon which up to two courses of brick survived. The brown adobe bricks were poorly preserved, and were between 23

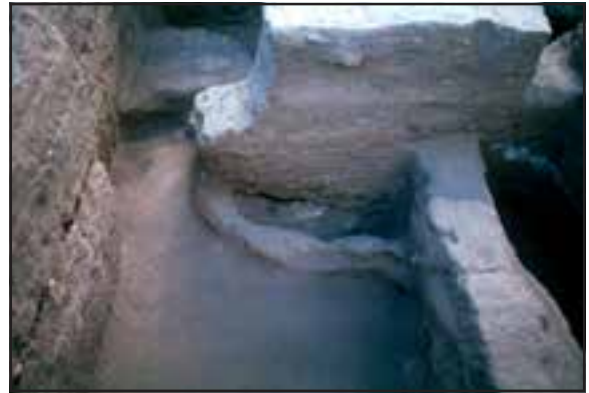
**Figure 4.72.** Features 331 and 332, an adobe wall and a molded adobe corner fireplace from an early presidio home, Tucson Presidio, AZ BB:13:13 (ASM).

Feature 332 was the fireplace found in the north-eastern corner of the Feature 331 room in excavation Unit 332 (see Figure 4.72). The fireplace consisted of a quarter-circle of adobe, 8-13 cm high. The adobe was quite irregular, and appears to have been molded in place by hand. The interior of the fireplace contained a dark gray-to-brown soft sandy silt with a large amount of ash and charcoal. A flotation sample was collected from the interior, but the rest of the fill was left in place.

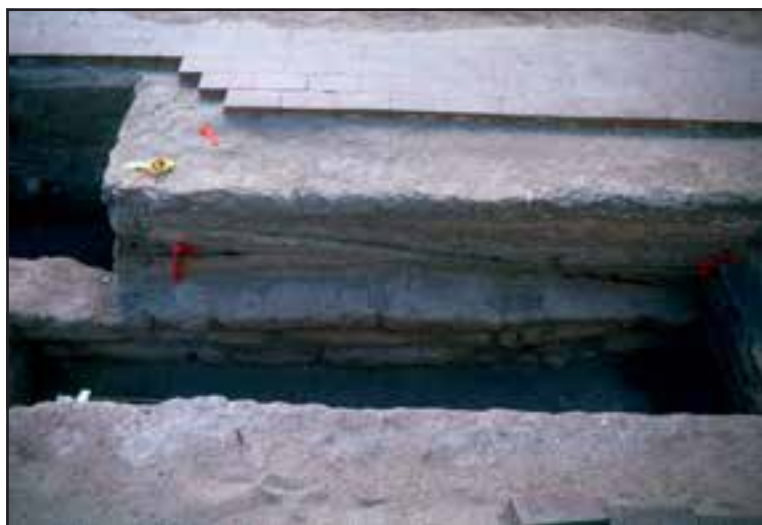
**Figure 4.73.** Feature 314, a late presidio-occupation to early American Territorial period adobe wall, Tucson Presidio, AZ BB:13:13 (ASM).

The arrival of the Americans in 1856 marked the end of the Tucson Presidio fort. A rapid increase in population and the reduced threat of Apaches led to the demolition of many presidio structures, including the western wall. Feature 300, the structure with thick adobe walls, had the northern wall truncated, probably as Main Street widened. The eastern wall was reused, with an east-west wall, Feature 314, appended to the northern corner (Figure 4.73). Feature 314 was a single-brick-wide adobe wall, sitting on Feature 319, a hard surface. It was found in excavation Units 201 and 202. The wall was 4.29 m long and 27 cm wide. It turns north at the eastern end, beyond the trenched area. The top of the three-course-tall wall ranged

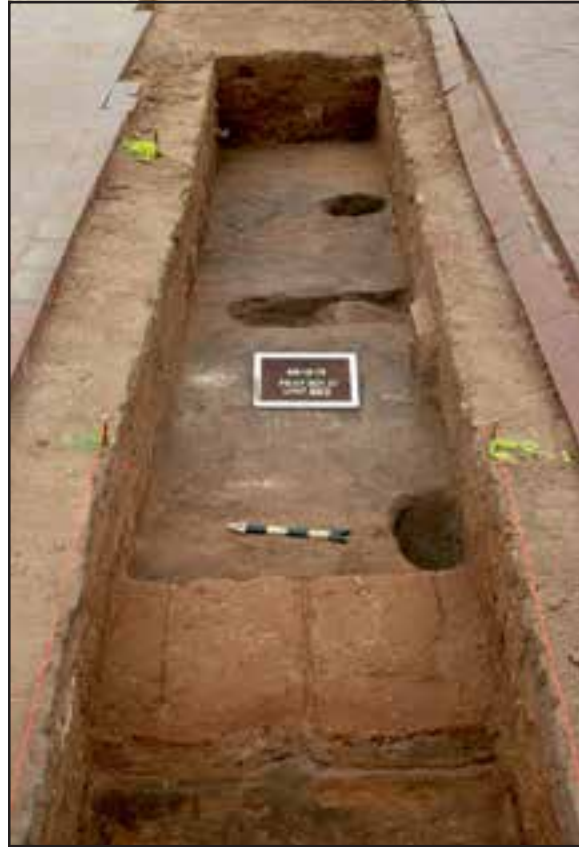
**Figure 4.74.** Features 301 and 302, the eastern foundation of the late 1860s Fish House and an adjacent hard ground surface; several postholes are also visible; Tucson Presidio, AZ BB:13:13 (ASM).

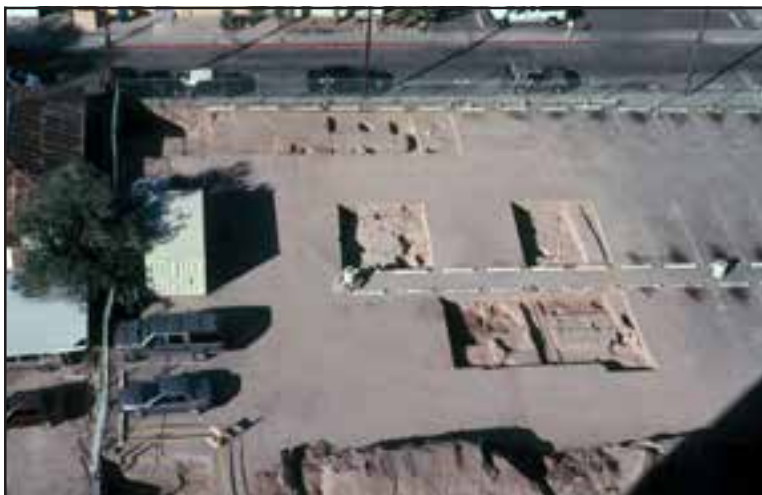
**Figure 4.78.** An overview of the presidio corner excavations, Tucson Presidio, AZ BB:13:13 (ASM).

The area was still needed for parking after work was completed, so only a small number of individual spaces could be examined. Archaeologists excavated 15 parking spaces (each measuring about 4.5 m by 2.7 m) in December 2002 and January 2003, revealing a wealth of features dating from the Hohokam Colonial period to the American Territorial period. Among these were many presidio-occupation features, including architectural remains and pits filled with large numbers of artifacts and food materials (Figures 4.77-4.78).

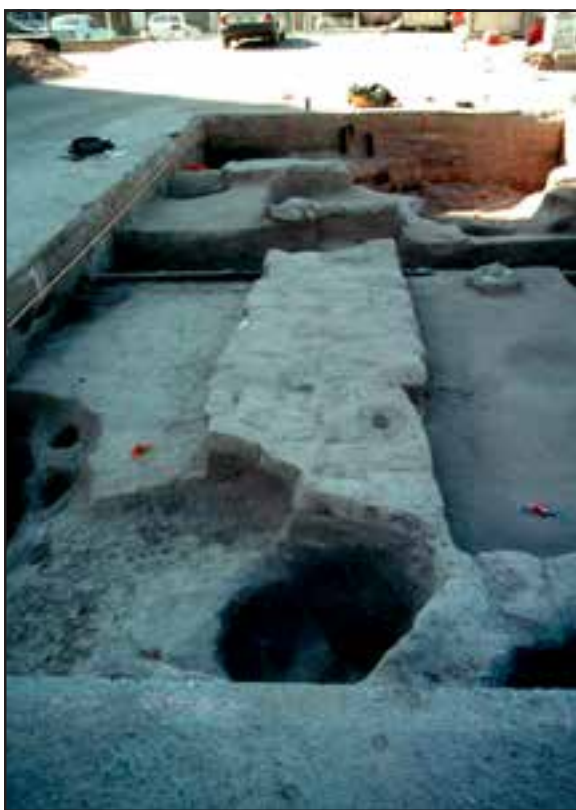
**Figure 4.79.** Feature 377, the southern foundation of the tower, looking to the west, Tucson Presidio, AZ BB:13:13 (ASM).

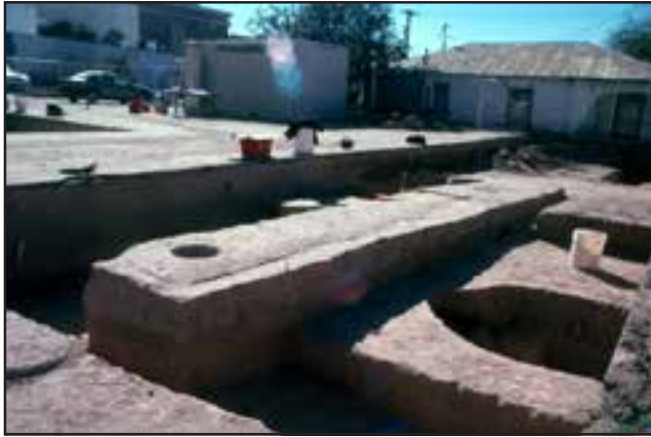
**Figure 4.80.** Feature 374, the northern foundation of the tower, looking to the southwest, Tucson Presidio, AZ BB:13:13 (ASM).

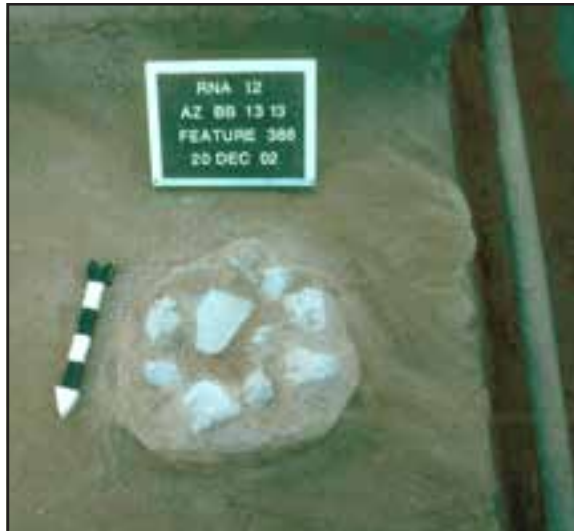
**Figure 4.81.** Feature 386, a cobble column support base within the southern foundation of the tower, Tucson Presidio, AZ BB:13:13 (ASM).

side the tower foundations probably represent post supports for the walkway. Feature 386 was a small cluster of 10 flat-lying rocks found some 50 cm north of the southern tower wall (Figure 4.81). The rocks lay in a 30-cm-diameter circle. Along the northern wall, archaeologists found Feature 404, a circular adobe area that probably served the same purpose (Figure 4.82). The adobe was 45 cm in diameter and

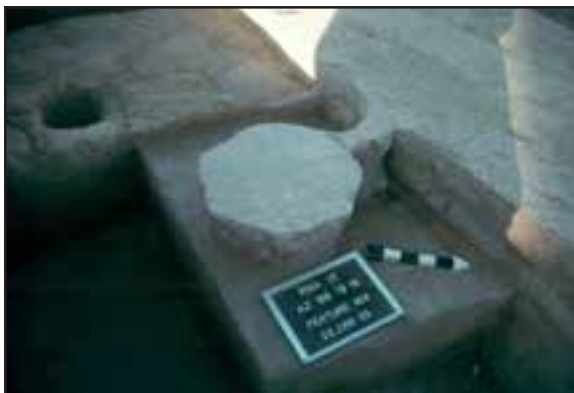
**Figure 4.82.** Features 404 and 495, an adobe column base and an interior room wall within the northern foundation of the tower, Tucson Presidio, AZ BB:13:13 (ASM).

The only other features that directly relate to the tower were a pair of adobe walls, Features 399 and 403, that extended from the southern side of the northern wall of the tower (see Figure 4.82). Feature 399 was 1.04 m wide, and a 1.09-m-long segment was uncovered, with the wall running into an unexcavated area. The wall was made from adobe bricks of varying sizes and colors, indicating it was probably built from recycled bricks. The function of the wall is uncertain, although it may have been the eastern wall of a small structure built inside the northwestern corner of the tower. Another possibility is that a staircase up to the wooden walkway lining the tower may have been located in this area. A third possibility is that it was a buttress built to help hold up the tower wall at this location. The second wall, Feature 403, it was at least 1.02 m long, mostly extending into an unexcavated area, and it was at least

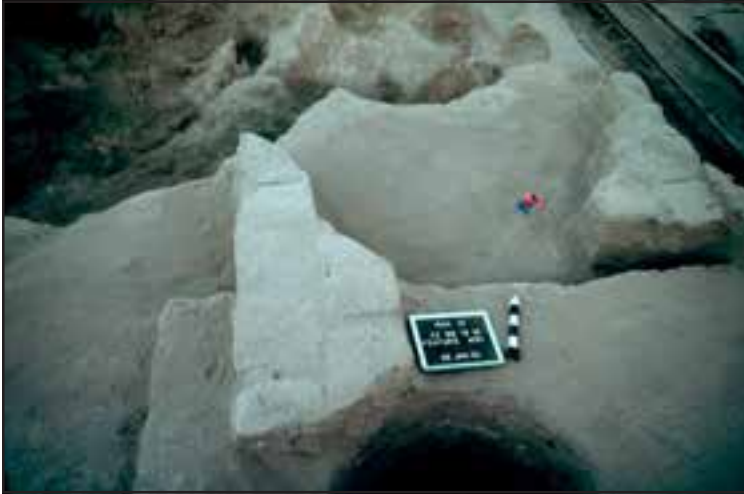
**Figure 4.83.** Feature 400, a small fragment of the eastern presidio wall, Tucson Presidio, AZ BB:13:13 (ASM).

The eastern wall of the presidio had been previously located within the Pima County Courthouse courtyard in 1992, and at the southern side of Alameda Street in 1991. The location of this wall was projected north into the parking lot, and a new segment was found within 41 cm of where it was expected (Figure 4.83). The surviving portion, Feature 400, had been badly damaged by American Territorial period pits, but enough survived to verify that it was also 56 cm (22 inches) wide, the length of a standard Spanish period adobe brick. Unfortunately, the juncture between the wall and the tower had been disturbed, making it impossible to determine how they

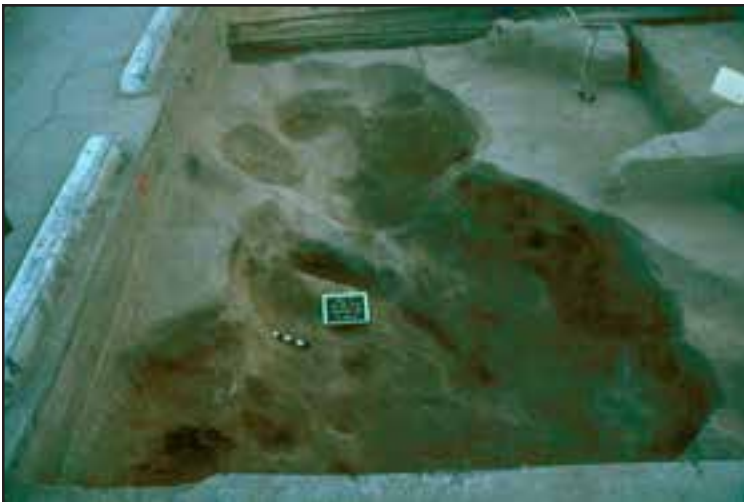
**Figure 4.84.** Feature 409, a presidio borrow pit, Tucson Presidio, AZ BB:13:13 (ASM).

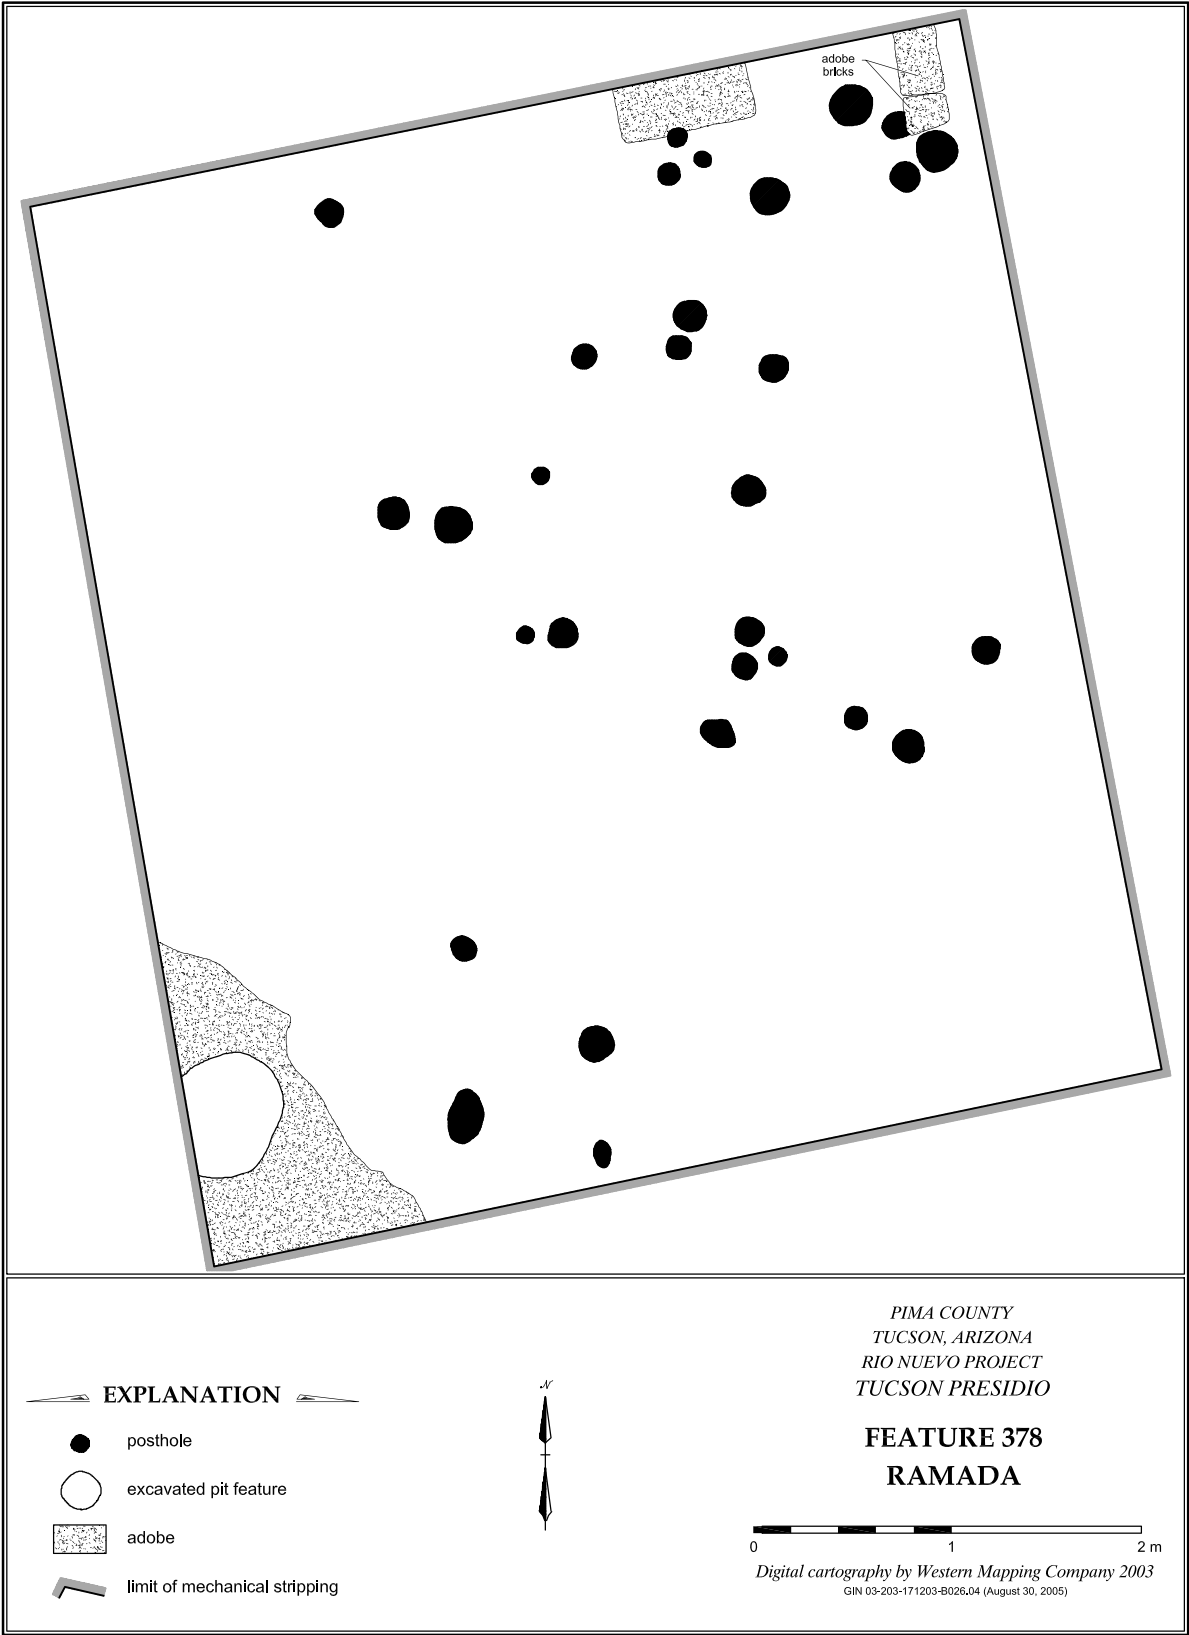
**Figure 4.90.** Feature 378, a set of American Territorial period postholes for a probable ramada structure, Tucson Presidio, AZ BB:13:13 (ASM).

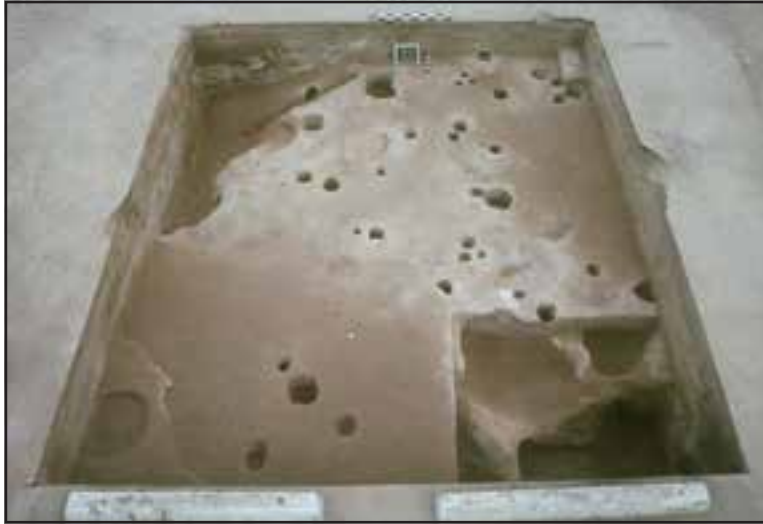
**Figure 4.91.** Photograph of the Feature 378 postholes and other features, Tucson Presidio, AZ BB:13:13 (ASM).

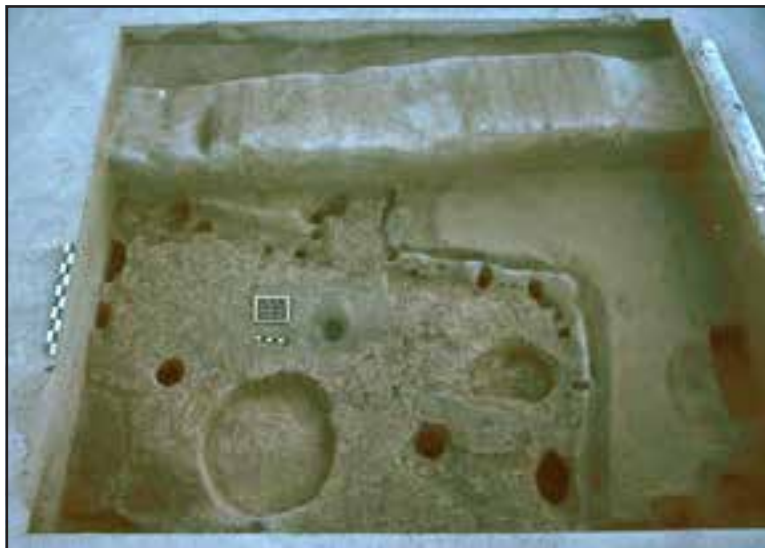
**Figure 4.94.** Feature 350, a Hohokam pithouse originally exposed in 1954, lies adjacent to the eastern wall of the northeastern tower, Feature 351, Tucson Presidio, AZ BB:13:13 (ASM).

During the original excavation in 1954, Features 350.02 and 350.03 were identified as separate presidio or American Territorial period features intrusive to the pit structure (Olson 1985). The lack of overlying stratigraphy and the small amount of intact fill in Feature 350.02 made it impossible to either support or refute this assessment.

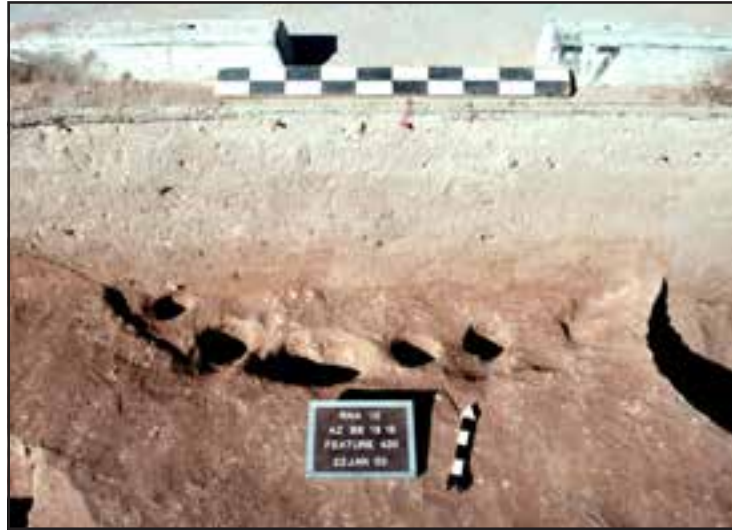
**Figure 4.95.** Feature 430, a partially excavated Early Agricultural period pithouse, Tucson Presidio, AZ BB:13:13 (ASM).

The profile showed the walls of the structure to be approximately 33 cm above the floor. It is unknown how the walls were impacted by either historic or

modern construction at the site. Neither the walls nor the floor of the structure appeared to have been plastered or prepared in any way. Except the six postholes and one small piece of daub, no evidence of a superstructure was found.

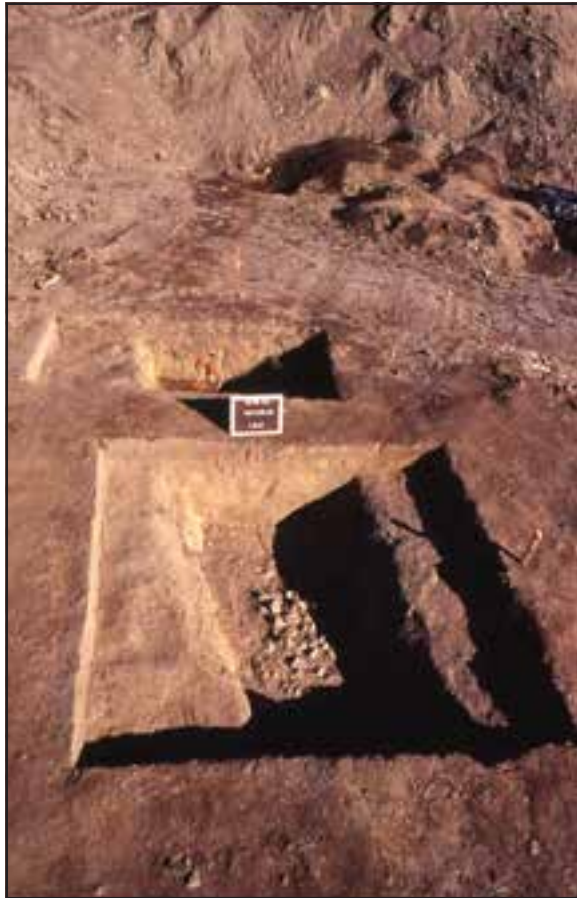
**Figure 4.98.** Photograph of canal Feature 53, AZ BB:13:481 (ASM), at the San Agustín Mission locus, the Clearwater site, AZ BB:13:6 (ASM).

70 cm wide at the base. The canal was basin shaped in profile and was 43 cm deep. Portions of the canal were apparently lined with fire-cracked rock. Three excavation units were placed in the feature, which was filled with a homogenous light brown to tan silt. The canal appears to have been filled in during a flood event—probably the same flood that dumped light-colored silt into numerous nearby Cienega phase pit structures and pits.

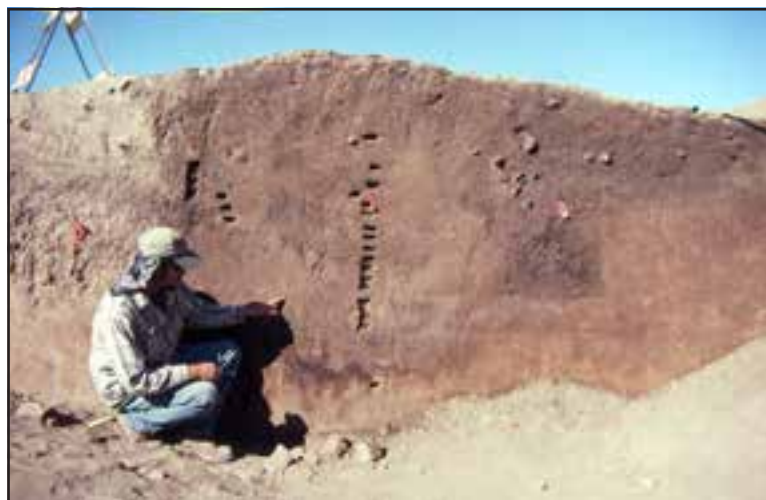
**Figure 4.102.** Photograph of canal Feature 137, AZ BB:13:481 (ASM), at the San Agustín Mission locus, the Clearwater site, AZ BB:13:6 (ASM).

Feature 137 (Figure 4.102) was a large canal found during backhoe scraping and feature excavation at the San Agustín Mission locus. The canal ran southeast to northwest, passing through the southwestern corner of the later mission compound. It was exposed for a distance of over 88.20 m. On average, it was 1.88 m wide and 1.30 m deep. The top of the canal had been truncated by modern ground disturbance.

In Trench 302, the canal was 7.58 m wide and 2.20 m deep, originating at 42 cm below the modern ground surface. The canal cut through the dark brown cienega clays that are present within the gardens into an underlying compact light brown sandy-silty clay. The canal was filled with a layer of fine, loosely consolidated sand at its base. Above this was a layer of compact dark brown blocky clay that probably represents fine sediments that were deposited as the canal was in use. Above this was a pale tan sandy clayey silt or sand that filled the canal during a flood. This flood completely filled the canal, and there is no evidence that the Hohokam ever attempted to clean out and re-use the canal. Hohokam sherds were common within the fill. The canal was

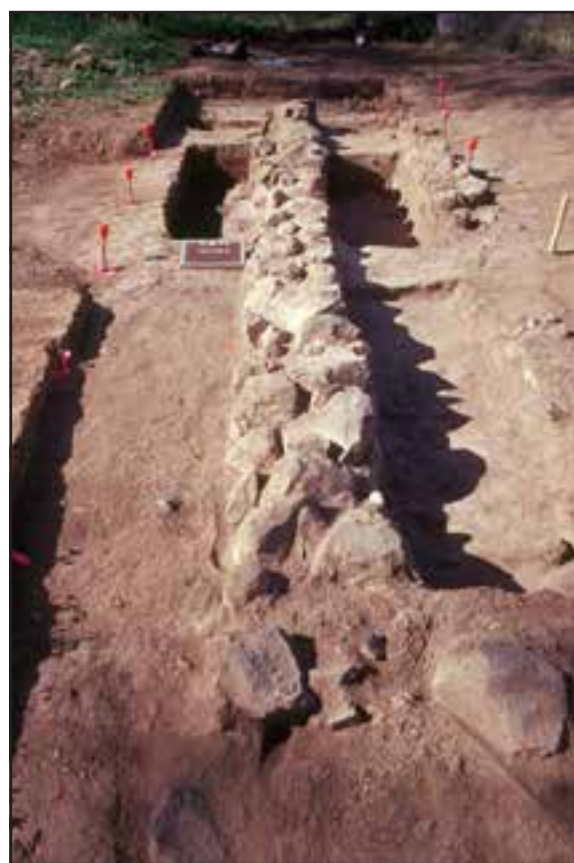
**Figure 4.116.** Feature 3, Solomon Warner's millrace; the northern wall of the millrace has been severely damaged by modern roadwork, San Agustín Mission locus, the Clearwater site, AZ BB:13:6 (ASM).

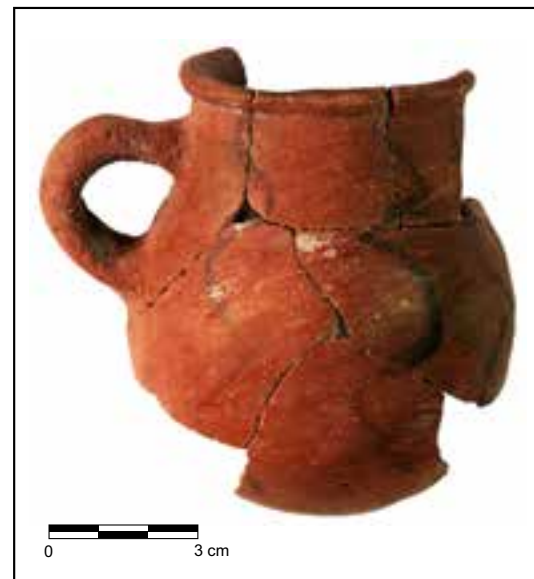
**Figure 7.10.** Papago Black-on-red cup, recovered from Feature 373, the Tucson Presidio, AZ BB:13:13 (ASM).

*Typological Approach.* The vessel forms of O'odham pottery recovered from presidio Feature 373 are reported in Table 7.31. Examination of Table 7.31 shows that more than three-quarters are bowl vessel forms, including numerous semi-flare-rim forms. A Papago Black-on-red cup recovered from Feature 373 is illustrated in Figure 7.10.

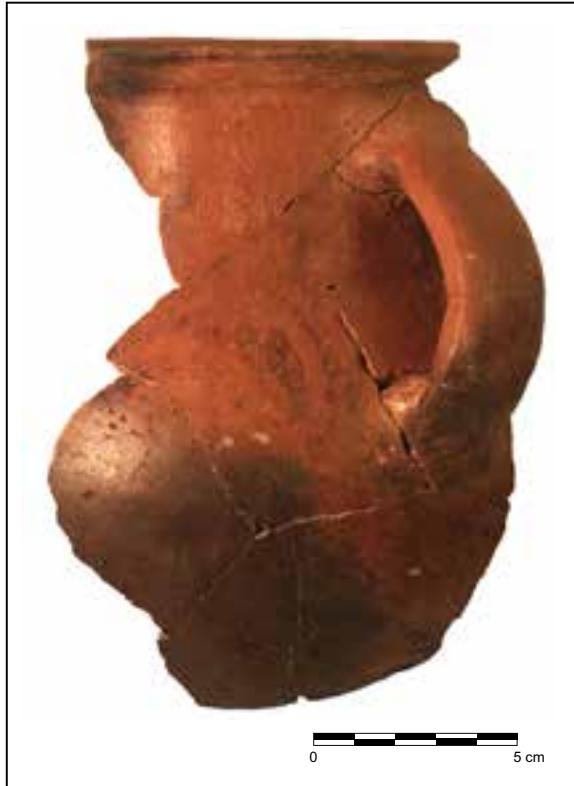
**Figure 7.11.** Papago Black-on-red pitcher, recovered from Feature 409, the Tucson Presidio, AZ BB:13:13 (ASM).

*Typological Approach.* The vessel forms of O'odham pottery recovered from presidio Features 409 and 441 are reported in Table 7.37. Examination of Table 7.37 shows that more than 64.5 percent are bowl vessel forms, including two semi-flare-rim forms. Figures 7.11 and 7.12 illustrate a Papago Black-on-red pitcher and outcurved bowl, respectively. An indeterminate Papago Red-on-buff or White-on-buff plate (Figure 7.13), a Papago Red-on-brown semi-flaring, angled long collar jar (Figure 7.14), and two Sobaipuri semi-flaring, angled long collar jars (Figures 7.15-7.16) recovered from Feature 409 are also illustrated.

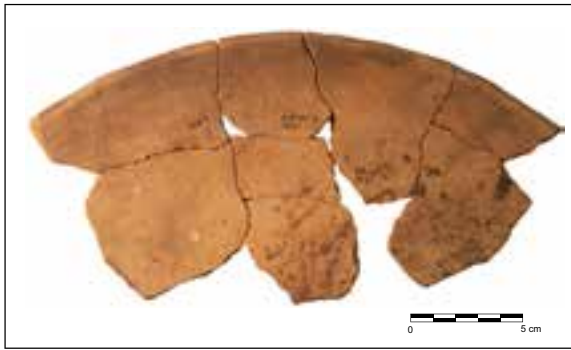
**Figure 7.13.** Papago Red-on-buff or White-on-buff plate, recovered from Feature 409, the Tucson Presidio, AZ BB:13:13 (ASM).

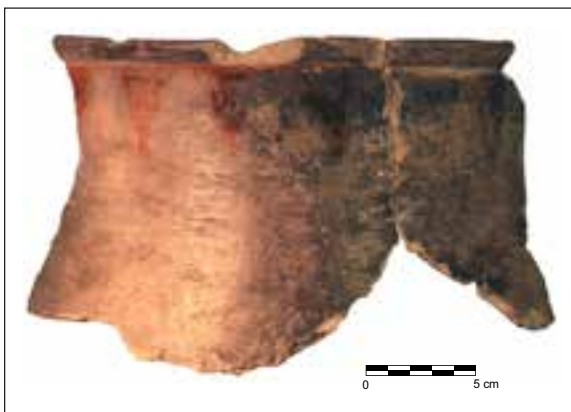
**Figure 7.14.** Papago Red-on-brown semi-flaring, angled long-collared jar, recovered from Feature 409, the Tucson Presidio, AZ BB:13:13 (ASM).

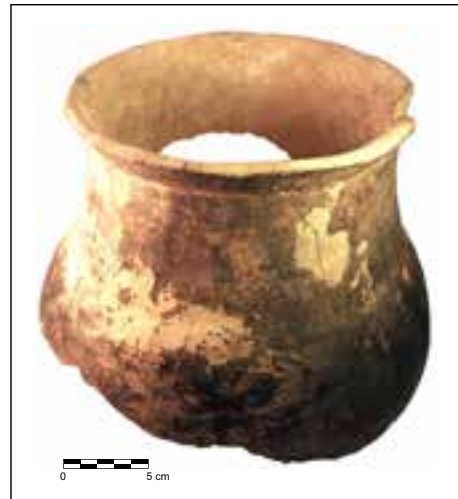
**Figure 7.15.** Sobaipuri semi-flaring, angled long-collared jar, recovered from Feature 409, the Tucson Presidio, AZ BB:13:13 (ASM).

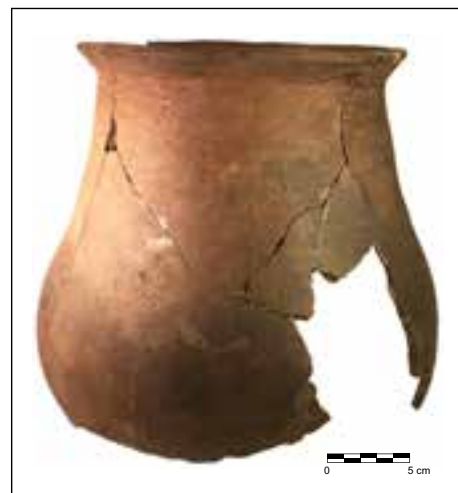
**Figure 7.16.** Sobaipuri semi-flaring, angled long-collared jar, recovered from Feature 409, the Tucson Presidio, AZ BB:13:13 (ASM).

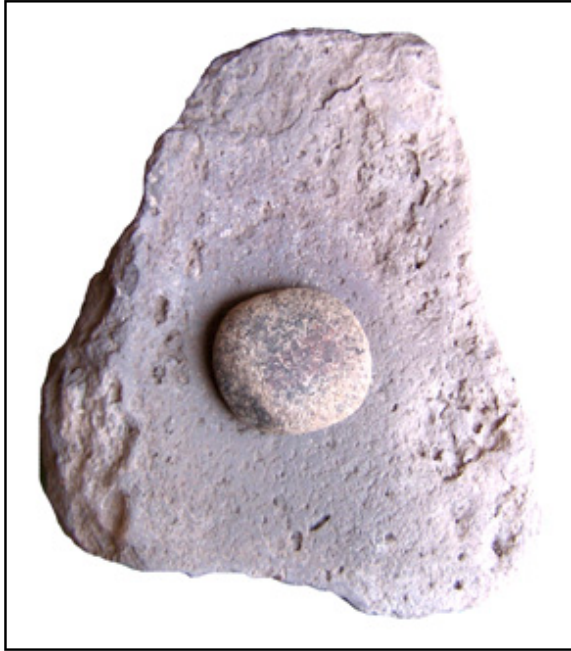
**Figure 9.2.** Flat/concave mano and metate recovered from Cienega phase pithouses at the Clearwater site, AZ BB:13:6 (ASM): (a) metate (FN 9251) recovered from the floor of Feature 3323; 55 cm long, 50 cm wide, and 14 cm thick; (b) mano (FN 9140) recovered from the floor of Feature 3327; 14.0 cm long, 13.1 cm wide, and 4.7 cm thick. The mano and metate are compatible in size and shape, but it is uncertain if they were used together.

any flat/concave mano could have been used (Figure 9.2). The secondary use of the mano from Feature 3327 to grind red pigment (see Table 9.9) was

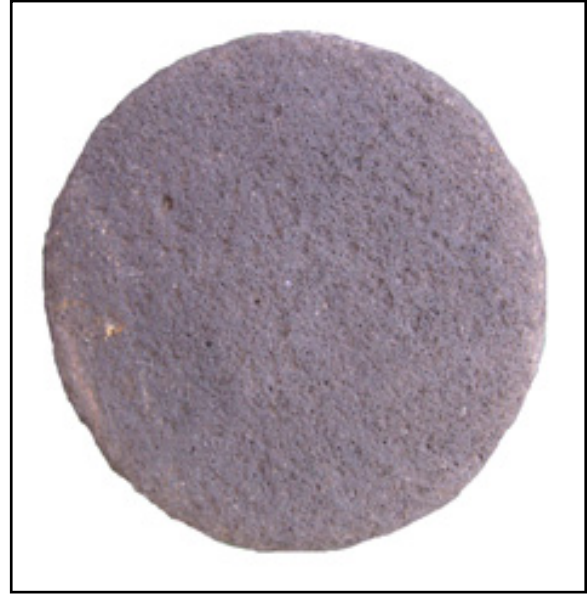
**Figure 9.3.** Flat/concave mano (FN 6195) recovered from a Cienega phase exterior pit, Feature 69, at the Clearwater site, AZ BB:13:6 (ASM); 17.0 cm in diameter and 5.8 cm thick.

In addition to the mano from Feature 3327, manos from Features 7 (floor), Feature 126 (interior pit), and Feature 9357 (roof/wall fall) were secondarily used to process red pigment (see Table 9.9). A flat/concave mano recovered from the fill of extramural pit Feature 69 was manufactured to a perfect disk and is unusually large (17 cm in diameter) (Figure 9.3). The use-wear is compatible with having been worked with a rocking stroke in a flat/concave metate. This mano and four others (Features 151, 3245, 3264, and 9357) were only used for food processing. One mano (Feature 3270) is too broken to recognize anything more than its artifact type.

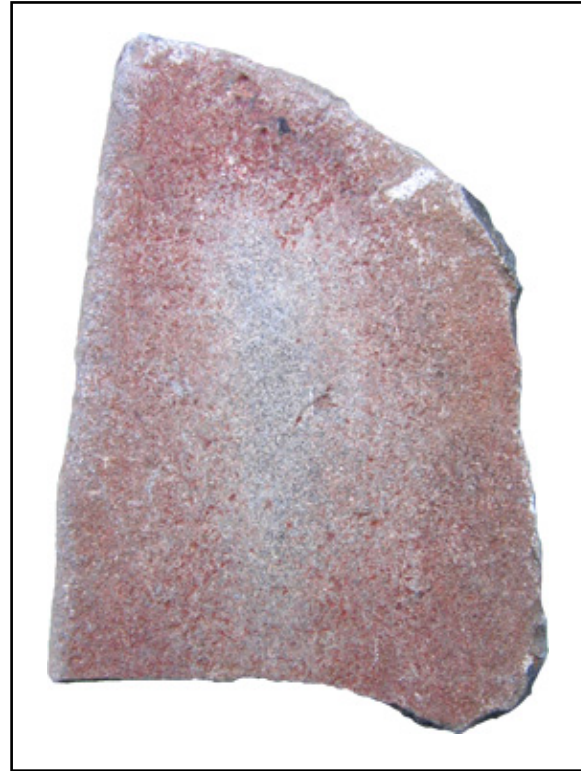
**Figure 9.5.** Lapstone (FN 5700) recovered from the floor of a Cienega phase pithouse, Feature 29, at the Clearwater site, AZ BB:13:6 (ASM). Both sides used to process red pigment with a slightly different shade processed on each side. Something other than pigment was subsequently processed wearing a clean spot in the middle of the grinding surface. Lapstone is 13.4 cm long, 10.2 cm wide, and 2.2 cm thick.

Evidence for processing pigment among Cienega phase contexts is abundant, with many tools secondarily used, such as a lapstone (Figure 9.5) and a netherstone from the floors of Features 29 and 3273, respectively. Also on the floor of Feature 3273 was a piece of ground hematite. The hematite is dark red (see Table 9.9) and the pigment stain on the netherstone is red (see Table 9.9). The manos found in Features 7 and 126 that were secondarily used to process pigment have already been mentioned.

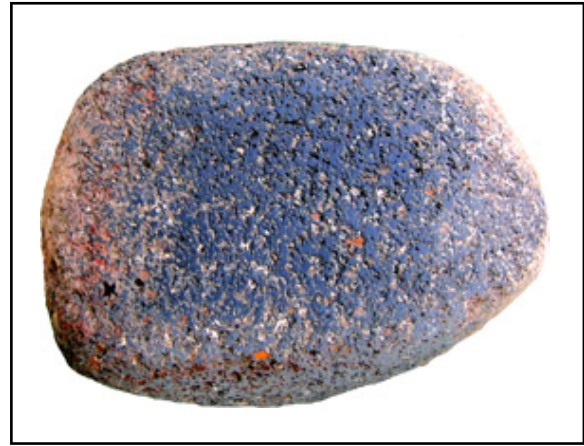
**Figure 9.6.** Flat/concave mano (FN 8245) secondarily used to process red pigment recovered from the floor of an Early Ceramic period pithouse, Feature 3014, at the Clearwater site, AZ BB:13:6 (ASM). Mano is 10.4 cm long, 6.1 cm wide, and 6.1 cm thick. Note that the color has been enhanced to make the pigment more clearly visible.

The only item clearly in contact with the floor in Feature 3014 is a flat/concave mano that was secondarily used to process red pigment (Figure 9.6; see Table 9.9). Processed earthy hematite was recovered near the floor, but it is a yellow shade of red (see Table 9.9). Colors were not the only ornamentation associated with this pithouse, however. A ground fragment of mica was either debris from ornament manufacture or an unfinished piece. It was recovered from near the floor. Another possible ornament was ground to shape, but retains much of its naturally rectangular shape. One narrow end has a small notch or a V-shaped groove in which there is use-wear from contact with something soft. The notch may have confined a sinew lashing that held another component in place. A lapstone found

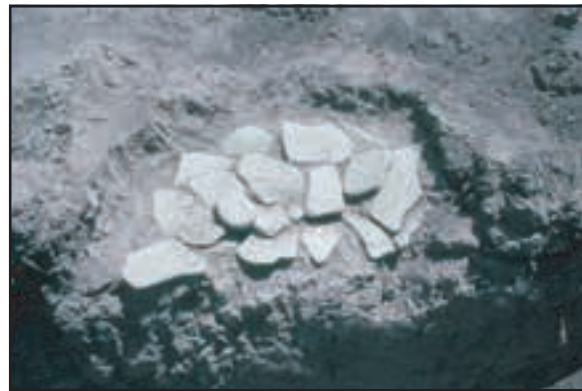
**Figure 9.7.** Field photograph of a tabular tool cache, Feature 3058, at the Clearwater site, AZ BB:13:6 (ASM).

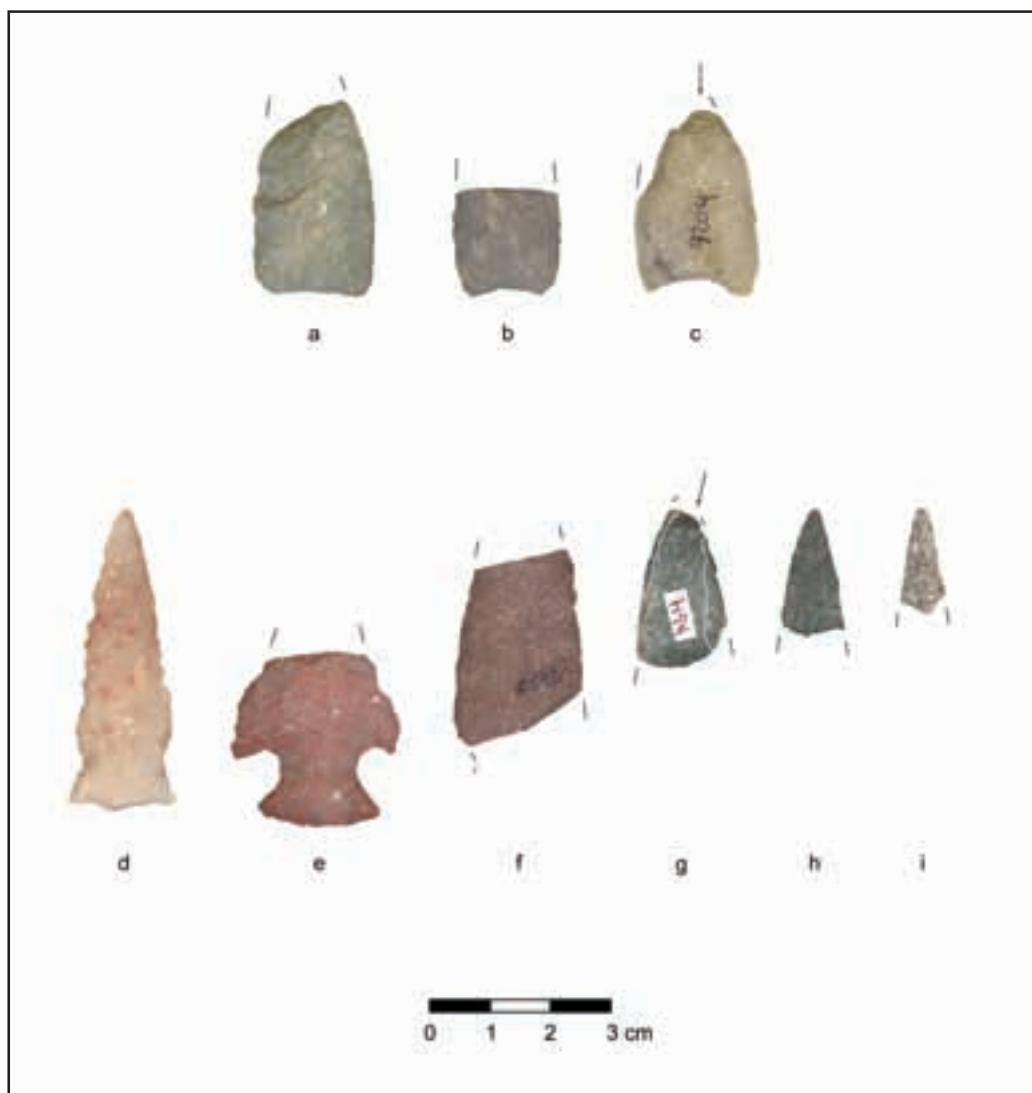
**Figure 10.1.** Projectile points from pre-San Pedro or unknown period contexts at the Congress Street locus, the Clearwater site, AZ BB:13:6 (ASM): (a-c) Cortaro; (d) Armijo-like; (e-f) San Pedro; (g-i) non-diagnostic tips.
