# **RIO NUEVO ARCHAEOLOGY, 2000-2003:**

**Investigations at the San Agustín Mission and Mission Gardens,  
Tucson Presidio, Tucson Pressed Brick Company, and Clearwater Site**

**Technical Report No. 2004-11  
Desert Archaeology, Inc.**

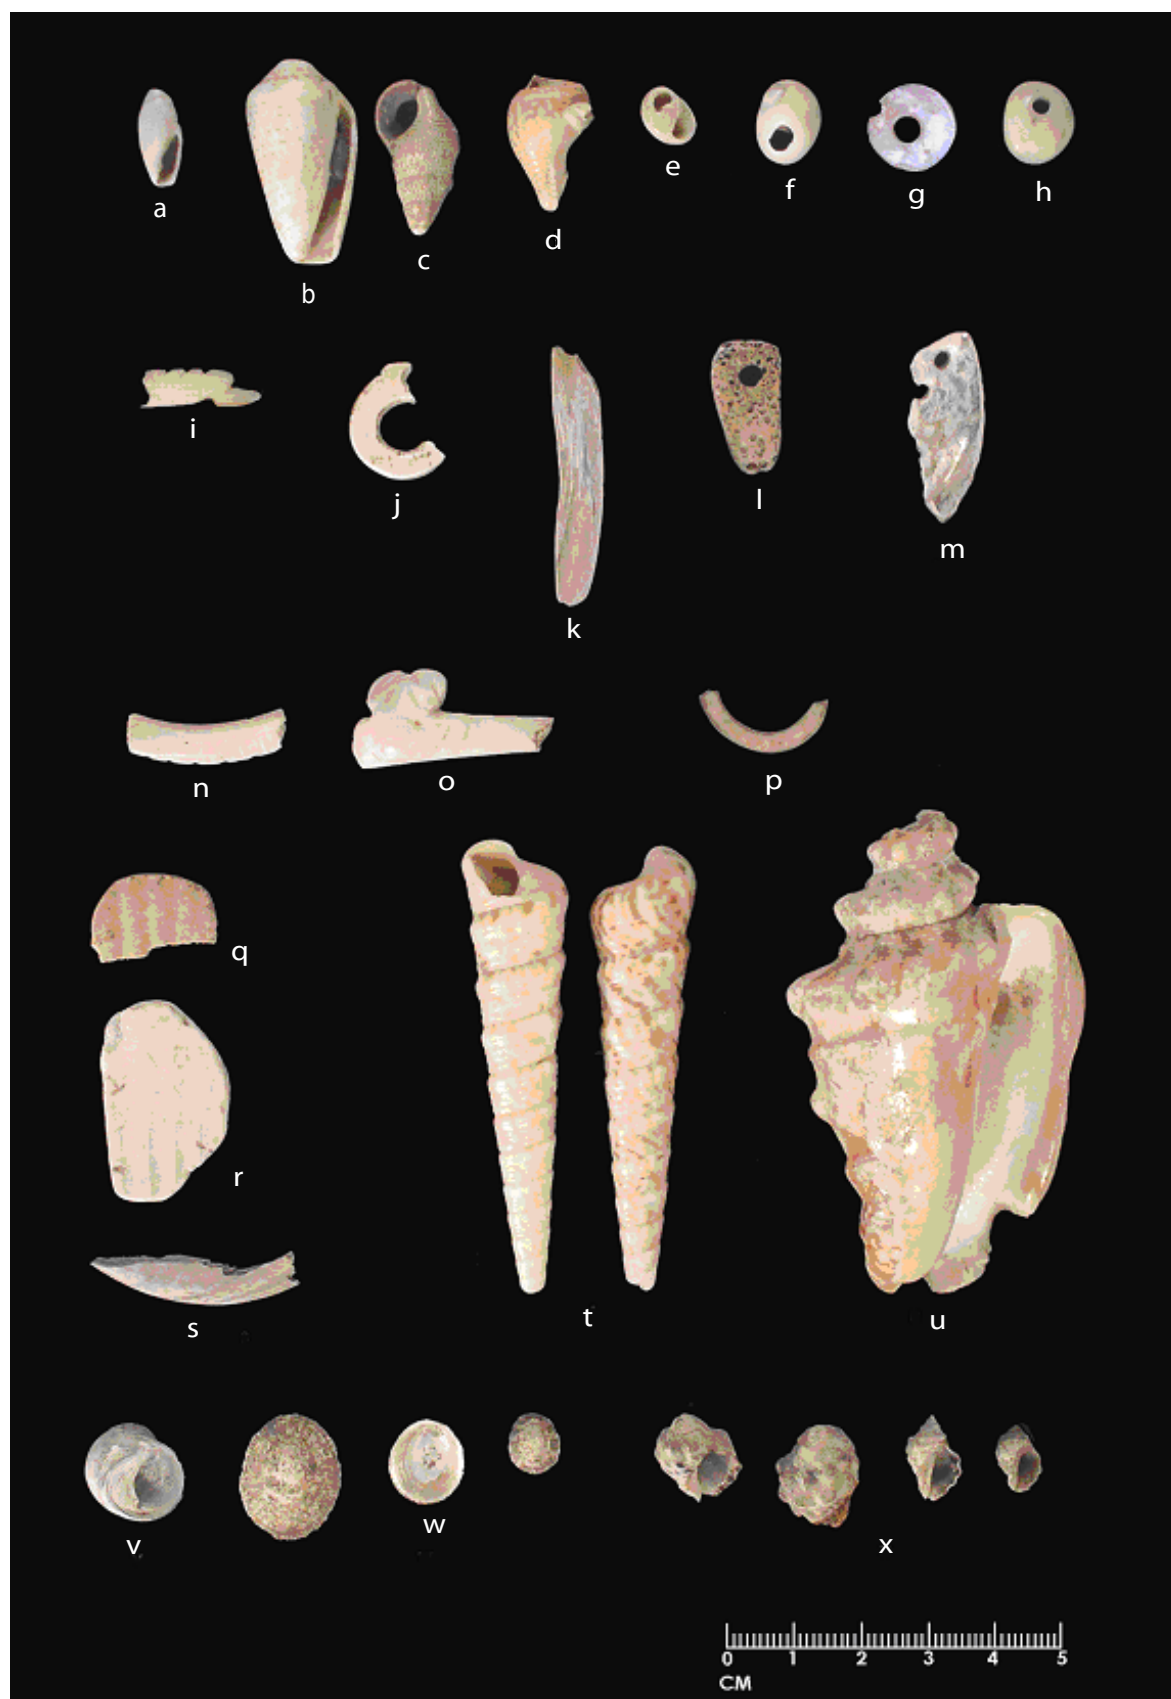
**Figure 11.1.** Examples of shell artifacts recovered from the Rio Nuevo excavations, the Clearwater site, AZ BB:13:6 (ASM).

*Whole Shell Beads.* Two different approaches are used for suspending whole shell beads. Most of those recovered from the Rio Nuevo excavations are simple spire-lopped bead forms (Figure 11.1a-b), in which the apex of a gastropod's shell is ground or broken away, and the interior columella structure is sufficiently cleared away to permit the passage of the cord. The other technique for perforating whole shell beads is to punch or grind a hole through the back of the body whorl (see Figure 11.1c-f) so that the cord passes through it and out the natural aperture. Perforated in this manner, the bulk of the shell will be suspended below the cord, which has led some researchers to group these with whole shell pendants. These are referred here to as beads due to their size, and further, when found in burials, they tend to be in multiple sets, often as bracelets or anklets.

*Other Bead Forms.* The only other shell bead present in the current sample is a single example of a “cap” bead (see Figure 11.1h). This type of bead is formed from the middle and lower portions of the spire of a medium-sized univalve, where the body of the shell whorl and the apex of the spire are completely removed. The shell here appears to have been either a *Conus* or *Oliva* valve. Beads of this style were reportedly used in a necklace that was recovered from a burial associated with a late Classic site along the San Pedro River (Carpenter 1977). Carpenter (1977) noted that the cap bead form could be the product of natural polishing and surface reduction from beach wear. The current specimen was recovered from the fill of a historic-era well at the Mission locus of the Clearwater site, and it may be an example of this natural process, because all the edges, including the interior structure, are rounded and polished.

*Decorated Bracelets.* Two bracelets in the sample exhibit decorative treatments that were intended to embellish the bracelet. The simplest of these is a section of the ventral margin from a bracelet that was decorated by cutting shallow notches along the exterior margin (see Figure 11.1n). The exterior surface is ground with a faceted profile so that the lower portion of the exterior surface forms a short vertical face at the margin. The adjacent underside of the margin edge is also ground smooth. Five shallow notches are cut into the lower edge as if to emulate the natural crenellations that were present along the margin prior to grinding the vertical face. The execution of these notches is somewhat variable, and they are unevenly spaced.

The other decorated specimen is a fragment in which the band is plain but the umbo area is carved into a realistic representation of a frog or toad (see Figure 11.1o). It is carved so that the head is directed toward the margin, with the beak forming the nose. No effort was made to show detail of the features of the head. The legs are depicted drawn up to the body as if the animal were at rest, but ready to leap.

A single fragment of a plain ring pendant (see Figure 11.1p) was recovered. It is manufactured from a medium-sized – probably juvenile – *Glycymeris* shell. The segment, which is approximately one-third of the band, incorporated the ventral margin of the shell. The exterior surface was ground back to form a vertical face similar to that present on many of the bracelets. The band was similar in finish and has a comparable band width (4.35 mm). The estimated diameter of the interior aperture – approximately 16 mm – made it relatively small in overall size.

Four specimens were recovered that seem to be ornaments still in the process of being manufactured. All but one are carved pieces of *Laevicardium* that appear to be pendants in various stages of production (see Figure 11.1q-r). Each of these pendant blanks

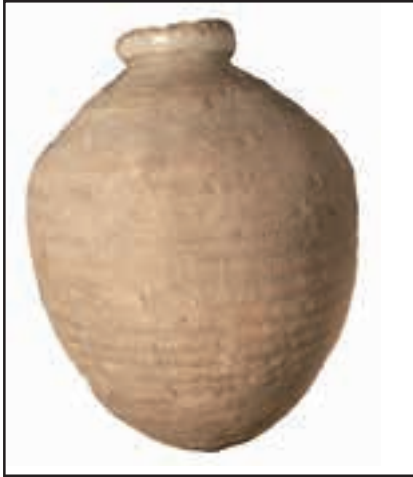
**Figure 12.1.** A Spanish period olive jar, provenience unknown (ASM 76-18-10).

Many of the containers used to transport luxury goods would have been made of perishable materials, but a handful of sherds from green glazed "olive" jars—thick terra cotta jars imported from Spain—were found in presidio-occupation features or soil layers in Tucson and other sites in Arizona (Figure 12.1). These jars, similar to Roman amphoras, were sturdy and useful for carrying liquids overland on pack trains (Deagan 1987:32). The 1820 inventory of Father Arriquibar's house in Tucson indicates he had "four pottery wine jars" (see Table 12.1).

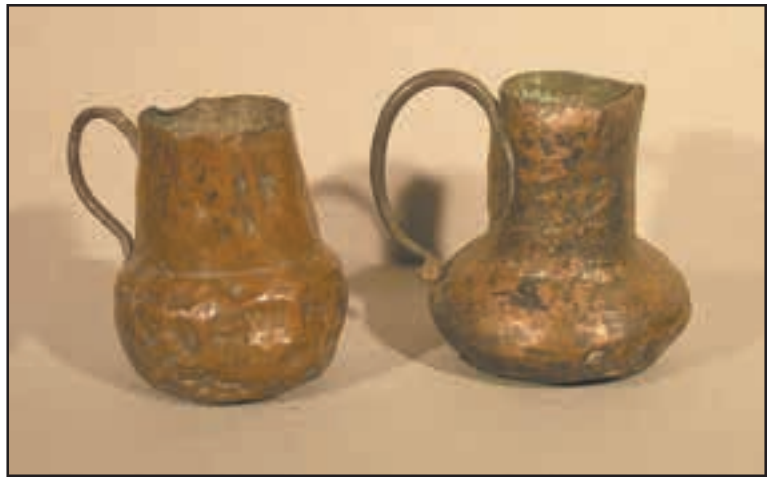
**Figure 12.2.** Copper *chocolateros* discovered near Marana, Pima County, Arizona (AHS/SAD 88.22.1 and 88.22.2).

recycled when they were no longer usable. Copper *chocolatero* pots have been found at Terrenate, Tubac, and near Marana (Figure 12.2). These small copper vessels have a bulbous base and a cylindrical top. They were used to brew hot chocolate, which was whisked with a wooden *molinillo* to make the beverage frothy.

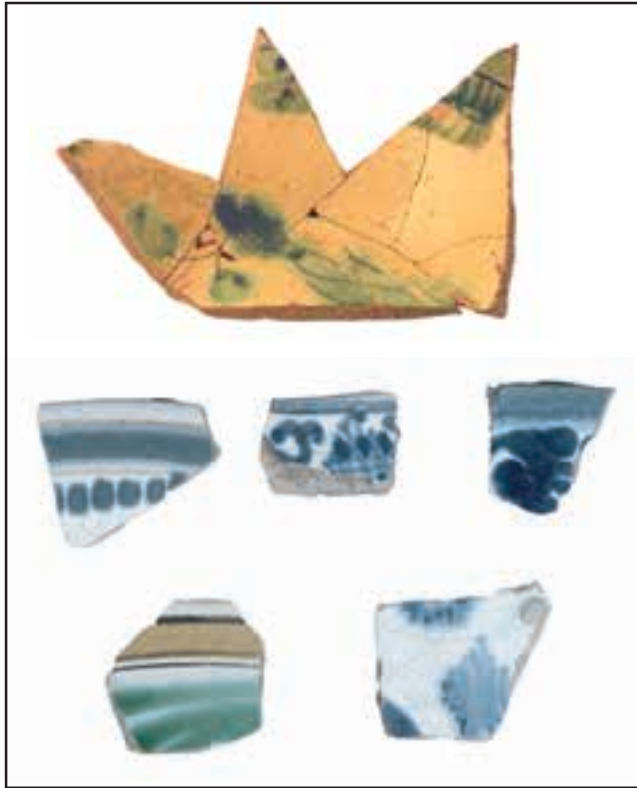
**Figure 12.3.** Mexican majolica from Spanish or Mexican period features from the Tucson Presidio, AZ BB:13:13 (ASM). Top: unidentified polychrome variety, Feature 409 (FN 3667 and FN 3786); middle row: San Elizario Blue-on-white, Feature 0 (FN 3221); unidentified blue variety, Feature 0 (FN 3901); and Puebla Blue-on-white, Feature 0 (FN 2232); bottom row: Aranama Polychrome, Feature 0 (FN 3632); and unidentified blue variety, Feature 376 (FN 2939).

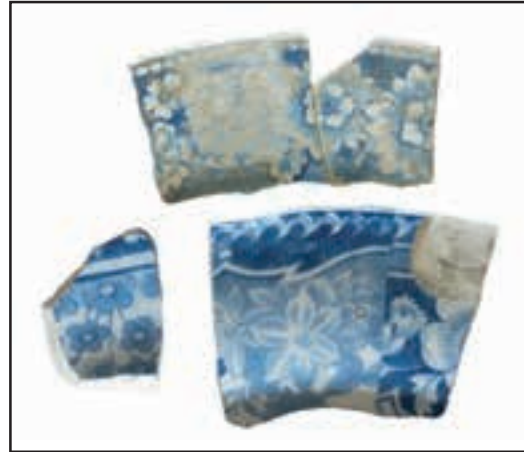
**Figure 12.4.** English transfer-print ceramics recovered from Spanish or Mexican period borrow pits within the Tucson Presidio, AZ BB:13:13 (ASM). Top: Feature 409 (FN 3667); bottom left: Feature 441 (FN 4345); bottom right: Feature 409 (FN 4148).

English ceramics became available after Mexican Independence, with an Anglo-Mexican trade treaty signed in 1824, allowing for the importation of English goods directly to Mexico. Small quantities of transfer-printed and shell-edged ceramics began to be sent to Tucson. Many of the transfer-printed vessels bore scenes depicting the European world. Residents would have looked at the scenes of castles, cathedrals, and forests in amazement. In a time before books, magazines, or newspapers, these images would have provided a glimpse of another world. A small number of pieces were found in Mexican period deposits. Most of these were blue, with floral designs (Figure 12.4).

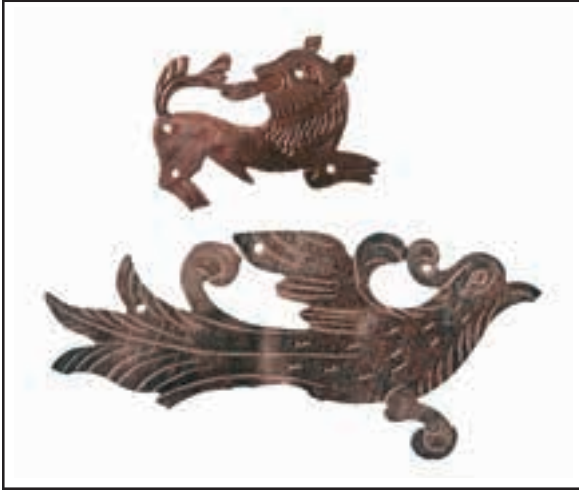
**Figure 12.5.** Brass gunstock ornaments from the Terrenate Presidio, AZ E:4:11 (ASM), dating to 1775-1780 (AHS/SAD 83-26-21 and 83-26-20).

The Spanish and Mexican soldiers stationed in Tucson relied on a variety of weapons for protection, including muskets, lances, knives, and several brass cannons. The presidio had an *armero*, whose job it was to care for and repair the weapons used by the soldiers. Inspection reports frequently commented on the poor condition of firearms, and on more than one occasion, the presidio commander requested additional muskets. The *armero* did the best he could under trying conditions, eventually recycling parts of muskets worn out from frequent use during campaigning. Because metal was valued and could be reworked into other items, such as nails or horse-shoes, relatively few pieces of weaponry have been recovered at Spanish and Mexican period archaeological sites in Arizona, except at the Presidio Santa Cruz de Terrenate. Excavations in the 1950s and artifact looting in the 1960s and 1970s at Terrenate located many items left behind when the fort was hastily evacuated in 1780. Numerous fragments of

brass gunstock ornamentation were among these (Figure 12.5).

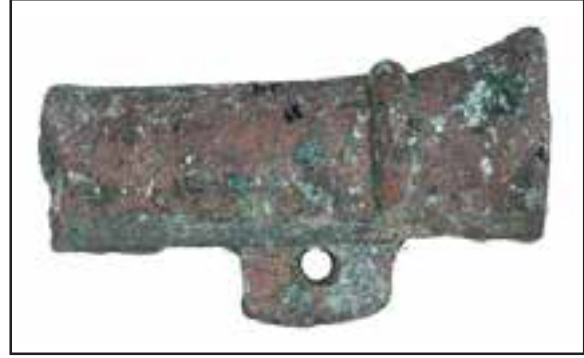
**Figure 12.6.** Brass ramrod holder recovered from the Tucson Presidio, AZ BB:13:13 (ASM), Feature 0 (FN 3273).

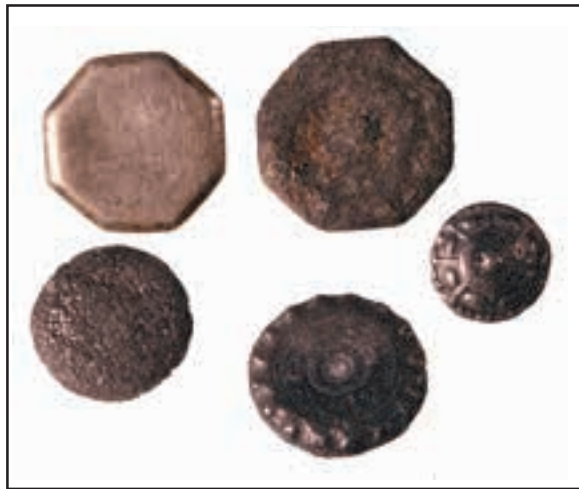
**Figure 12.7.** Brass buttons from the Terrenate Presidio, AZ E:4:11 (ASM), dating to 1775-1780 (AHS/SAD 83-26-74, 76-79).

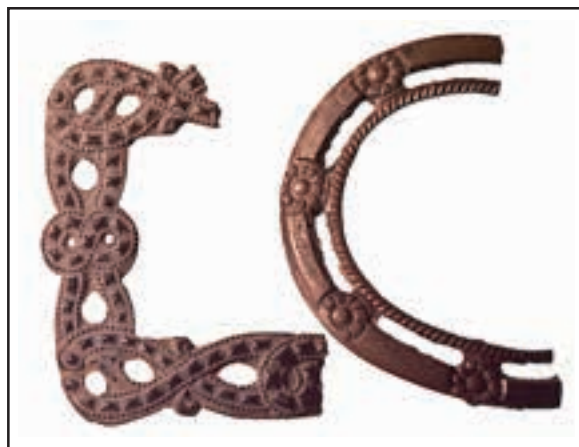
**Figure 12.8.** Brass clothing buckles from the Terrenate Presidio, AZ E:4:11 (ASM) (AHS/SAD 83-26-34, 83-26-32A).

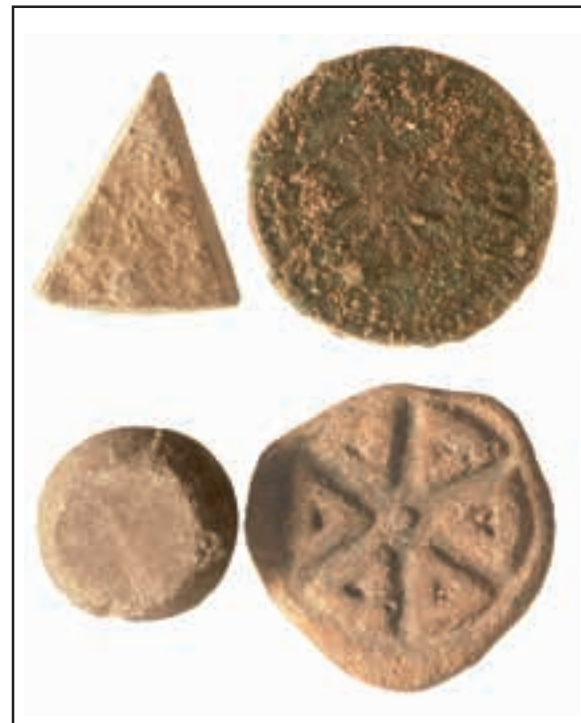
**Figure 12.9.** Small metal artifacts from the Tucson Presidio, AZ BB:13:13 (ASM). Top row: a “piece of eight” and a Mexican *cuarto real*, Feature 373 (FN 2454 and 3606); bottom row: a pair of gaming pieces fashioned from lead musket balls, Feature 0 (FN 2811 and FN 3015).

into a pie-shaped wedge to make change, were also recovered. Several gaming pieces manufactured from flattened musket balls were probably used by presidio residents to play chess, checkers, or in other pastimes (Figure 12.9).

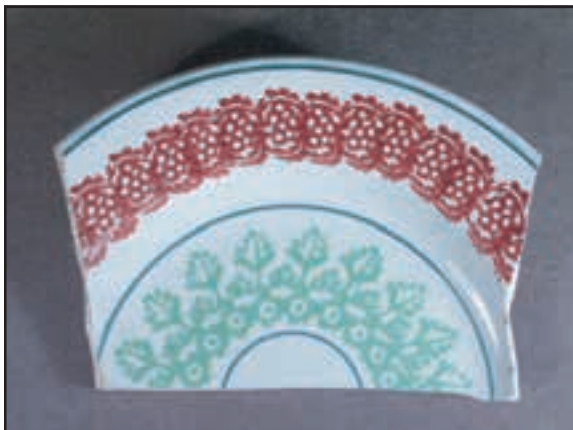
**Figure 12.10.** A sponge-printed plate from an American Territorial period borrow pit, Feature 376 (FN 2594) at the Tucson Presidio, AZ BB:13:13 (ASM).

A total of 9,279 artifacts was found in the excavated portion of this borrow pit. The base of the pit contained items from the late 1870s, while the uppermost portion of the pit had artifacts from the 1890s. As is typical of most historic-era sites in southern Arizona, architectural items and artifacts used to store, prepare, and serve food were most common (Table 12.2). At least five Mexican mixing and cooking bowls were represented by 34 fragments. Two pieces of yellowware bowls were also found. A pan, a lid to a large pot, and a pot handle were present. Food-service items included bowls, cups, saucers, plates, a brass tablespoon, a rice bowl, a shot glass, stemware, and two glass tumblers. Several pieces were decorated with a sponge-print design featuring pineapples and leaves (Figure 12.10). Elaborate serving dishes sometimes used in more affluent households were not present.

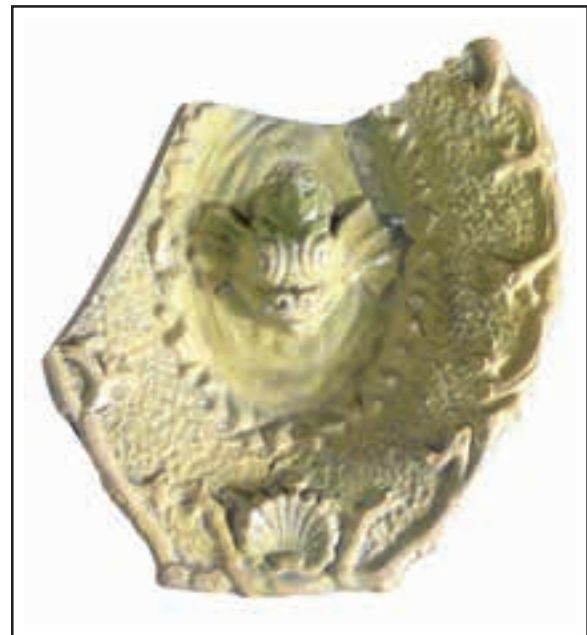
**Figure 12.11.** A decorative English bowl with a fish design found in an American Territorial period borrow pit, Feature 376 (FN 2523) at the Tucson Presidio, AZ BB:13:13 (ASM).

Pieces of furniture are not often found at archaeological sites, either because furniture was rarely discarded, or because, once discarded, its components become unrecognizable (nails) or decompose (wood and cloth). Four porcelain drawer pulls, a candlestick, and a clock were represented by artifacts found in the large pit. These items were probably tossed away when they broke and were unrepairable. A decorative English bowl with a fish peering from inside was an unusual find (Figure 12.11).

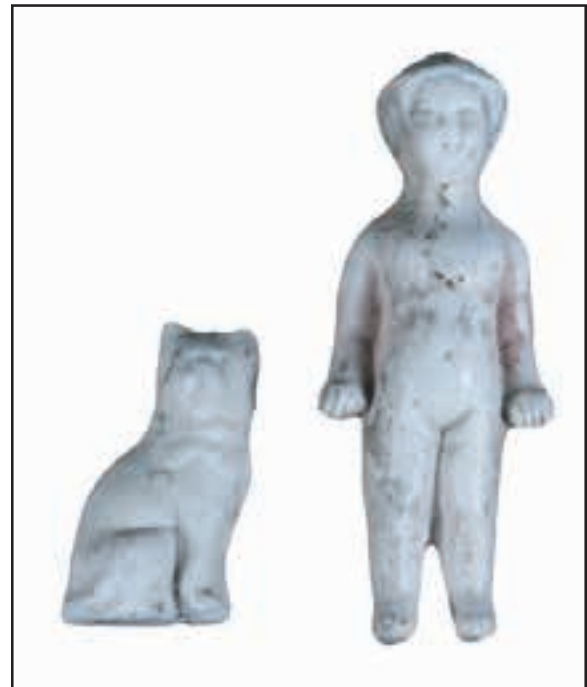
**Figure 12.12.** Bisque porcelain children's toys recovered from an American Territorial borrow pit, Feature 359 (FN 2678) at the Tucson Presidio, AZ BB:13:13 (ASM).

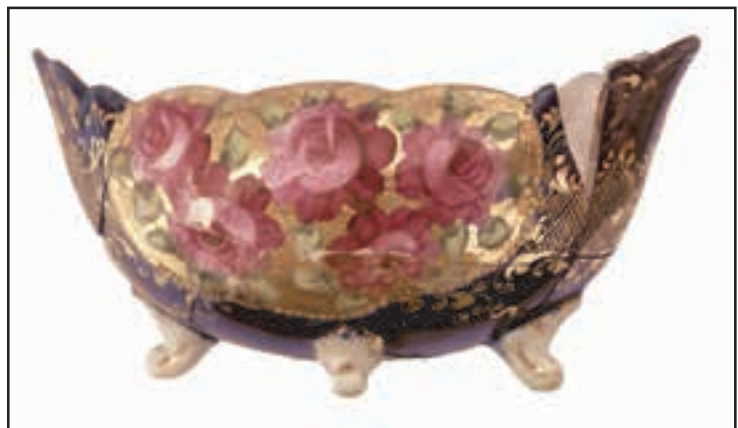
**Figure 12.13.** A decorative bowl found in an American Territorial period well, Feature 360 (FN 2983 and FN 3024) at the Tucson Presidio, AZ BB:13:13 (ASM).

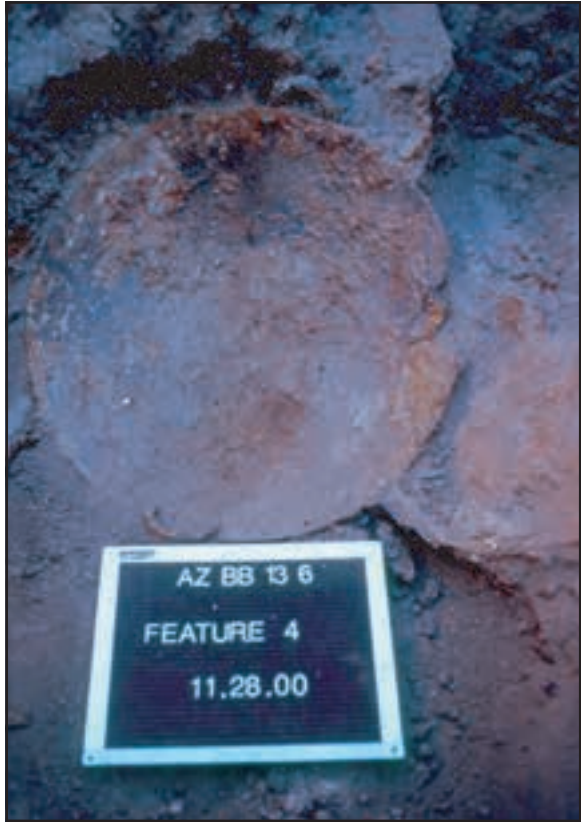
**Figure 12.14.** An iron wok found in the Chinese well, Feature 4, at the Clearwater site, AZ BB:13:6 (ASM).

found lying on its side, pressed up against the wall of the well. It had two looped iron handles soldered to the outside of its large iron bowl. It appeared very similar to modern woks. The wok did not appear to be broken, and it is unknown why it would have been discarded. Similarly, the pot and pan did not appear damaged or worn out. These items may have been discarded when households changed or when their owners died.

Food preparation artifacts included a complete wok (Figure 12.14), a deep pot, a pan, and fragments from four Mexican bowls (Figure 12.15). The wok was

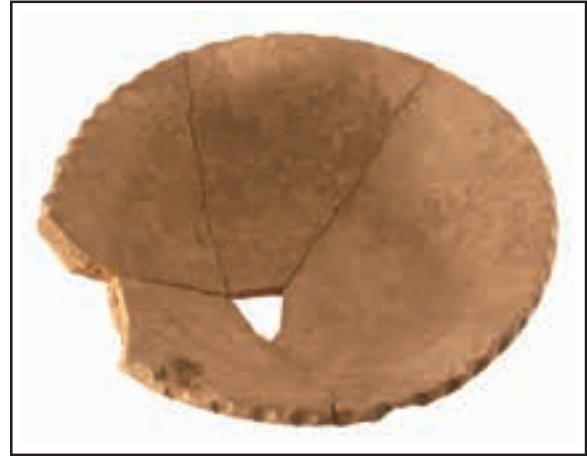
Four ceramic bowls found in the well were made from coarse earthenware; these were imported from Mexico. Each had a rounded strap handle attached to one side of the rim, with the opposite side having a series of fingerprint indentations, perhaps to help when handling the bowl. The interiors were glazed green and brown. Only the upper rims of the exteriors were glazed, and several of these bowls had soot on their exteriors, indicating they were used to cook or warm foods directly over fires.

**Figure 12.15.** A Mexican earthenware bowl found in the Chinese well, Feature 4 (FN 5450, FN 6303, and FN 6317) at the Clearwater site, AZ BB:13:6 (ASM).

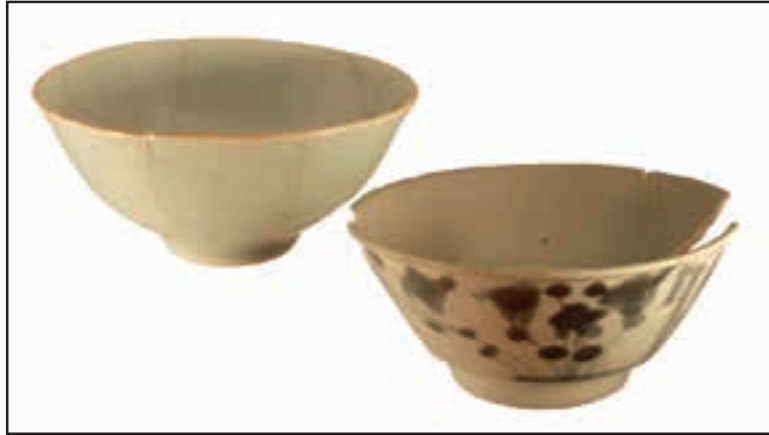
**Figure 12.16.** Celadon and Bamboo rice bowls from the Chinese well at the Clearwater site, AZ BB:13:6 (ASM). Left: Feature 4 (FN 5137 and FN 5311); right: Feature 4 (FN 5311, FN 6418, and FN 6461).

The serving vessels found in the well were mainly manufactured in China. Rice bowls (*fan wan*) were represented by two Bamboo and two Celadon examples (Figure 12.16). These bowls would have held sauces or stews, which would have been eaten with the five Four Seasons and one Celadon soup spoons found in the well. A large Four Seasons serving bowl would have conveyed food to the dining area.

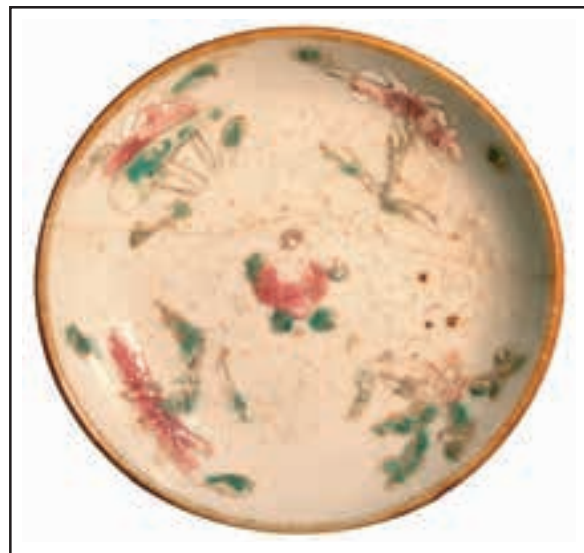
**Figure 12.17.** Four Seasons sauce bowl from the Chinese well, Feature 4 (FN 5308) at the Clearwater site, AZ BB:13:6 (ASM).

The Chinese often seasoned meals with imported sauces and spices. Two small sauce bowls—one decorated in the Four Seasons pattern and one small, plain white example—were found (Figure 12.17).

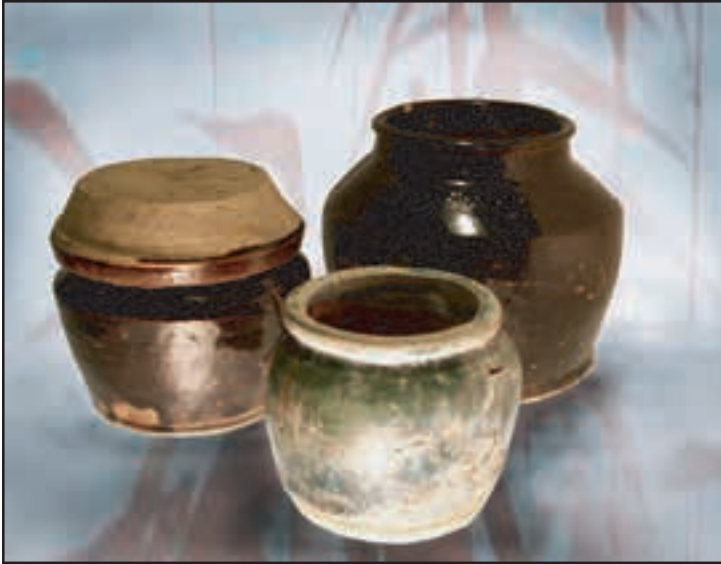
**Figure 12.18.** Food and sauce jars from the Chinese well at Clearwater, AZ BB:13:6 (ASM). All are from Feature 4: lid, FN 6303; small brown jar, FN 6303 and 5450; green jar, FN 6303 and 6359; large brown jar, FN 5121.

unglazed. One smaller jar has a lovely green glaze on the outside. Seven glazed and unglazed jar lids once capped these food containers, originally sealed in place with white clay or some other substance (Lister and Lister 1989:40-41).

Six wide-mouthed jars (*Fut How Nga Peng*) of varying sizes once held tofu, sweet bean paste, beans, pickled turnips, cabbage, shrimp paste, sugar, or condiments (Yang and Hellmann 1996) (Figure 12.18). Most of the jars had brown glaze on their interior and exterior, although the exterior base was usually

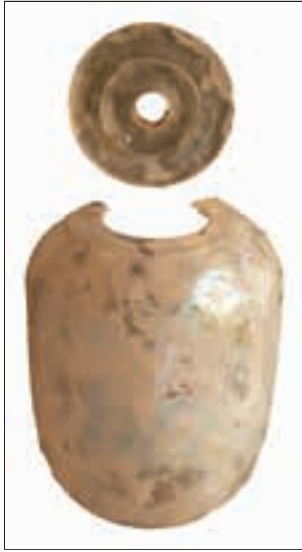
**Figure 12.19.** Glass opium lamp from the well, Feature 4, disk (FN 5119); globe (FN 5289) at the Clearwater site, AZ BB: 13:6 (ASM).

within the farmers' household. Two glass opium lamps were also present (Figure 12.19). These lamps have a glass base, a glass reservoir, and a circular pierced glass disk that caps the reservoir. Two reservoirs and one disk were found in the well.

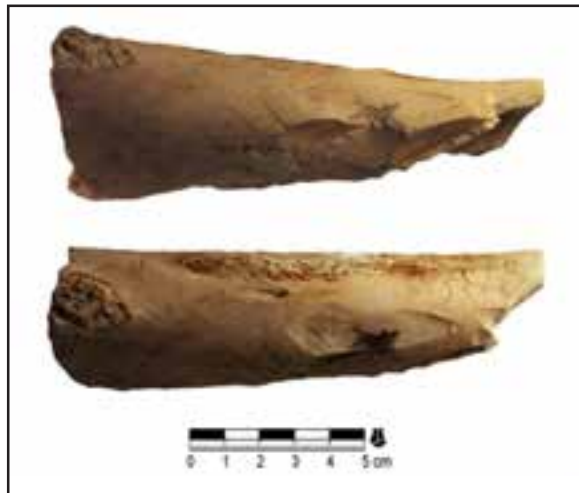
**Figure 13.3.** Cattle femur from the Tucson Presidio, AZ BB:13:13 (ASM), showing chopmarks (top) and impact scar (bottom).

specimens where the femur head was chopped through. Horizontal chopmarks through the distal femur epiphyses likely indicate separation from the tibia. There are only two examples of intact femur shafts with chopmarks; one example is illustrated in Figure 13.3. This specimen represents the division of the element into portions. The distal tibia does not appear to be involved in the disarticulation of the lower hind leg. Instead, chopmarks through the calcaneus and astragalus indicate the removal of the lower hind leg.

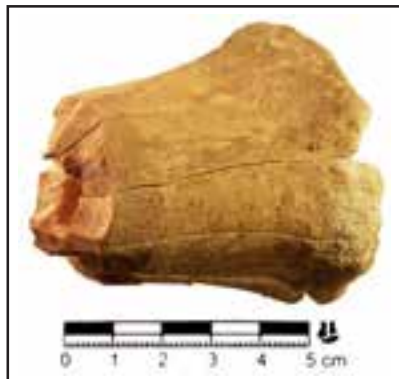
**Figure 13.4.** Cattle metacarpal from the Tucson Presidio, AZ BB:13:13 (ASM), with chopmarks.

Metacarpals and metatarsals were chopped through the shaft, possibly to remove the feet (Figures 13.4-13.5). However, it is more expedient to separate the feet from the metapodials by chopping into the joint between the distal metapodial and the first phalanges rather than chopping through the shaft of the metapodial (Landon 1996:91). Only two distal metapodial specimens exhibited chopmarks. This

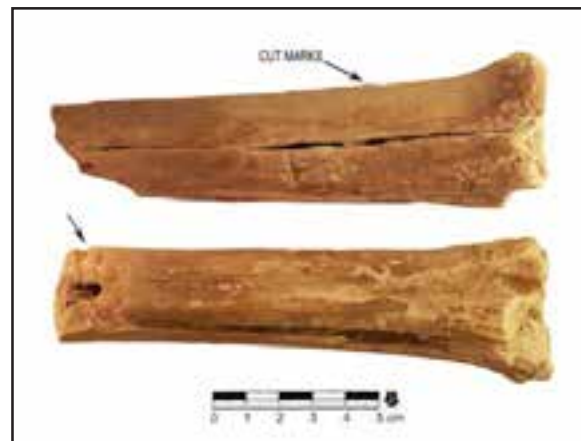
**Figure 13.5.** Cattle metatarsal from the Tucson Presidio, AZ BB:13:13 (ASM), showing cutmarks (top) and chopmarks (bottom).

suggests the metapodials were fractured for marrow. Only one proximal metatarsal (see Figure 13.5) exhibits the transverse cutmarks encircling the shaft that indicate skinning (Landon 1996:90).

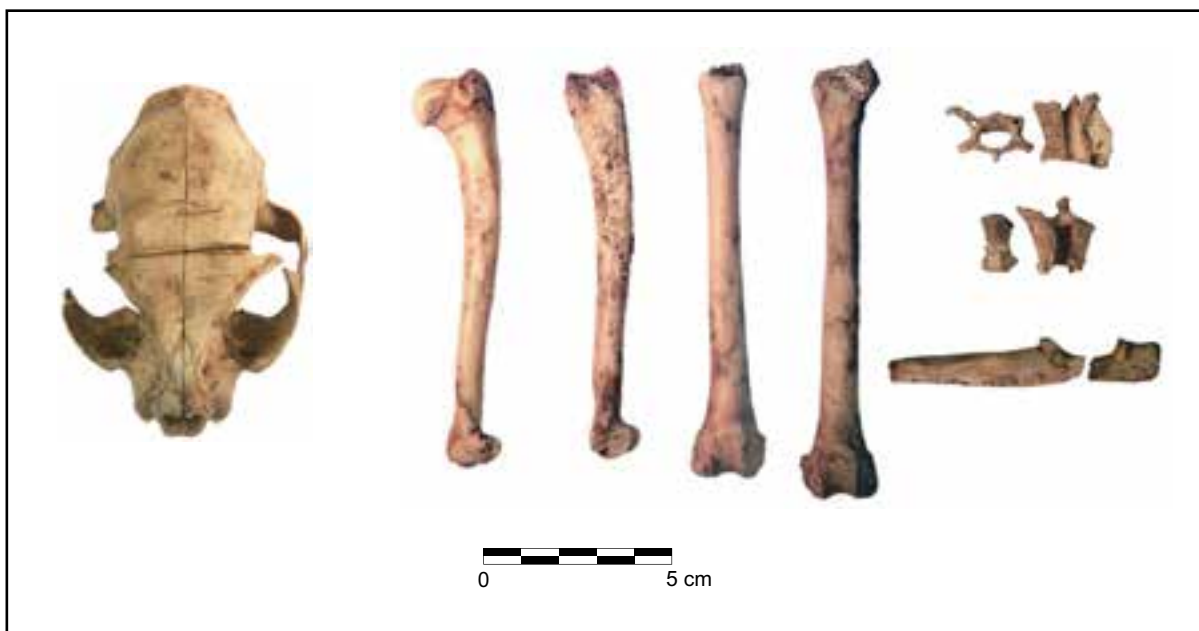
**Figure 13.6.** Chopmarks on domestic cat (*Felis silvestris*) bones from Feature 4 at the Clearwater site, AZ BB:13:6 (ASM).

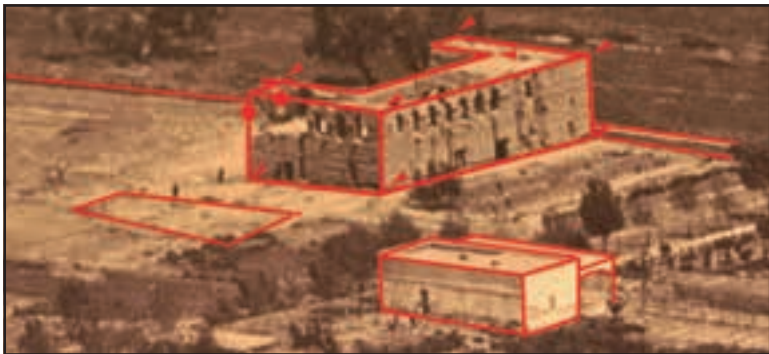
**Figure 21.2.** The second step in the modeling was to mark the same points in the first photograph onto a second photograph and to add extra points.

Information from these photographs was digitized (Figure 21.1). In the second step, known points from the first photograph were marked on another photograph, and then extra points, not visible in the first photograph, were added (Figure 21.2). By continuing this process with several photographs, a composite model was ultimately generated (Figure 21.3).

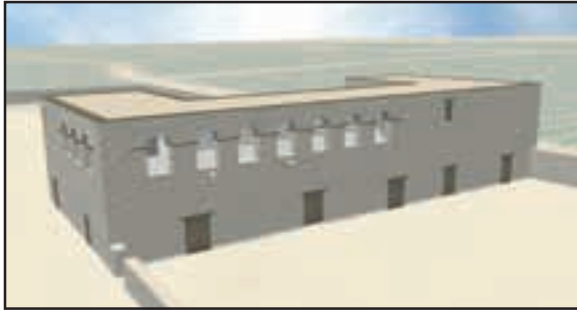
**Figure 21.7.** The convento model placed in three-dimensional space.

To increase the realism of the wireframe model, the model was covered in surfaces by a process called texture mapping (Figures 21.6-21.7). In this process, textures were applied to the model to give it a solid appearance. The surfaces created for the mission model came from a variety of sources. The color values for the adobe bricks and wall plaster came from bits of brick and plaster found during excavation of the mission site. The colors for the wood and fired clay bricks were taken from photographs of similar materials from contemporary buildings at the Mission of San Xavier del Bac and Tumacácori National Historical Park.

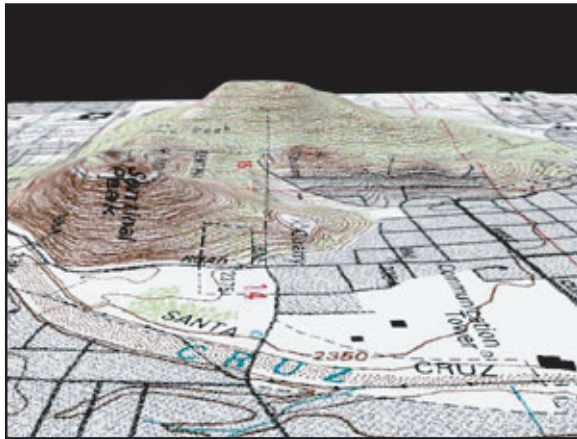
**Figure 21.8.** The terrain model, utilizing USGS topographic map data.

The USGS map provides details about the location of geological features, such as A-Mountain (Sentinel Peak), as well as information about changes in elevation (Figure 21.8). Based on survey data obtained during the excavation, the mission compound could be placed on the topographic map with a high degree of accuracy (Figure 21.9).

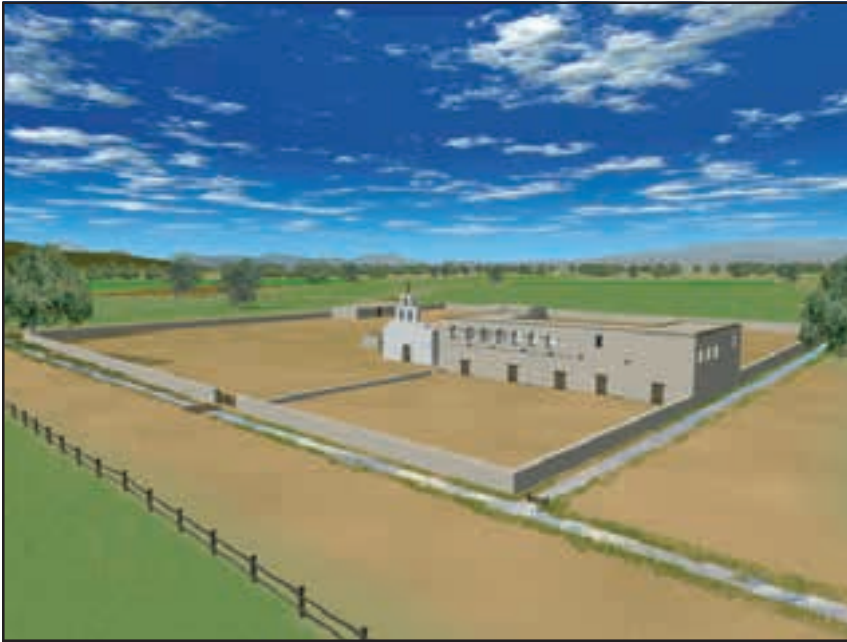
**Figure 21.10.** A conjectural reconstruction of the San Agustín Mission, Tucson, Arizona, as the mission might have appeared sometime around A.D. 1820.

The resulting model is not complete—it is a virtual hypothesis meant for study and critique (Figure 21.10). The model represents an educated guess of what the mission may have looked like, although this is still a conjectural reconstruction. Additional evidence, yet to be found, may change current ideas about the appearance of the mission.

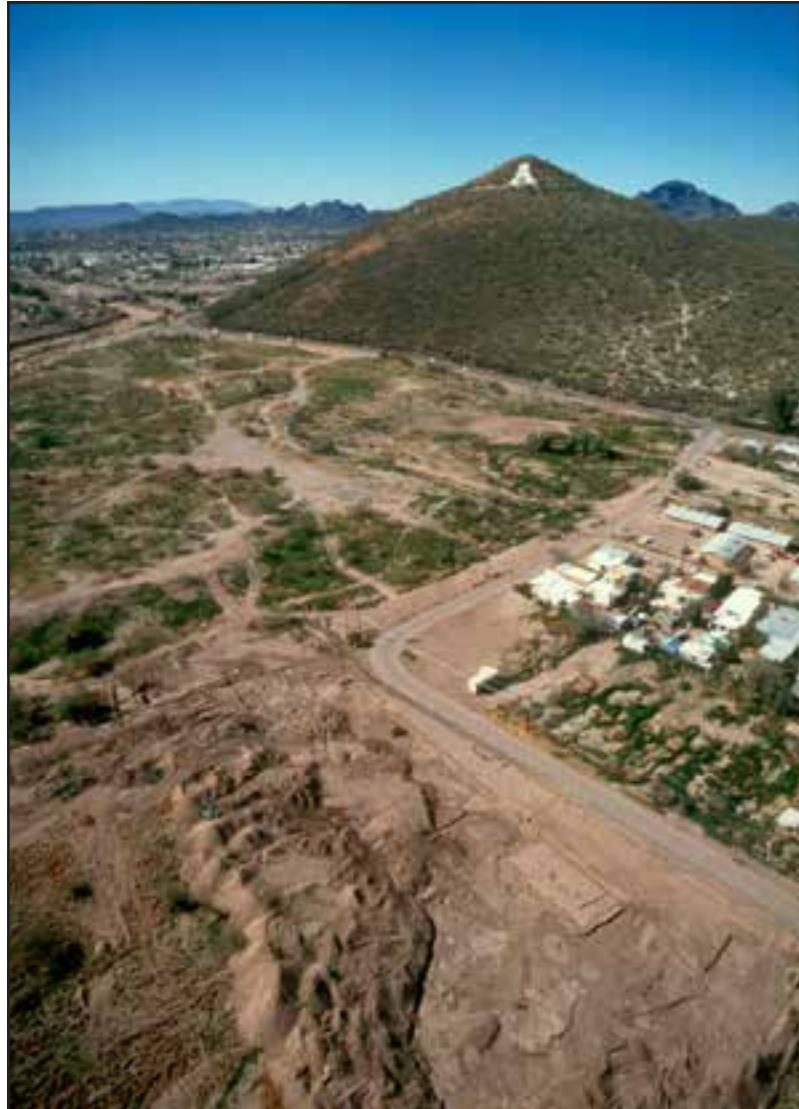
**Figure 22.1.** The Rio Nuevo Archaeological project uncovered the last surviving remnants of the Spanish period San Agustín Mission in Tucson's birthplace below A-Mountain. (In this photograph, the foundations of the mission granary are in the lower right; nearby white circles mark pithouses and pits of an early farming village occupied about 2,500 years ago. Photograph by Adriel Heisey.)

Between the twenty-first century B.C. and the arrival of the railroad in 1880, the series of communities that developed in Tucson's birthplace at the base of A-Mountain (Figure 22.1) and in the downtown area shared characteristics that define communities everywhere. They were groups of people living together, facing the same challenges, interacting face-to-face, having a general familiarity with the everyday life of each other, sharing certain beliefs and customs, and maintaining the necessary demographic balance and group memory to reproduce themselves and pass their cultures on to subsequent generations. Because each type of community shared these characteristics and developed from the previous one, the history of Tucson communities has a trajectory that can be traced through time.

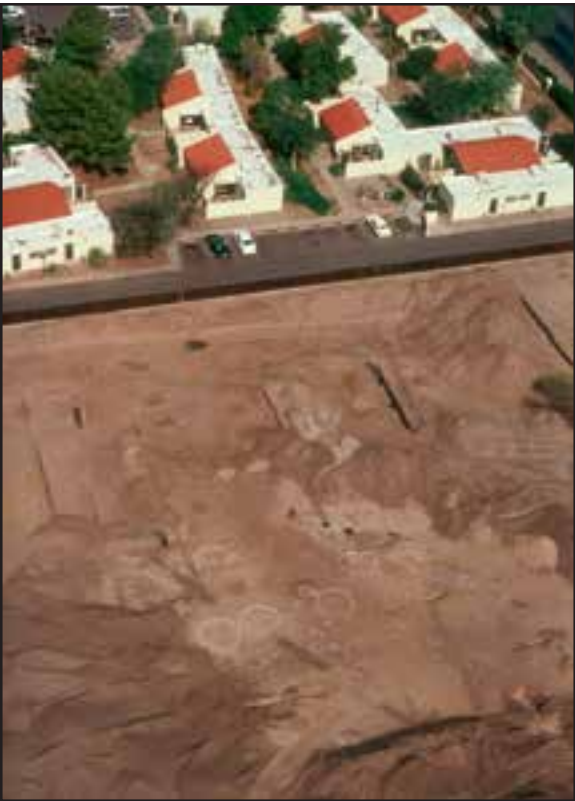
**Figure 22.3.** White circles mark pithouses and pits of a 4,100-year-old early farming settlement south of West Congress Street. (Photograph by Adriel Heisey.)

The earliest documented community in the floodplain at the base of A-Mountain was a settlement of seven pithouses surrounded by numerous pits for storage and other purposes, occupied about 4,100 years ago (2100 B.C.) (Figure 22.3). Named the Clearwater site, AZ AA:13:6 (ASM), the archaeological remains suggest it was a seasonal settlement occupied during the summer months by a band of hunter-gatherers who moved around the Tucson Basin throughout the year. Sediments, pollen, and charred plant remains preserved in the cultural features of this settlement show that the high water table created by a combination of geology and hydrology allowed these first Tucsonans to cultivate maize (corn), a then-recently introduced tropical cultigen, in this location. This method of water-table farming was probably the earliest type of agriculture in the Southwest (Mabry 2005).

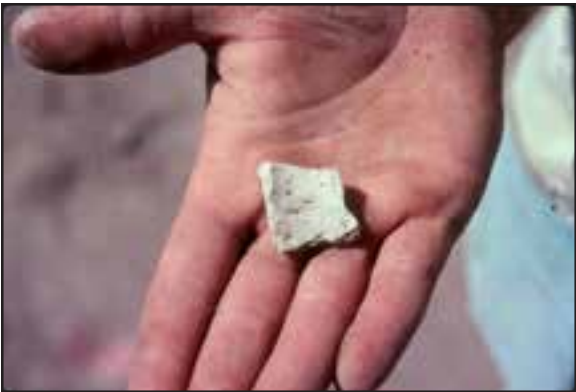
**Figure 22.4.** Pieces of pottery discovered in the 4,100-year-old pithouses are the oldest known pottery in the southwestern United States.

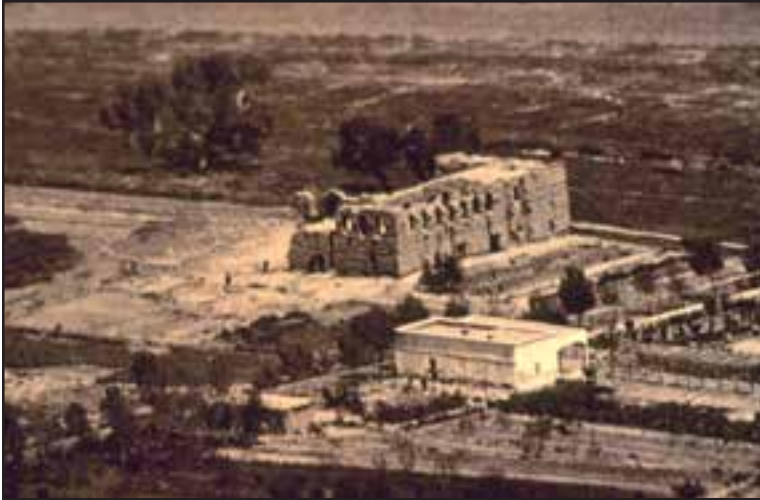
**Figure 22.5.** When this photograph was taken in 1880 from A-Mountain (then known as Sentinel Peak), the ruin of the two-story convento was the last standing structure of the San Agustín Mission (Photograph no. 18233, AHS/SAD).

system of irrigation canals providing water for agricultural fields where maize, beans, and squash were being grown. Kino would later introduce European crops and livestock, including wheat, peaches, cattle, horses, and sheep. Census records in the 1750s and 1760s suggest a few hundred people lived in the settlement, including Sobaipuri Pimans who arrived in 1762 from the San Pedro River area. A detailed census prepared in 1801 by Father Llorens listed almost 250 people at San Agustín, including Pimans, Papagos, and Gileños. By the 1820s, the mission was largely abandoned, as people moved away to San Xavier and the Gila River, or perished from European diseases (Dobyns 1976). Late nineteenth century photographs document the disintegration of the mission ruins (Figure 22.5).

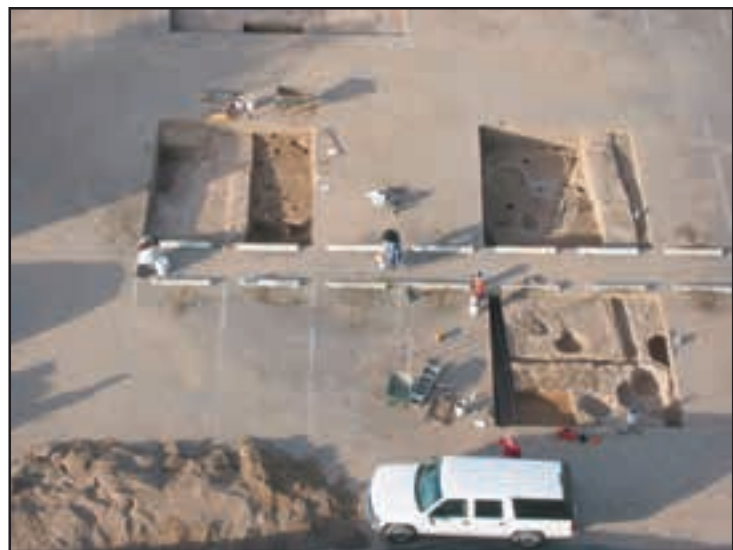
**Figure 22.8.** The wall foundations of a corner tower of the Tucson Presidio were found beneath a parking lot on the corner of Washington Street and Church Avenue; a prehistoric Hohokam pithouse is visible beneath the wall.

Architectural remains reveal that a large square tower stood at the northeastern corner of the fort (Figure 22.8), projecting 20 ft out from the walls of the presidio to provide a line of fire along the northern and eastern walls. Soldiers stood guard inside the 20-ft-tall tower, standing on a wooden walkway, watching out for the Apaches.
