August 13, 2024

Subject: Significant and Unmitigated Watershed Degradation Due to Inadequate Erosion Control Measures on SunZia Roads and Disturbance Areas

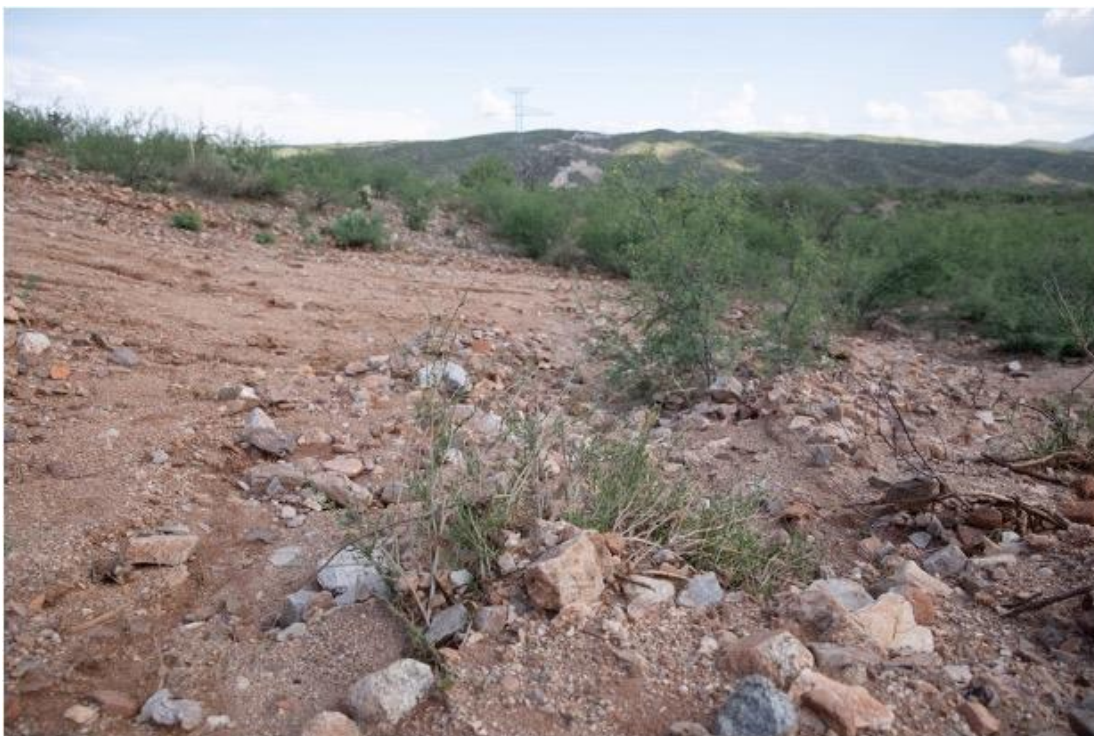
The denudation and degradation of land surfaces and loss of soil productivity directly impact habitat and water quality. As plants are covered in sediment, water retention decreases, edge effects and habitat fragmentation increase, and the potential for invasive plant colonization increases (Figure 1) (2013 FEIS pp. 4-28, 4-64). As silts and clays are mobilized by precipitation, the decreased water quality in the San Pedro River and its tributaries negatively impacts fish, amphibians, aquatic invertebrates, and aquatic birds, either directly or by decreasing foraging success (2013 FEIS pp. 4-65 to 4-67).

Figure 1. Surface wasting below tower pad site S1-098/2, July 29, 2024.

forming and soil and hydrological systems are being damaged. Please instruct appropriate personnel to take immediate steps to install the required water bars, additional silt fences, and related measures to counter the stream and watershed degradation that are actively unfolding.

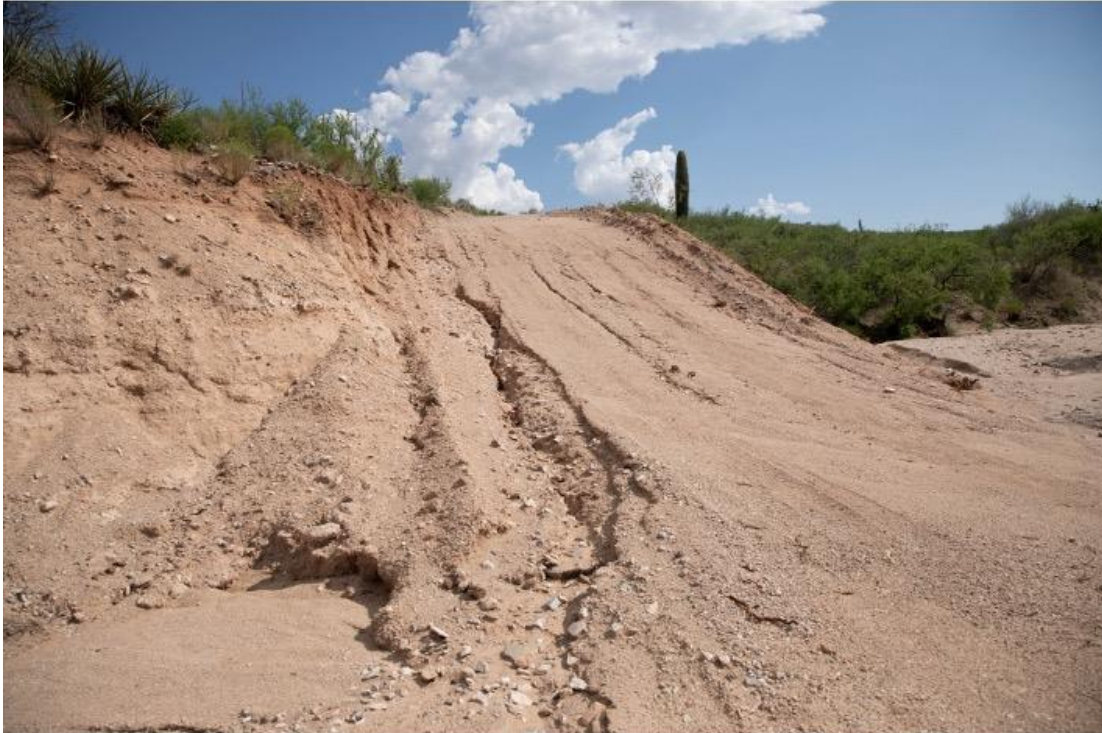
SunZia's *Erosion, Dust Control and Air Quality Plan* (Plan of Development, Appendix A) describes mitigation measures for “Drainage Control” and “Reducing Short-Term Erosion and Sedimentation” (POD p. A6-7). The plan requires “drainage control structures to direct surface runoff away from the road surface to prevent rill and rut development and to control runoff and sediment discharges.” These measures include detention basins, silt fences, water bars at appropriate intervals, rolling dips, ditches, culverts, and appropriate grades and inclination (POD pp. A6-7). Although SunZia has built a few detention basins and installed some silt fences, these efforts have been inadequate to prevent hundreds of rills and ruts on access roads (Figure 3), dispersion of silt fences (Figure 4), and fissures at tower pad and pull/tension sites (Figures 5 and 6).

Figure 3. Rills and ruts forming on access road near 32.359648°, -110.486519°, July 25, 2024.

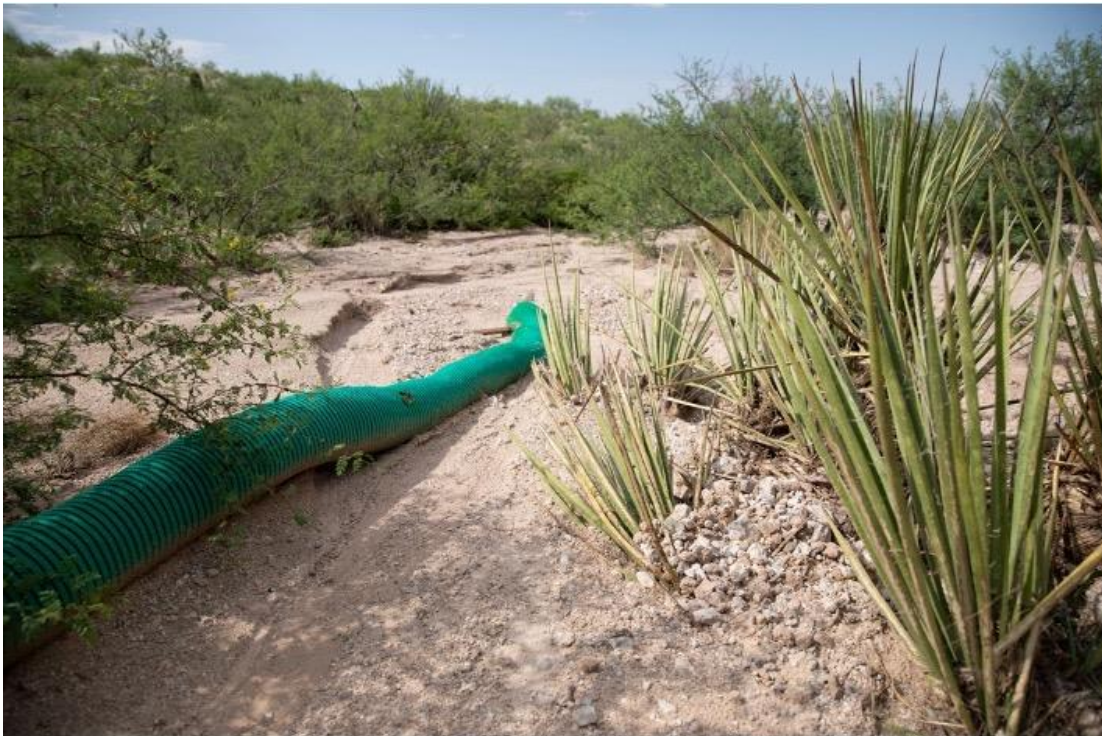
Figure 4. Silt fences made of synthetic material dispersing into the drainages near 32.364137°, -110.492155°, July 29, 2024.

SunZia construction and monitoring crews have failed and are failing to prevent major erosion and stream siltation. SunZia tower installation in the Valley is complete, except where helicopter-placement is required. With “substantial completion” of all work by “heavy equipment such as concrete or water trucks, pole delivery, cranes etc.,” it is past time for the installation of the water bars, cross ditches, and biodegradable silt fences, and for the removal of the downslope road berms not already destroyed by runoff.

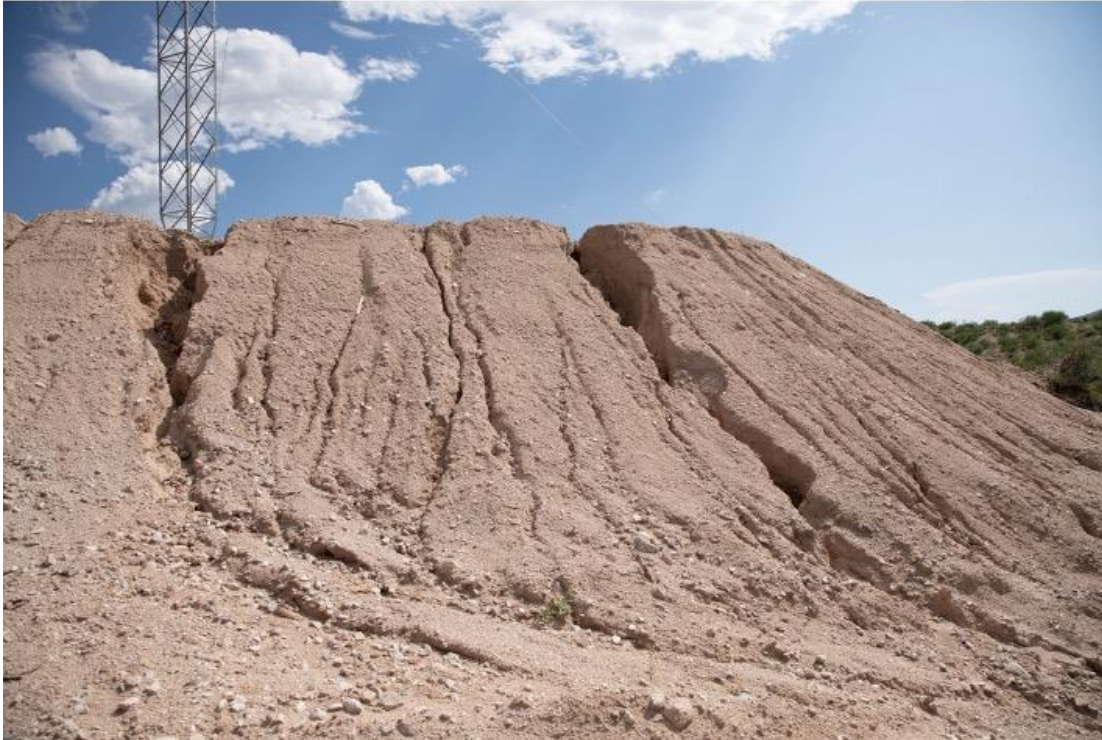
Figure 5. Fissured slopes at tower pad site S1-095/3, July 29, 2024.

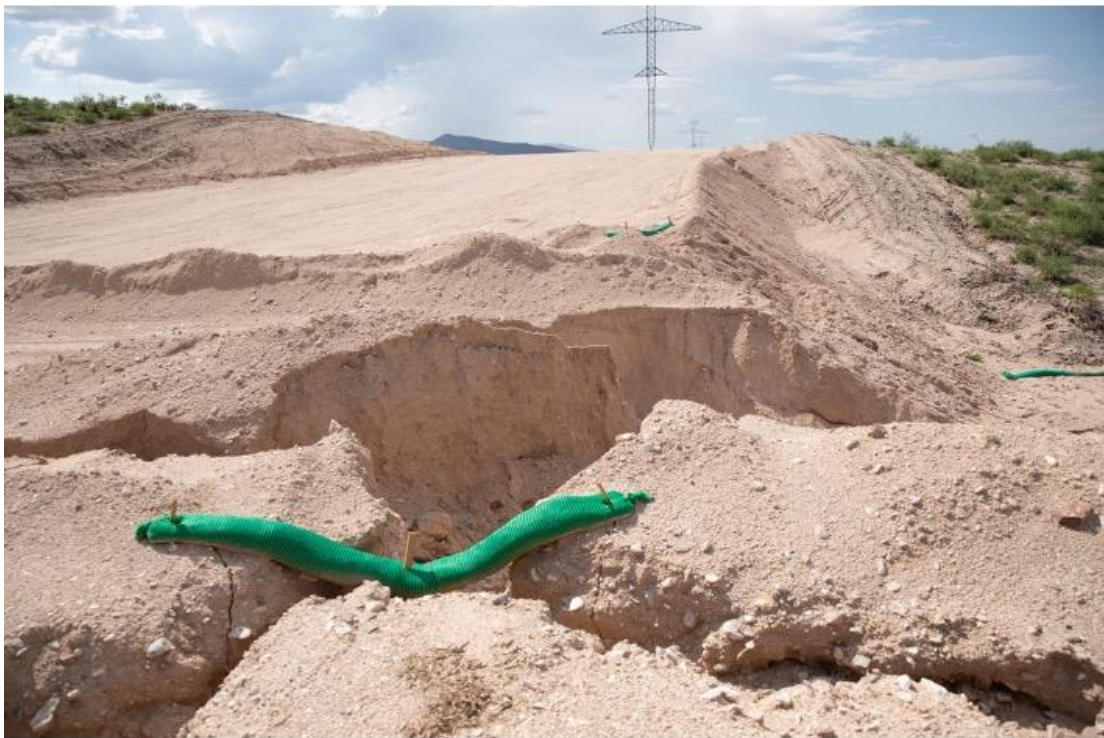
Figure 6. Gullies forming on pull/tension sites near 32.364137°, -110.492155°, July 29, 2024.
